ARMY RESEARCH LABORATORY

T-55 Engine Compressor Stator Vane Investigation

ARL-TR-2123

November 1999

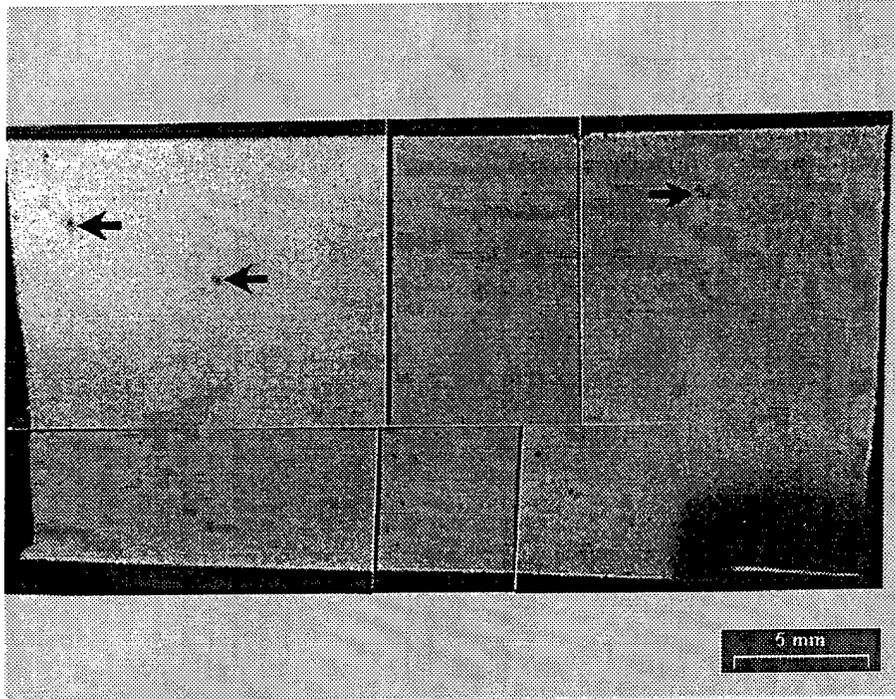
The previous findings obviously constituted failure of the visual requirements stipulated by AMS 2400 Rev. S [2]. The corrosion observed on the as-received components was indicative of a coating system that was not capable of providing protection under normal environmental conditions. It was readily apparent that this coating system would not be adequate to pass the engine corrosion test requirement, an environment much more severe than our standard atmosphere.

Figure 3. Concave Side of a Single Vane Showing Corrosion Pits.

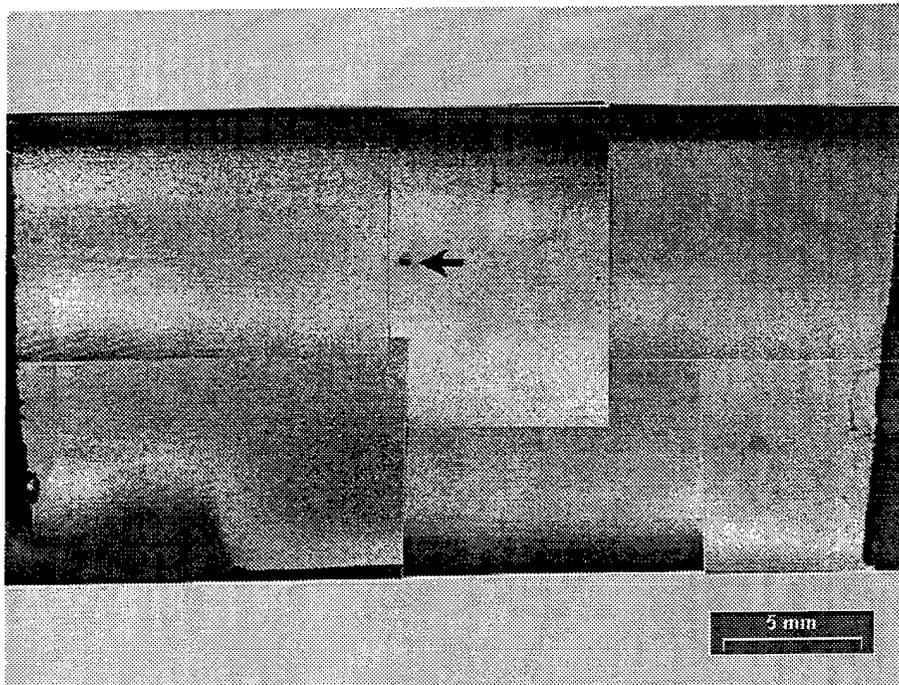
Figure 4. Convex Side of a Single Vane Showing Corrosion Pits.

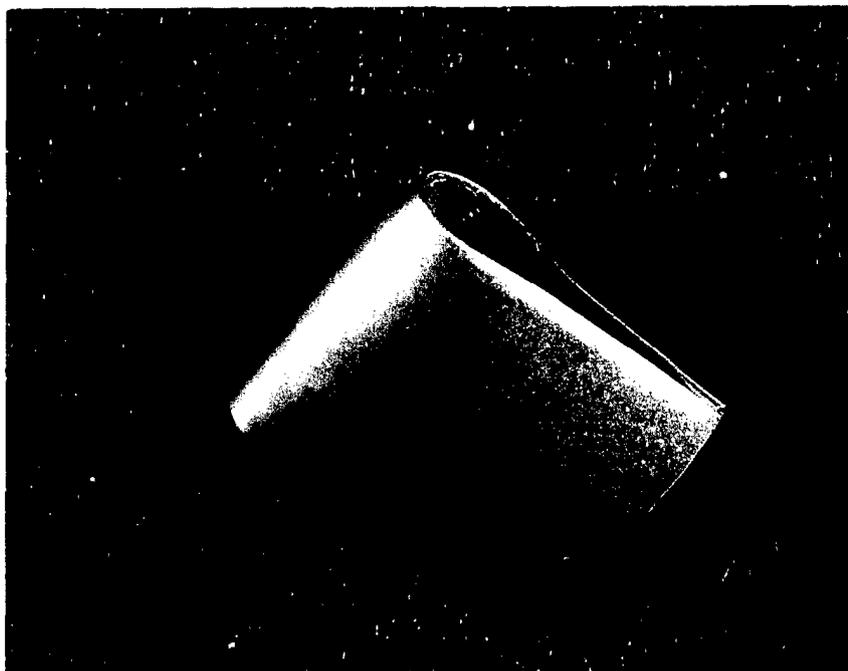
specimens shall not show separation of the plating from the basis metal, when examined at 4× magnification, after being bent rapidly, in accordance with ASTM-E-290, through an angle of 180° around a mandrel with a diameter equal to the thickness of the specimen [2, 3]. A single vane was carefully sectioned from the interior and exterior shroud of the assembly. The sectioned vane was then bent around a mandrel with a diameter approximately equal to the thickness of the vane. The bent vane can be observed in Figure 7. No evidence of failure was noted.

Figure 7. ARL Vane Bend Test Specimen (Magnified Approximately 3×).

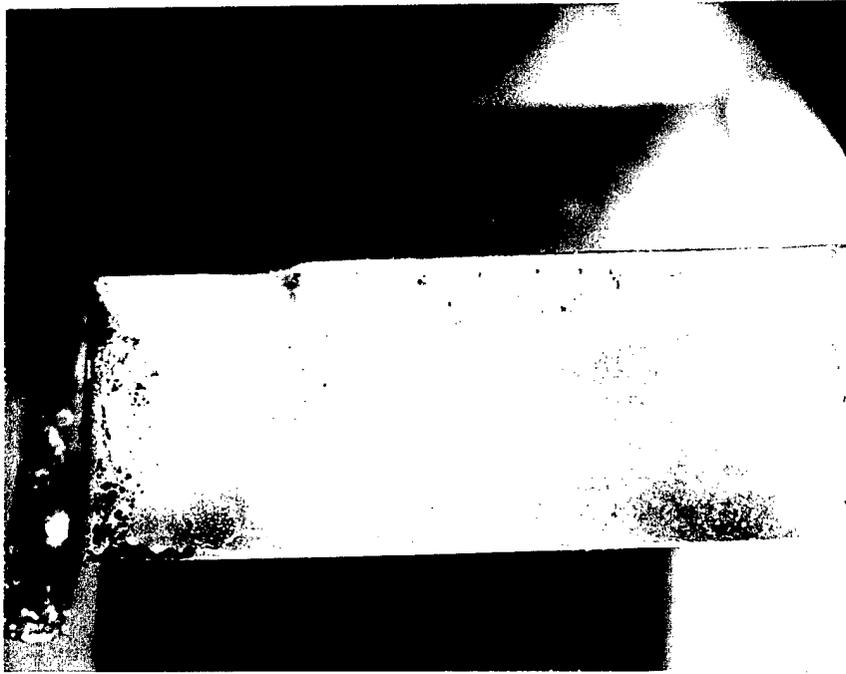
3.4 Corrosion Testing. According to AMS 2400 Rev. S, ferrous metal parts shall show no visual evidence of corrosion of the basis metal after being subjected to a 200-hr continuous salt fog exposure conducted in accordance with ASTM-B-117 [2, 4]. The assembly in the as-received condition would have failed the corrosion resistance test criteria based upon the visual examination, due to the presence of the dark corrosion pits. However, the test was conducted to alleviate doubt. Figures 8, 9, and 10 show the vanes after 24, 125, and 200 hr of exposure, respectively. The dark corrosion spots increased in magnitude, and corrosion of the base metal occurred, constituting failure. Figure 10 is a color depiction to more clearly

Figure 8. Typical Vane Corrosion After 24 hr Salt Fog Exposure (Magnified Approximately 3x).

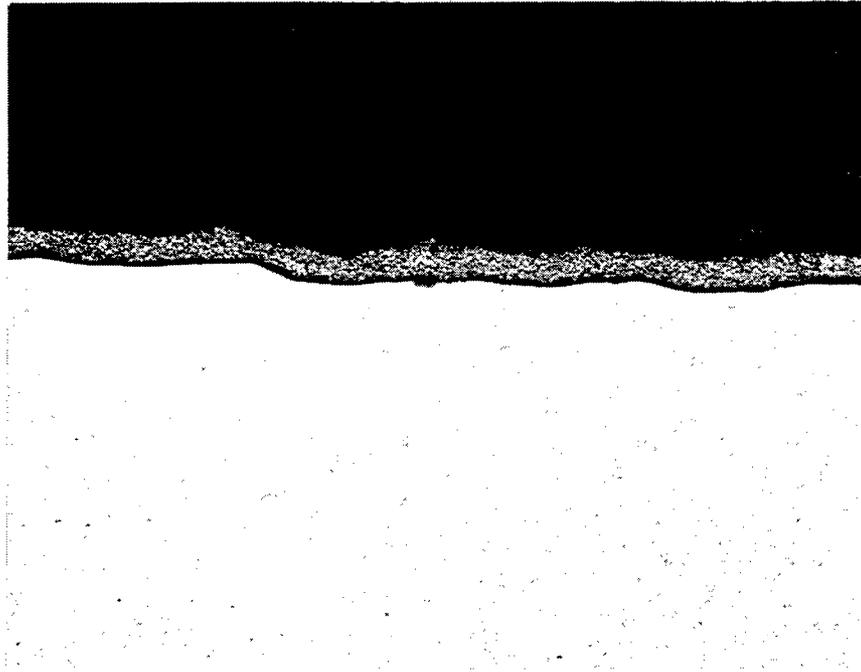
3.5 Coating Thickness. These components were designated to have a 2400-3 coating system, according to AMS 2400 Rev. S [2]. Table 1 of AMS 2400 Rev. S lists the thickness requirement for designation 2400-3 as 0.0003–0.0005 in, with the only exception being that this only applies to areas that can be touched by a 0.75-in-diameter sphere, as established in section 3.4.1.4 [2]. Cross-sections of several vanes were prepared metallographically and examined per ASTM-B-487 [5]. Figure 11 shows a representative area along the convex side of a vane near the inner shroud where the cadmium plating was approximately 0.0003 in thick. In contrast, Figure 12 is indicative of the nonuniform cadmium plating observed on much of the concave side of a vane near the inner shroud. In this area there is only a hint of plating evident, which would account for the poor corrosion resistance.

Figure 11. Cadmium Plating Thickness on the Convex Side of the Vane (Magnified 500 \times).

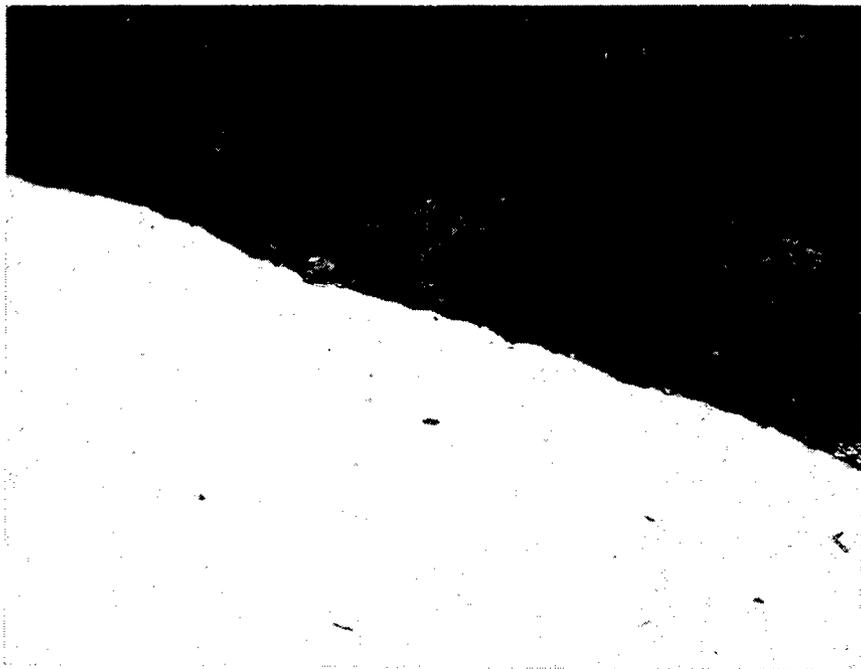
Figure 12. Cadmium Plating Thickness on the Concave Side of the Vane (Magnified 500 \times).

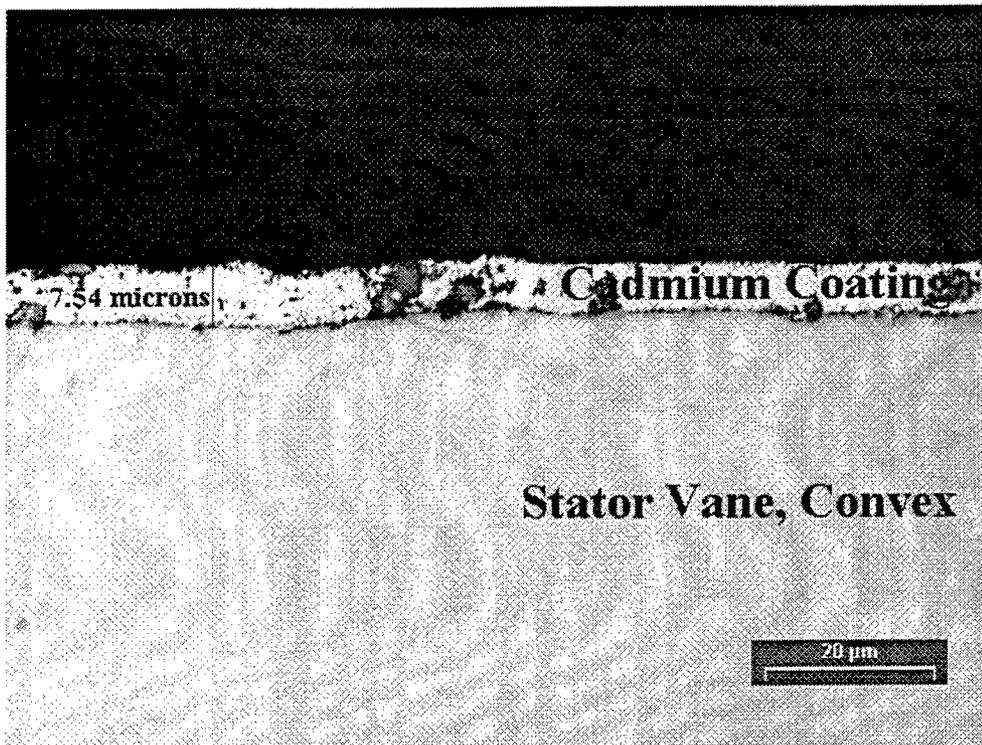
Figure 13. Typical Plating Thickness on the Convex Side of the Vane.

Measurements were taken in several locations along the components. The results show that the coating was thin in most locations but especially near the inner shroud where corrosion was abundant after the 200-hr salt fog test. Table 1 presents the cadmium thickness measurements, including the locations, taken on the part.

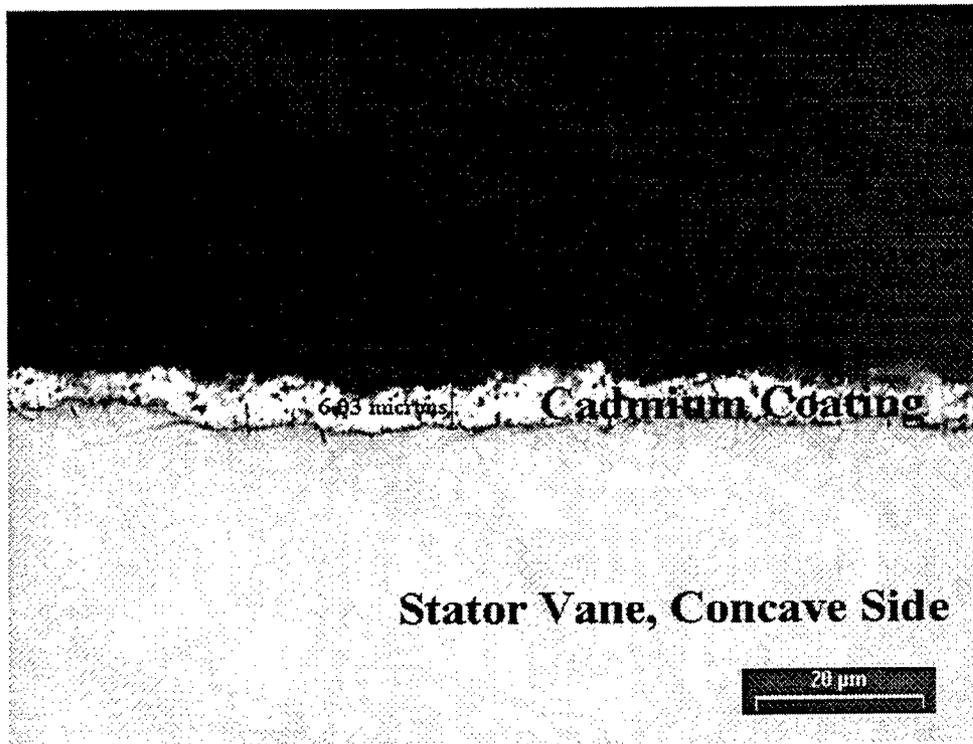
Figure 14. Typical Plating Thickness on the Concave Side of the Vane.

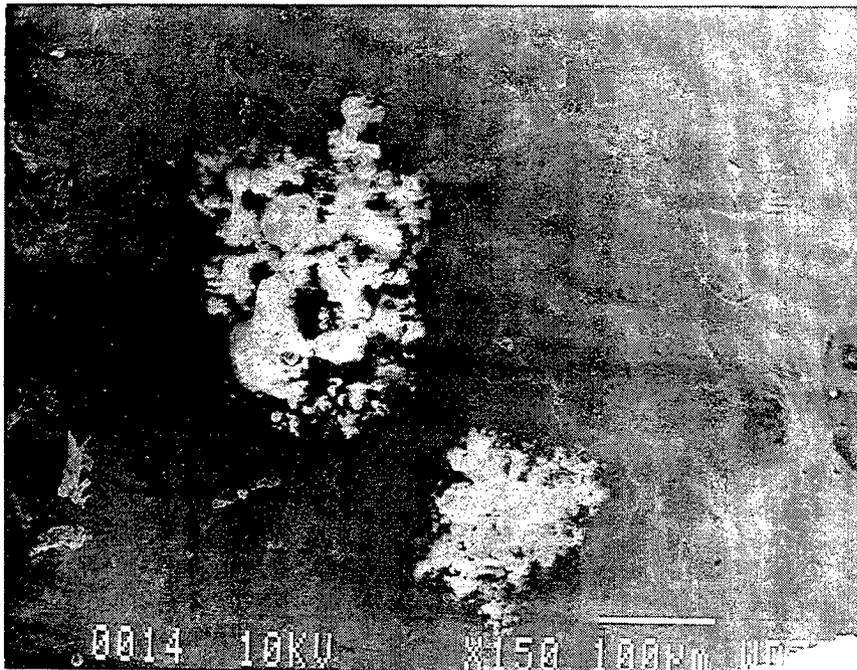
dark areas of corrosion were verified to be pits containing a significant amount of corrosion product. A cadmium plating was detectable on all surfaces; however, in some instances, base metal elements were also detectable, indicating a thin or discontinuous coating. Figures 15 and 16 show the corrosion product within the pits in both secondary and backscatter electron imaging, respectively.

Figure 15. Secondary Electron Image of Corrosion Product Within a Pit (Magnified 150×).

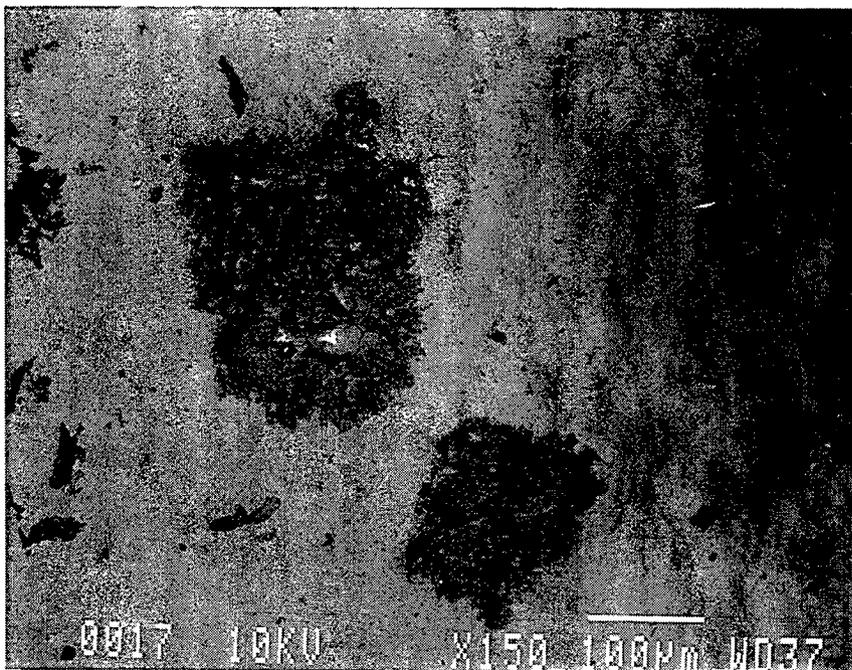
Figure 16. Backscatter Electron Image of the Product Within a Pit (Magnified 150×).

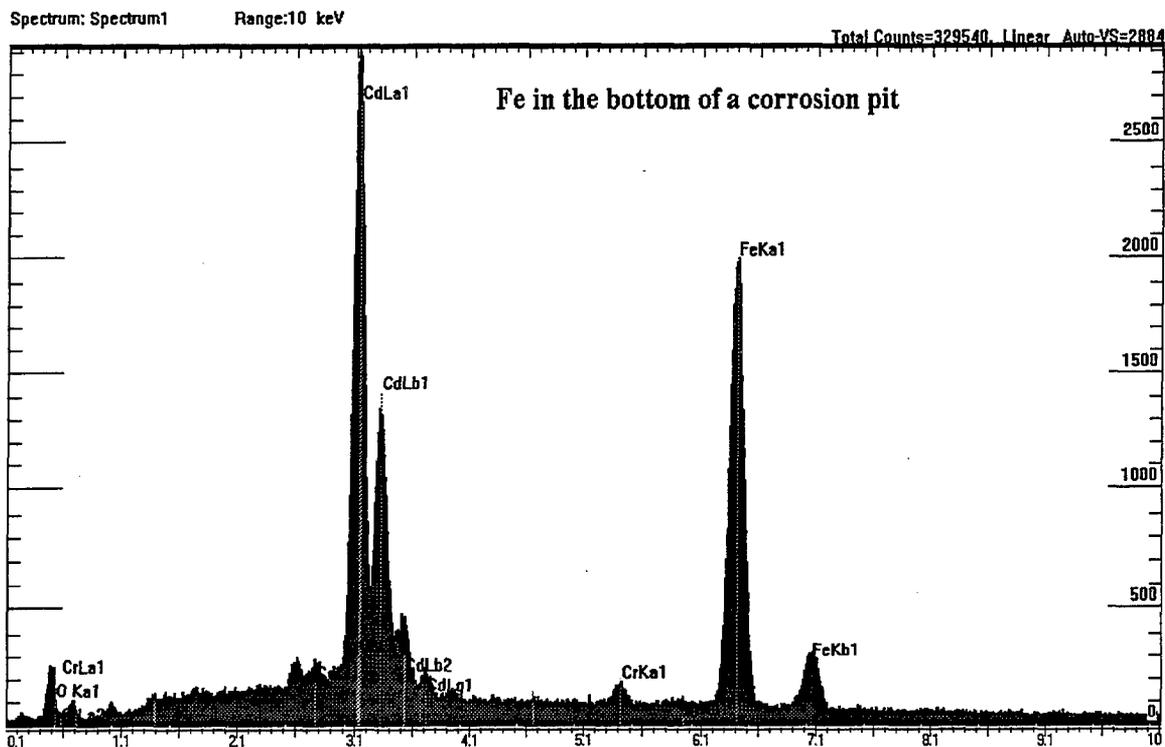
These corrosion pits were found to extend to the base metal as evidenced by the Fe peak in the EDS spectrum. This is depicted in Figure 17.

Figure 17. EDS Spectrum Showing Iron Within the Corrosion Pit.

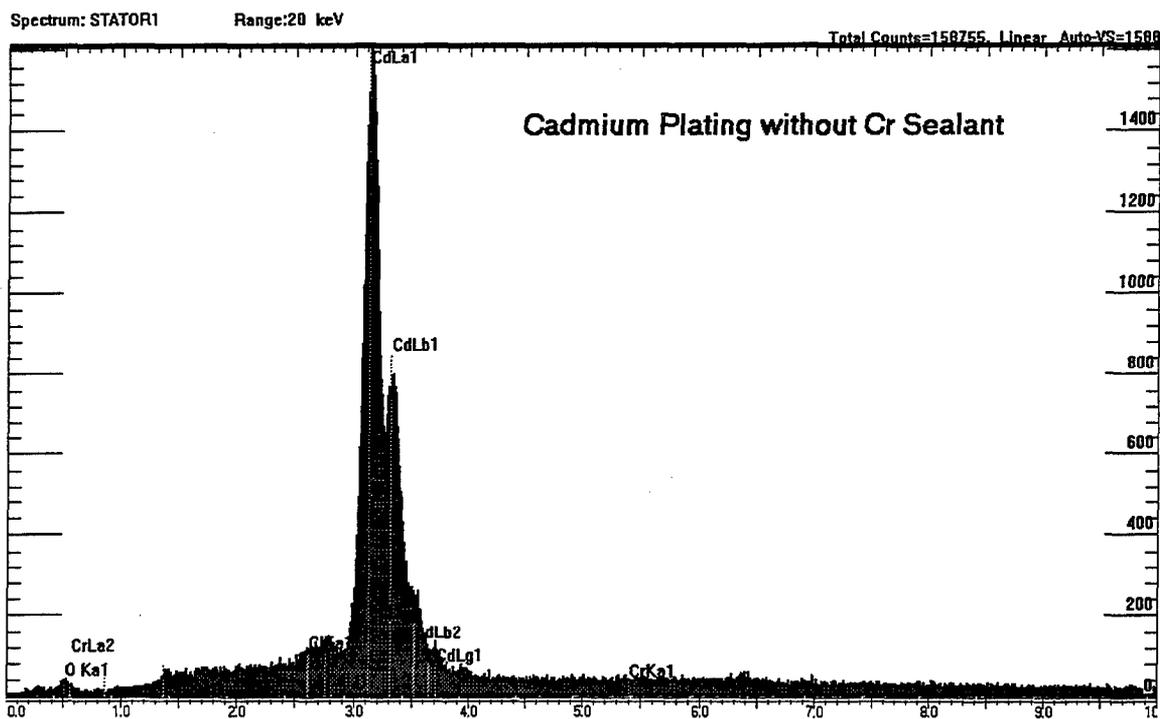
Specification AMS 2400 Rev. S stipulates that the cadmium must be sealed with a chromic acid sealant or with a chromate or phosphate treatment when specifically approved [2]. An attempt was made to verify the existence of a chromium or phosphorus sealer over the cadmium coating. These sealers would be evidenced by the presence of the elements Cr or P, respectively, within the EDS spectrum. Neither element was observed above the scatter within the EDS spectrum. Figure 18 presents the EDS spectrum from a representative stator vane. The only elements observable in Figure 18 are oxygen (O) and cadmium (Cd). To further investigate, a cadmium-plated nut known to have a chromate sealer was analyzed and indeed was found to contain a significant amount of the element Cr within, or on top of, the cadmium coating. Figure 19 presents the EDS spectrum showing the Cr peak. These findings suggest that either the sealer was absent or below detectable limits. In either case, the corrosion protection afforded would be minimized.

Figure 18. EDS Spectrum Displaying the Absence of Cr on the Stator Vane.

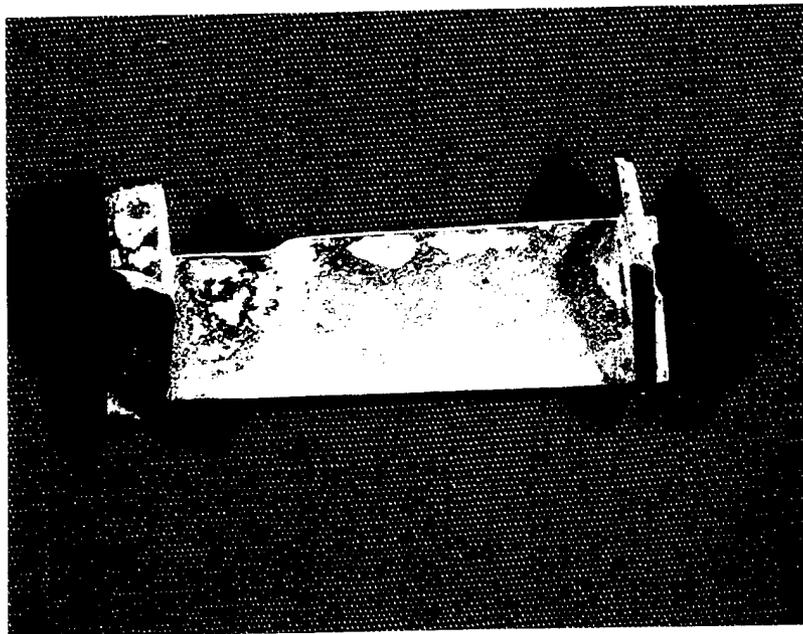
After 200 hr exposure per ASTM-B-117, the new stator exhibited significant white product along the vane and severe pitting within the braze area, as shown in Figures 36 and 37. Figures 38 and 39 depict the corrosive action on the 0.42% dipped old stator and general corrosion can be observed. This general corrosion was more representative of the previous results obtained. However, the area of corrosion seemed to be limited to the inner shroud braze area. Comparative macrographs of the new stator vs. the old 0.42% dipped stator are shown in Figures 40 and 41. After 200 hr of exposure, general corrosion of the 0.42% dipped stator was observable near the inner shroud braze area and pitting was observable on the new corrosion system stator. It could not be determined which corrosion-resistant coating performed better. Neither would pass the corrosion requirements established in AMS 2400 Rev. S [2].

Figure 36. New Stator Section After 200 hr Salt Fog Exposure, Concave Side (Magnified 1.5×).

Figure 37. New Stator Section After 200 hr Salt Fog Exposure, Convex Side (Magnified 1.5×).

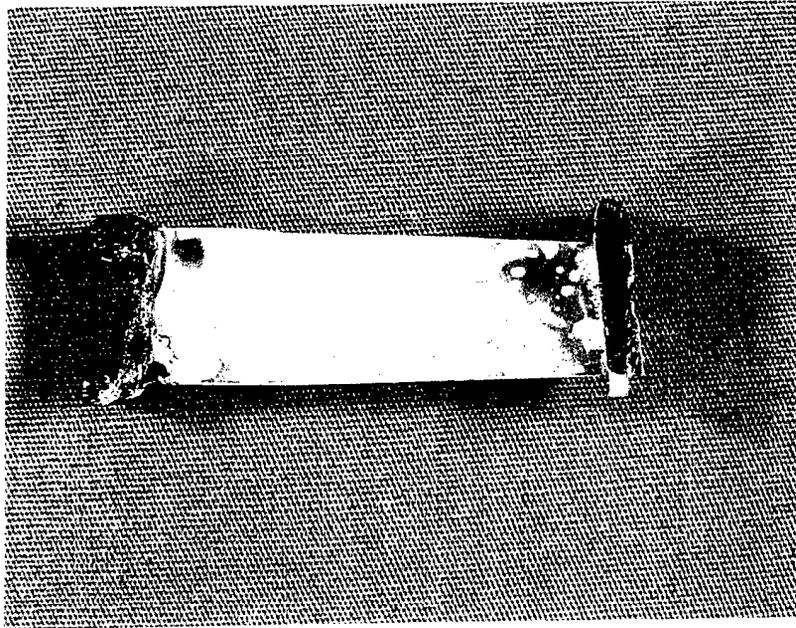
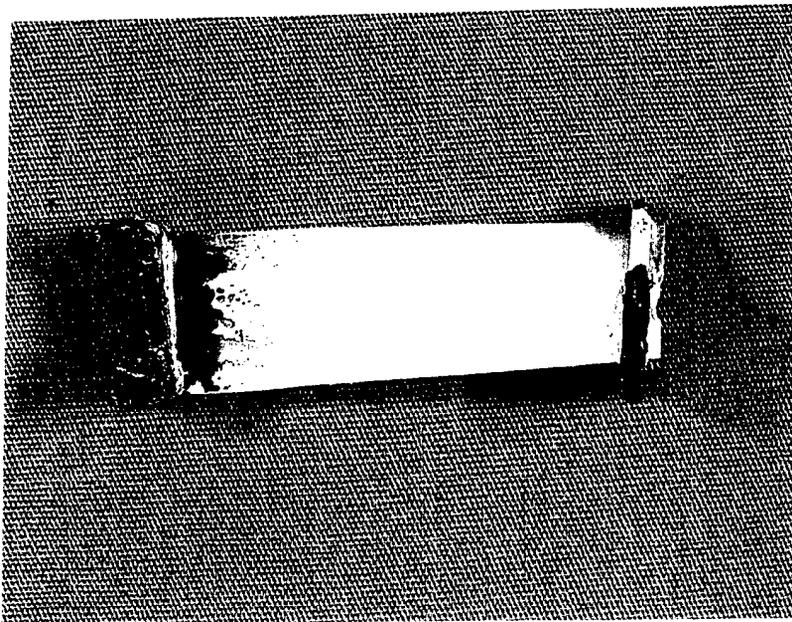
Figure 38. 0.42% Dipped Stator After 200 hr Salt Fog Exposure, Concave Side (Magnified 1.5×).

Figure 39. 0.42% Dipped Stator After 200 hr Salt Fog Exposure, Convex Side (Magnified 1.5×).

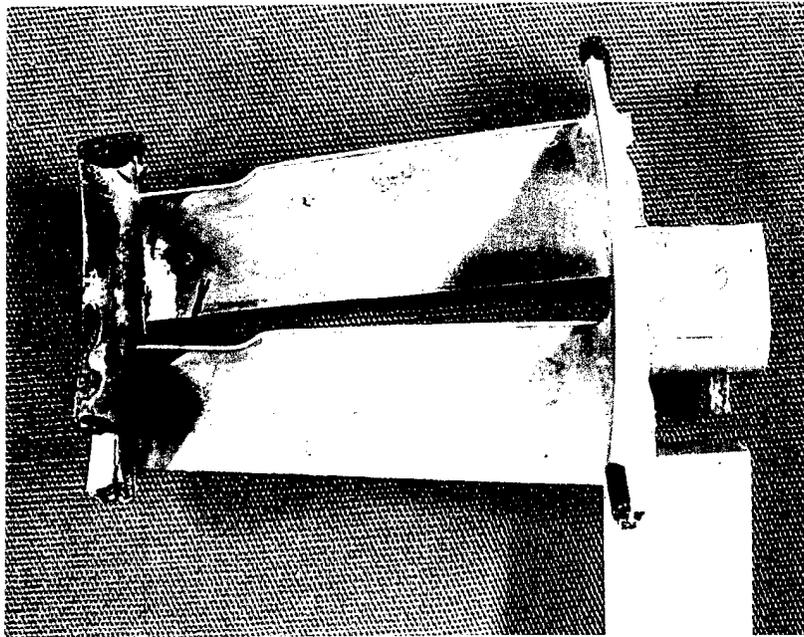
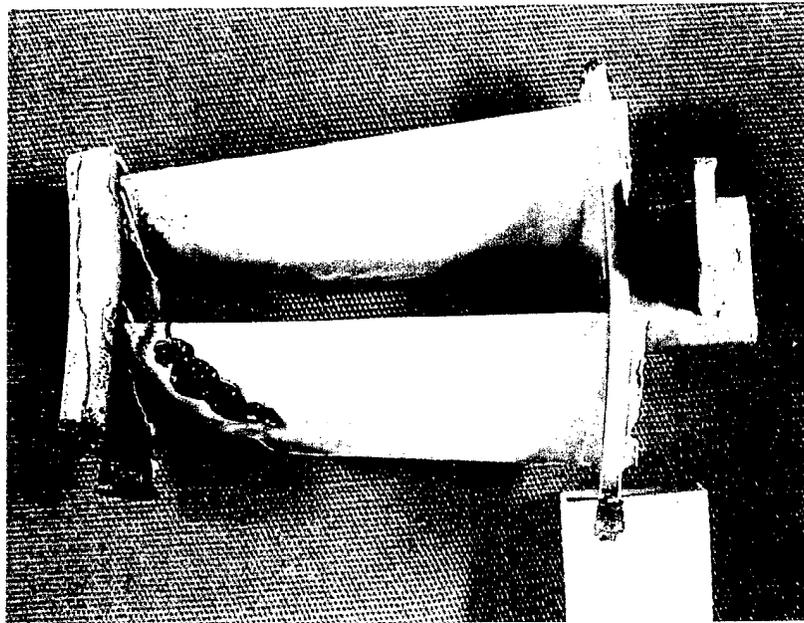
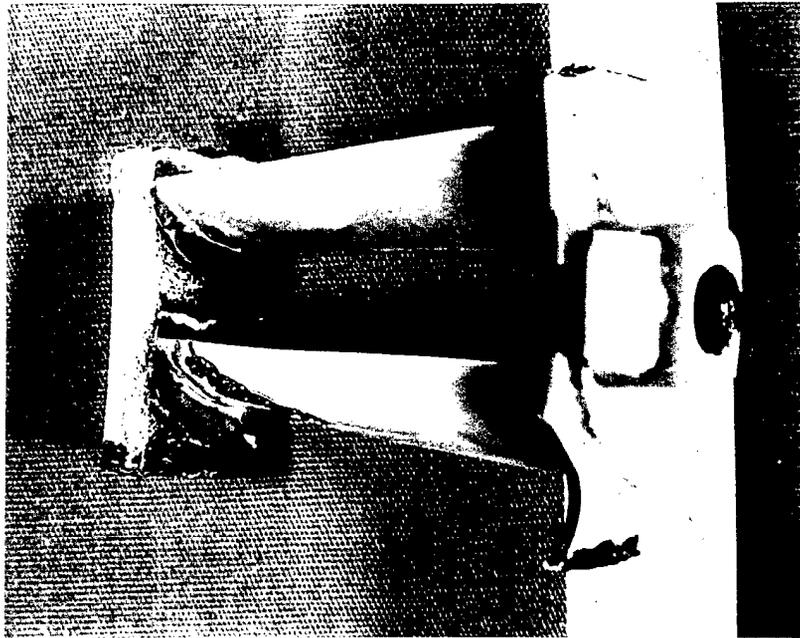
Figures 42–44 depict the 2.33% dipped old stator after 200 hr of salt fog exposure per ASTM-B-117. Some slight corrosion was evident along the braze and inner shroud. However, this section appeared to completely inhibit the white cadmium oxide product from forming and looked the best in comparison to the other sections.

Figure 42. 2.33% Dipped Stator After 200 hr Salt Fog Exposure, Concave Side (Magnified 1.5 \times).

Figure 43. 2.33% Dipped Stator After 200 hr Salt Fog Exposure, Convex Side (Magnified 1.5 \times).

Figure 44. 2.33% Dipped Stator After 200 hr Salt Fog Exposure, Braze Area (Magnified 1.5×).

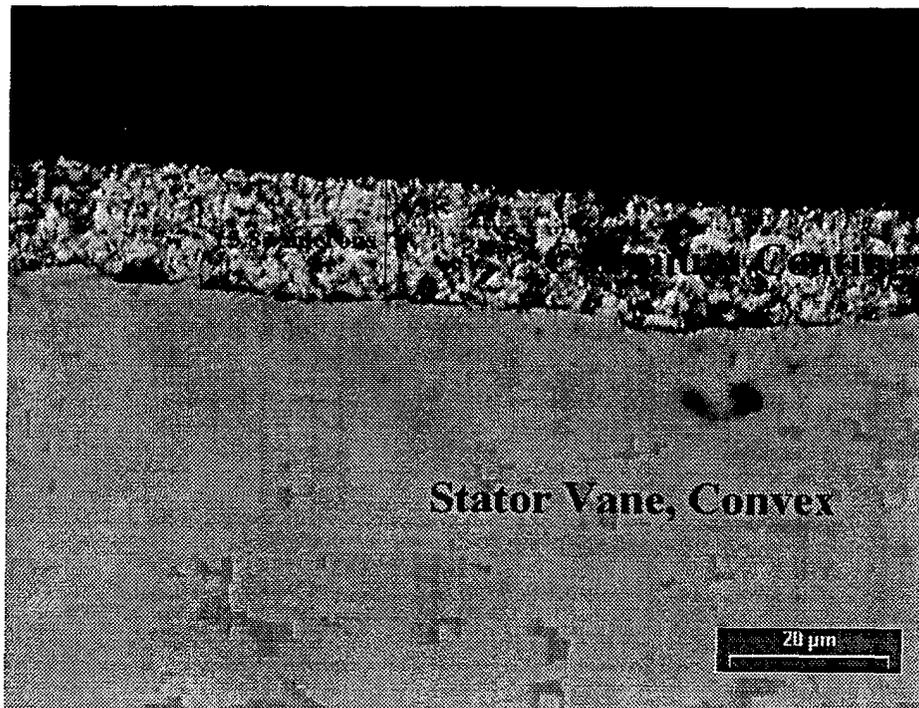
4.2 Coating Thickness. Similar cross sections of several vanes were prepared metallographically and examined per ASTM-B-487, as previously discussed [5]. Figure 48 shows a representative area along the convex side of a vane near the inner shroud where the cadmium plating was approximately 0.00065 in thick. In contrast, Figure 49 is indicative of the

Figure 48. Cadmium Plating Thickness of New Stator Near Inner Shroud, Convex Side.

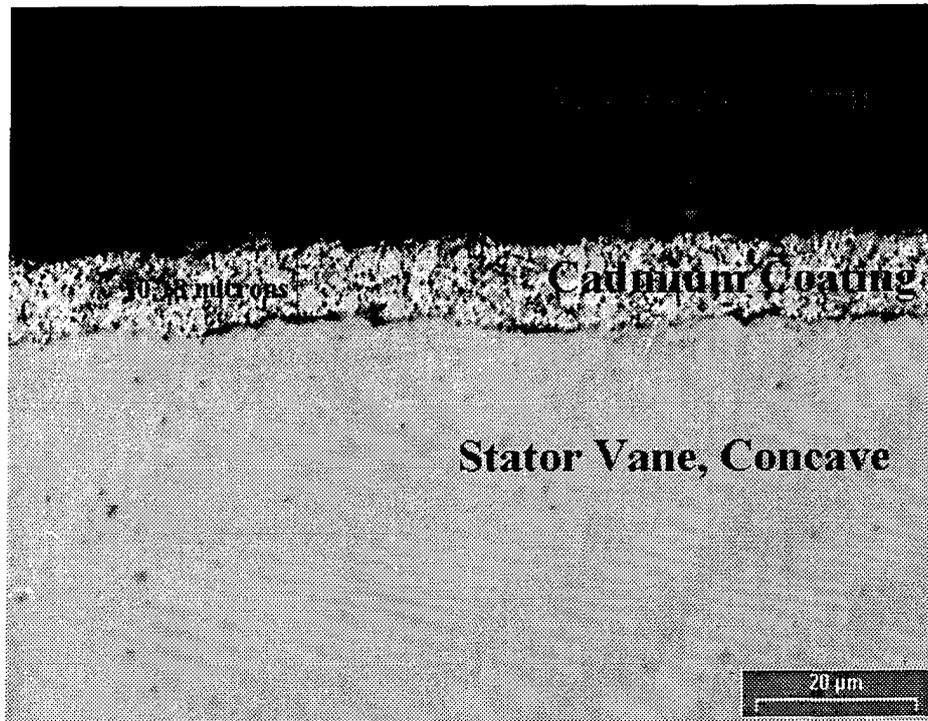
Figure 49. Cadmium Plating Thickness of New Stator Near Inner Shroud, Concave Side.

cadmium plating observed on much of the concave side of a vane near the inner shroud where the thickness was approximately 0.00043 in.

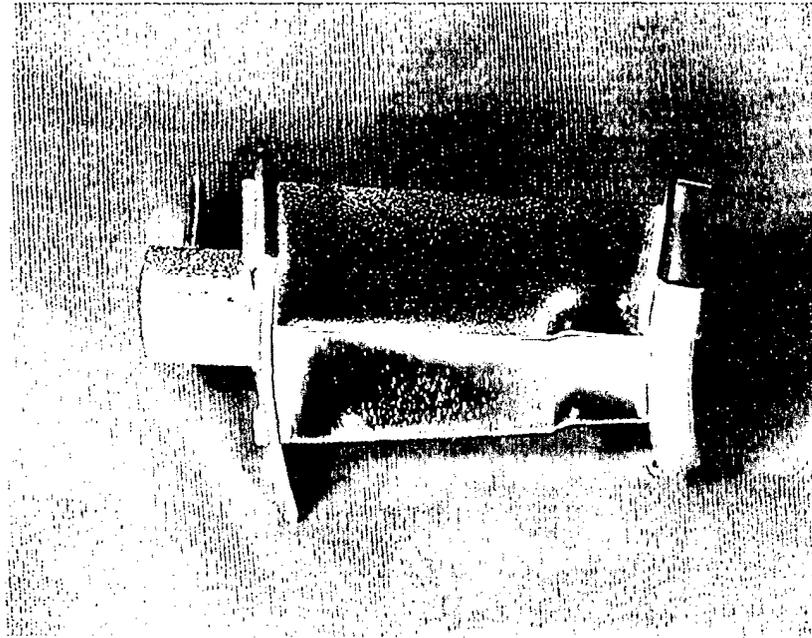
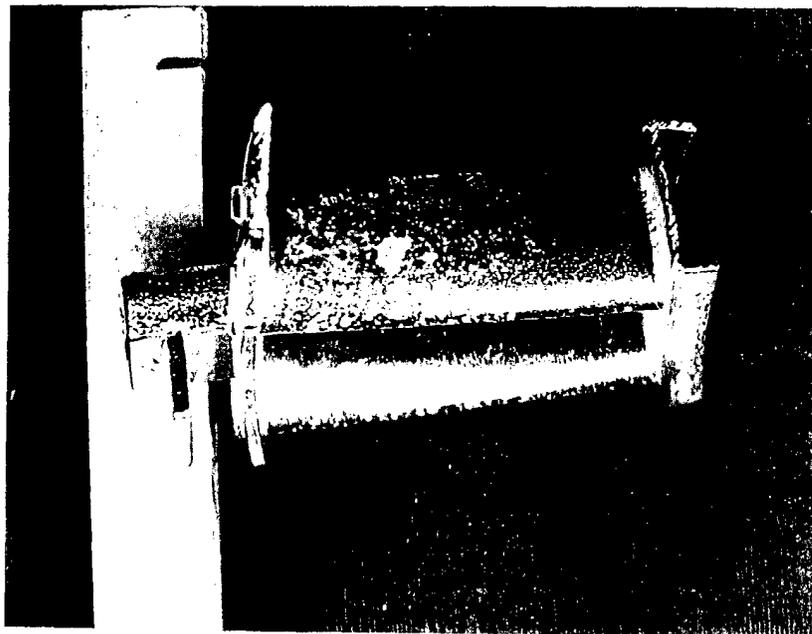
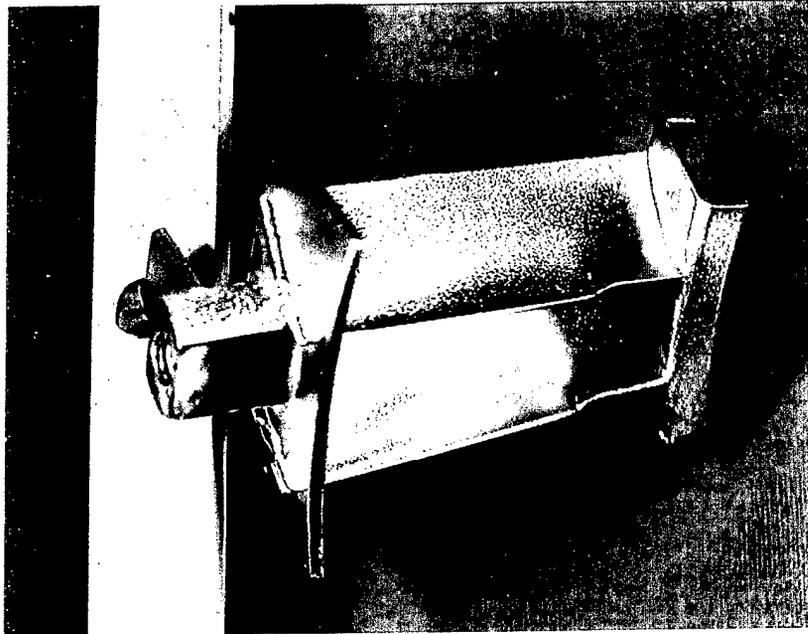
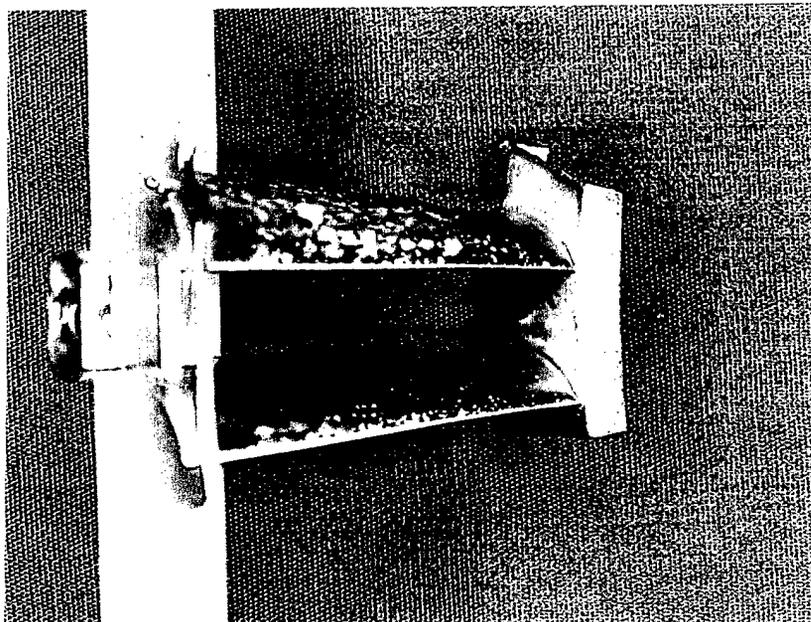
After 200 hr exposure, the new stator barely exhibited any significant white product along the vane and no pitting within the braze area, as shown in Figures 58–61. Only some small water spots on the convex side of the vane were evident.

Figure 58. 200 hr Salt Fog Exposure of the Stator, Concave Side (Magnified 1.5x).

Figure 59. 200 hr Salt Fog Exposure of the Stator, Convex Side (Magnified 1.5x).

Figure 60. 200 hr Salt Fog Exposure, Braze Area, Concave Side (Magnified 1.5×).

Figure 61. 200 hr Salt Fog Exposure, Braze Area, Convex Side (Magnified 1.5×).

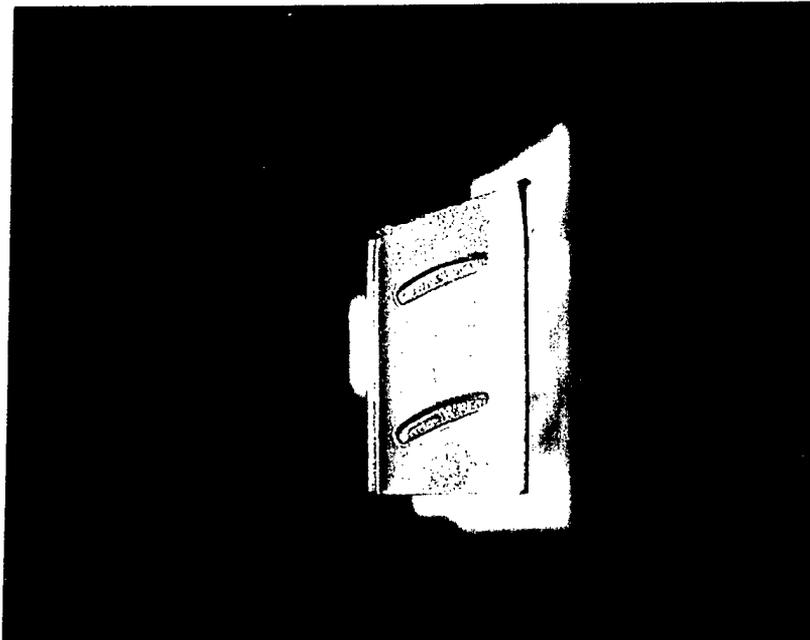
Figure 62 shows the inside edge of the inner shroud where significant corrosion had occurred on previous samples. No corrosion was visible on this stator section. After the 200-hr exposure period, the yellow hue had started to fade but was still evident. The chromic acid treatment appeared to have greatly increased the performance of the components under salt fog exposure testing, as expected. This stator section's corrosion resistance satisfied the requirements of the governing specification.

Figure 62. Inside Edge of Inner Shroud Showing Brazed Vanes (Magnified 1.5×).
