**Failure Analysis of an AH-64 Main Rotor Damper
Blade Rod End, P/N 7-211411186-5**

by Scott M. Grendahl and Marc S. Pepi

ARL-TR-3100

December 2003

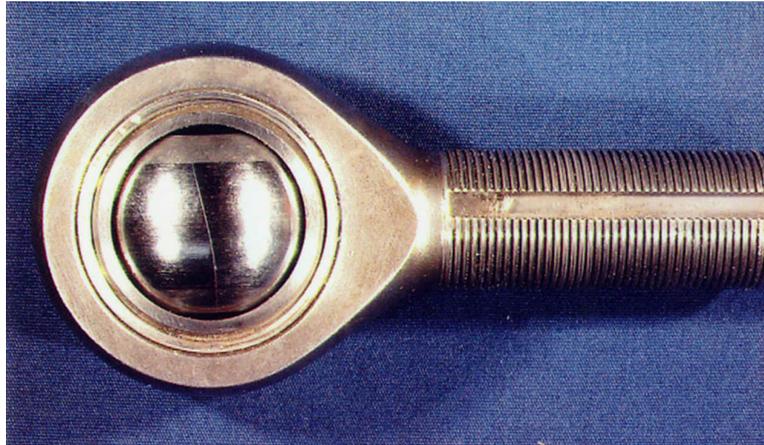
The failed part is shown in figure 2 in the as-received condition (approximately 1x magnification). The ball component of the assembly contained a “through” (i.e., complete) crack that was observed along the exterior as well as the interior (see figure 3). The body and the outer ring were sectioned by ARL in order to extract the cracked ball. Special care was taken not to damage the crack. Figures 4 and 5 show both halves of the cracked ball. One half of the ball, subsequently labeled “A” (see figure 4), was cleaned in an Alconox solution to remove the

Figure 2. Failed component in the as-received condition (mag ~1x).

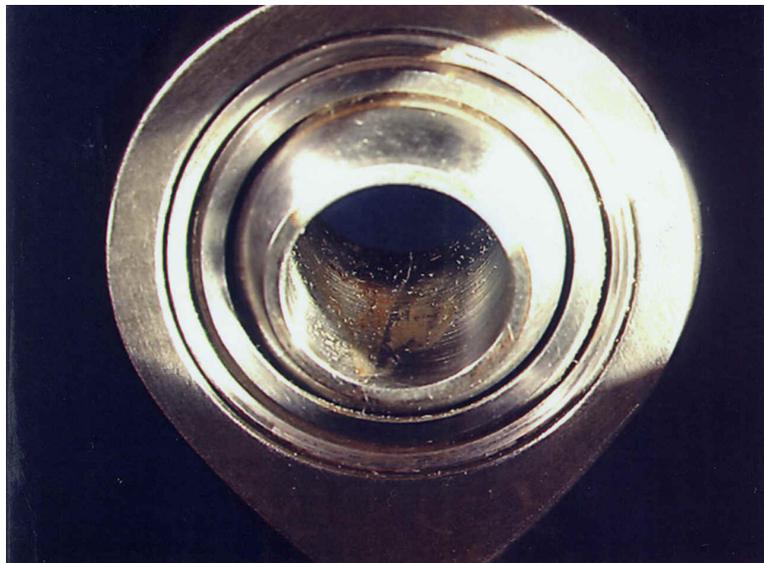
Figure 3. Through crack visible along the interior bore (mag ~2x).

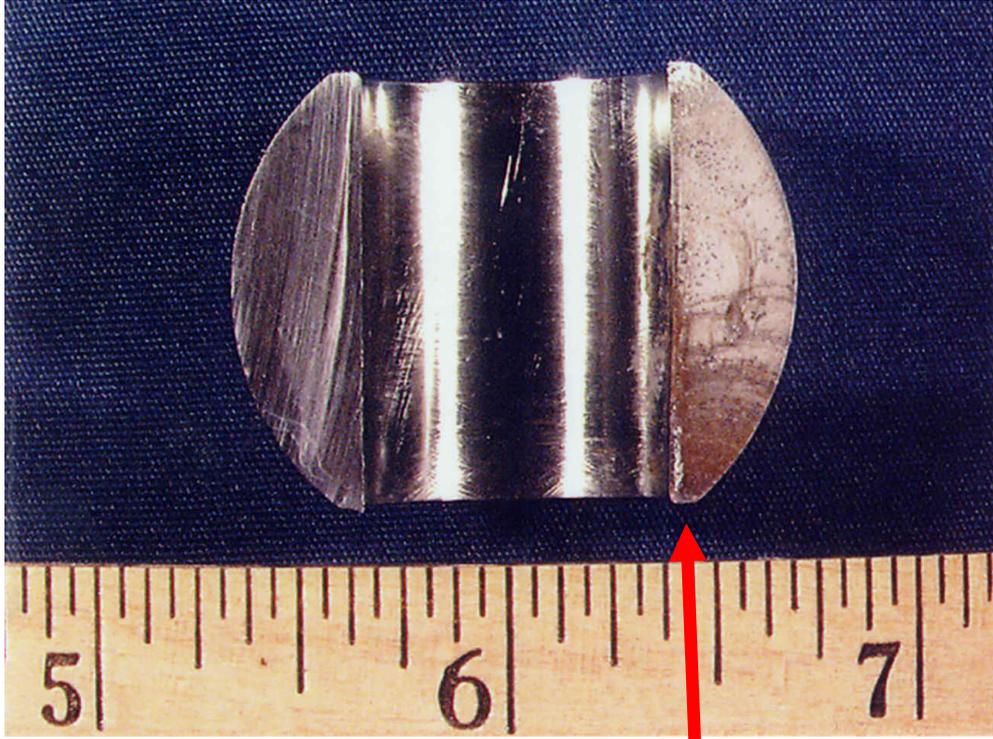
coarse corrosion products. After cleaning, evidence of beach marks (i.e., groups of fatigue striations) became apparent, as well as the fracture origin indicated by the arrow.

Figure 4. Fracture half "A" cleaned in an Alconox solution (scale in inches).

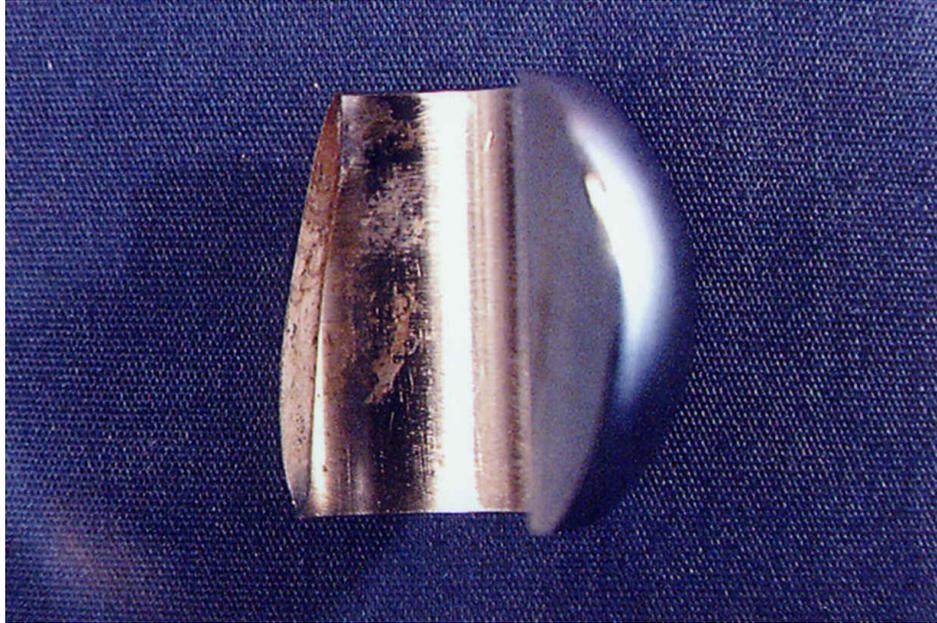
Off-axis views of the ball halves are presented in figures 6 and 7 to detail the corrosion observed along the internal bore of the ball near the through crack. This corrosion may have formed after the crack propagated entirely through the ball.

Figure 6. Fracture half “A” showing corrosion along the inside bore (mag ~2x).

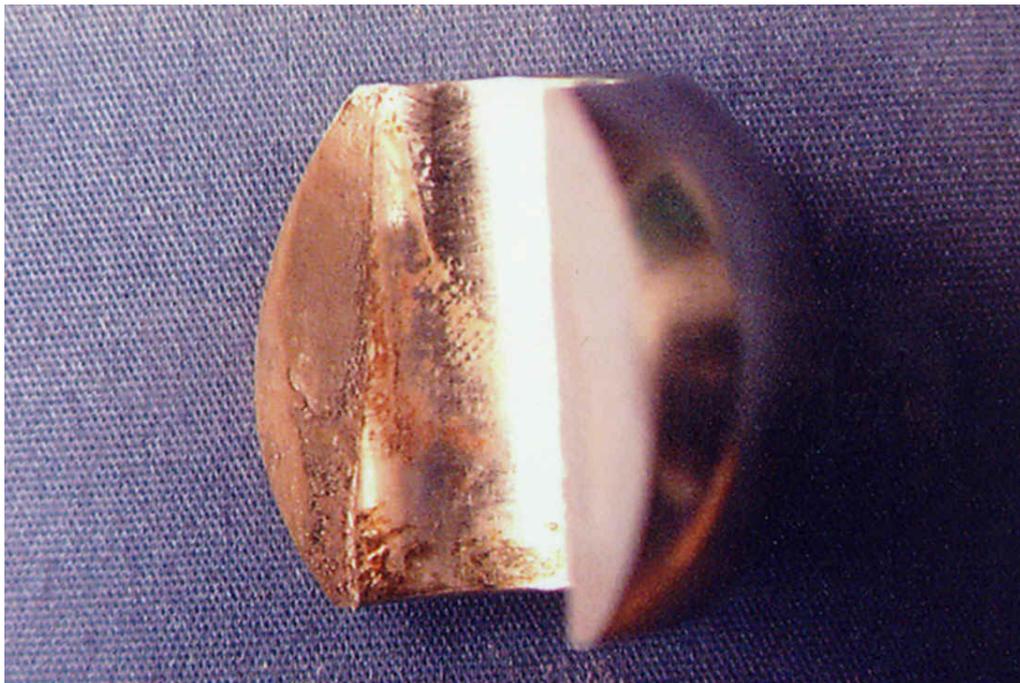
Figure 7. Fracture half “B” depicting corrosion along the inside bore (mag ~2x).

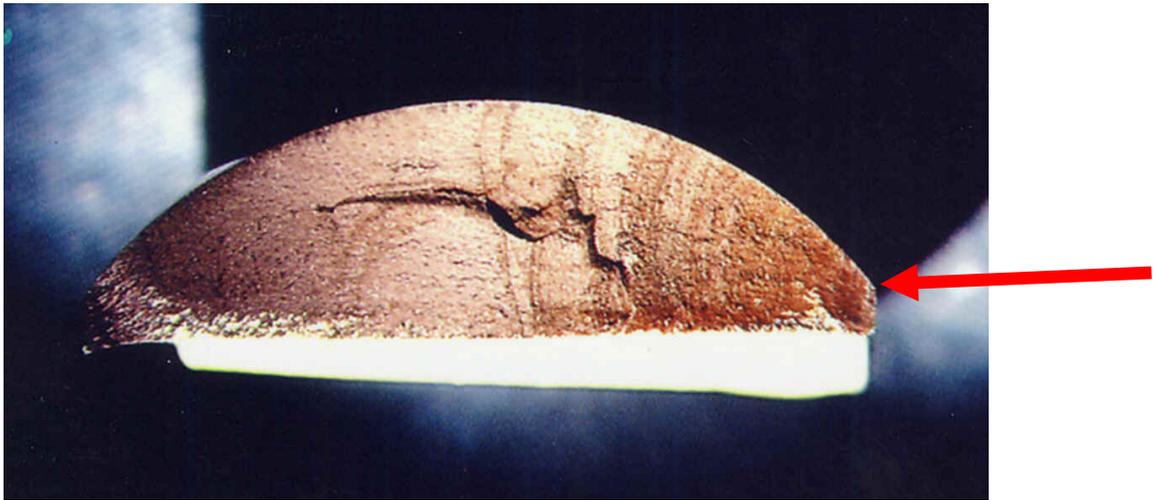
Figure 8 depicts the fracture origin from half “A”. Note the progressive, distinct beach marks emanating outward from the origin, which indicate fatigue crack propagation. The fracture propagated on a relatively flat plane until approximately one-quarter into the cross-sectional area

of the ball; thereafter cracking occurred on different planes. Separate distinct beach marks can be observed at the halfway point and again at the three-quarters position.

Figure 8. Fracture half “A” detail, two distinct fracture planes (mag ~2x).

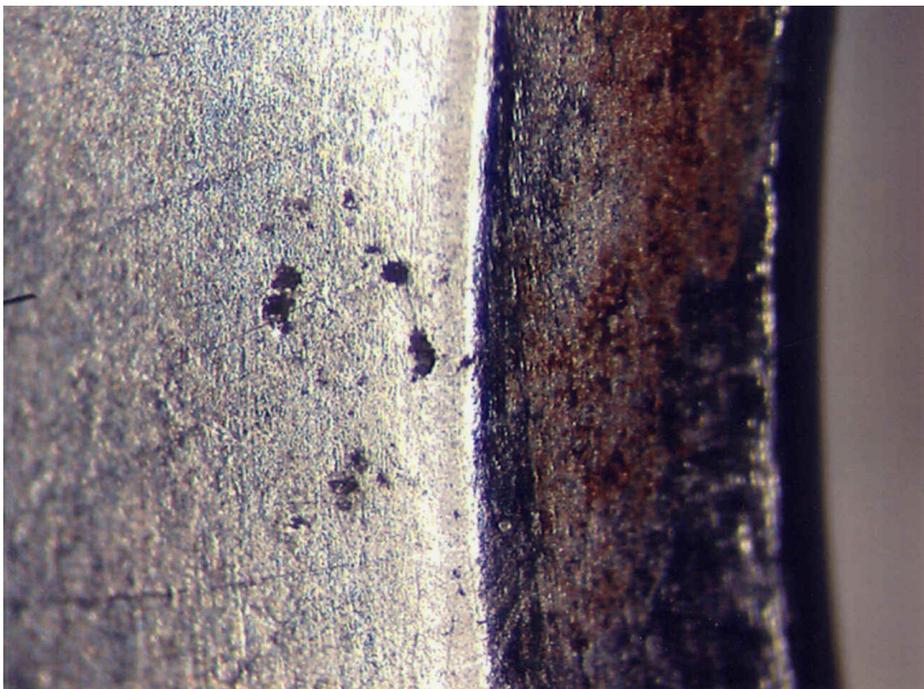
Further examination of fracture half “A” revealed numerous corroded areas, as shown in figures 9 through 11. The areas of attack were approximately 0.19, 0.04, and 0.01 inch from the origin. Figure 12 depicts the sites in figure 11 at higher magnification to show detail more clearly.

Figure 9. Corroded areas near fracture origin (mag ~30x).

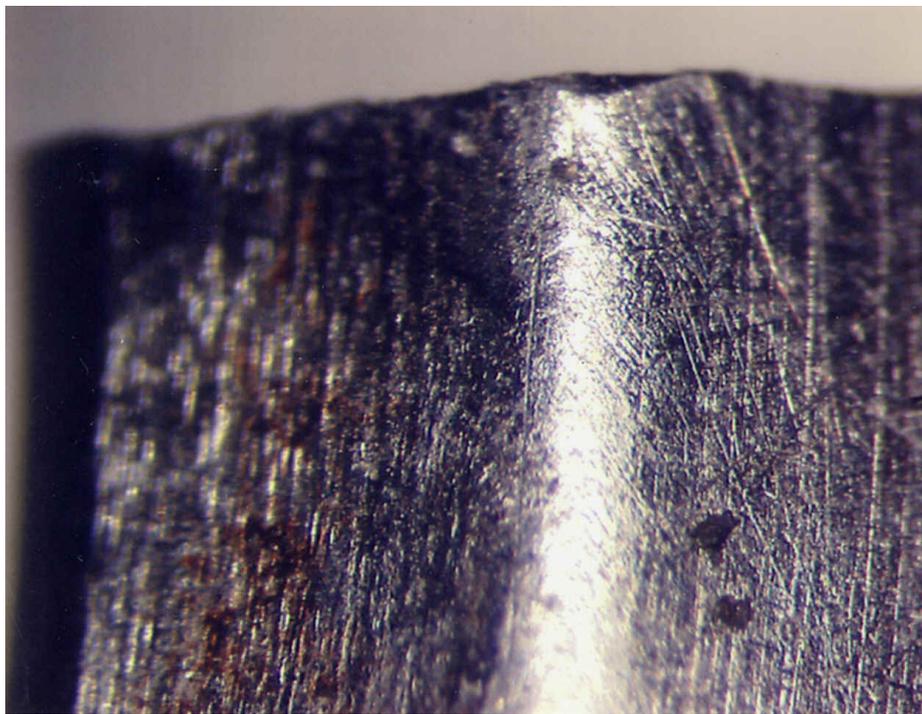
Figure 10. Attacked areas near origin of fracture (mag ~50x).

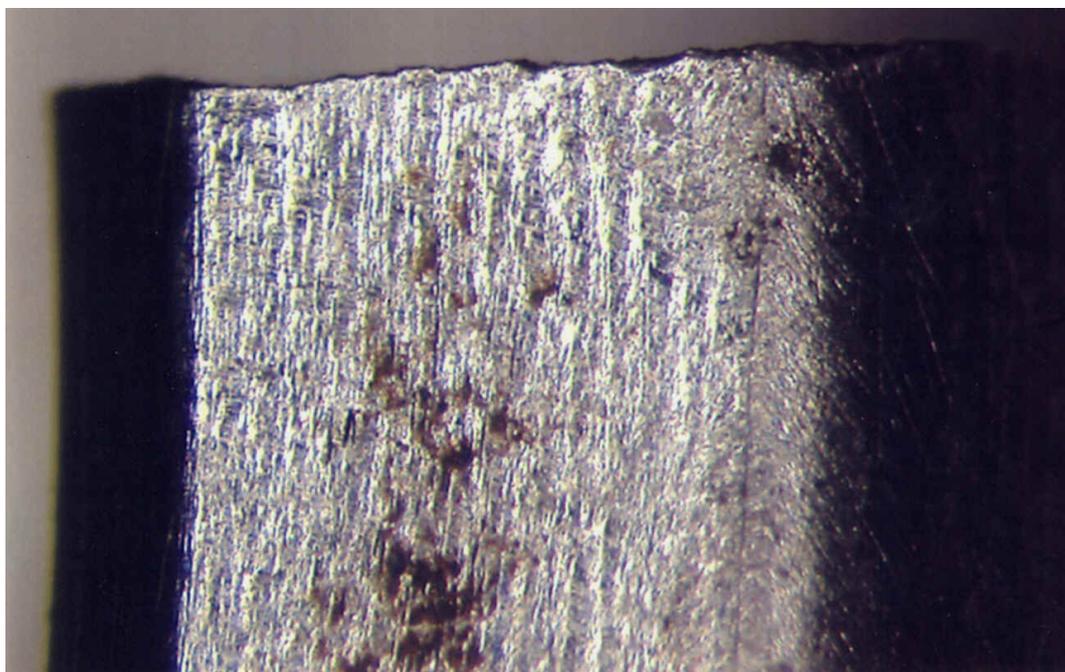
Figure 11. Corrosion on chamfered edge adjacent to fracture plane (mag ~40x).

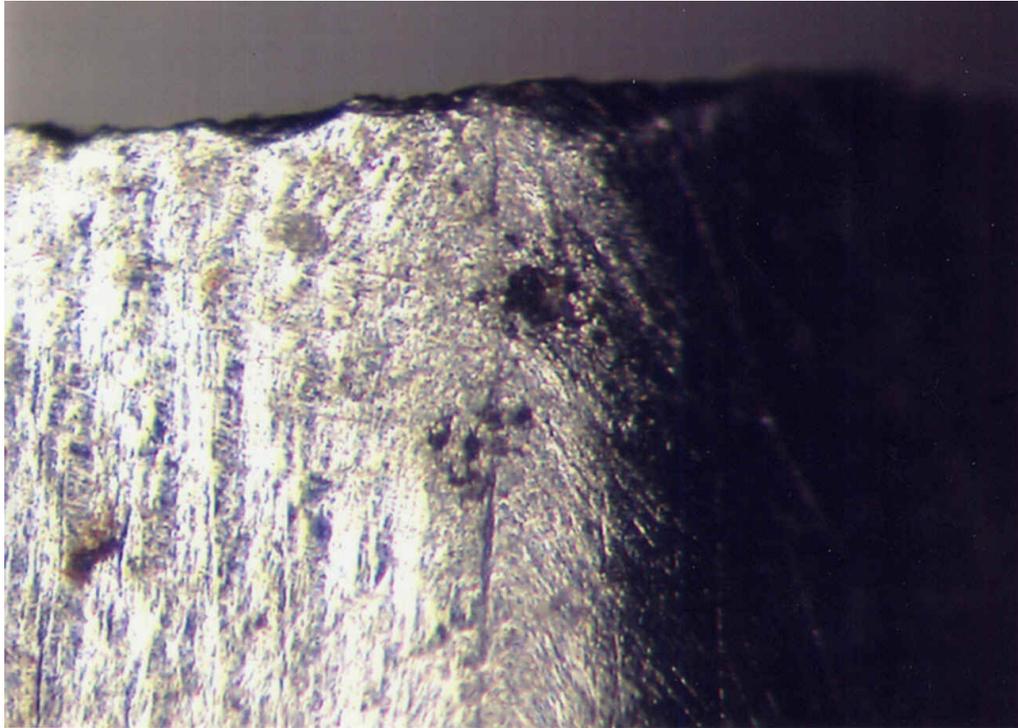
Figure 12. Detail of Figure 11 showing localized corrosion near origin (mag ~100x).

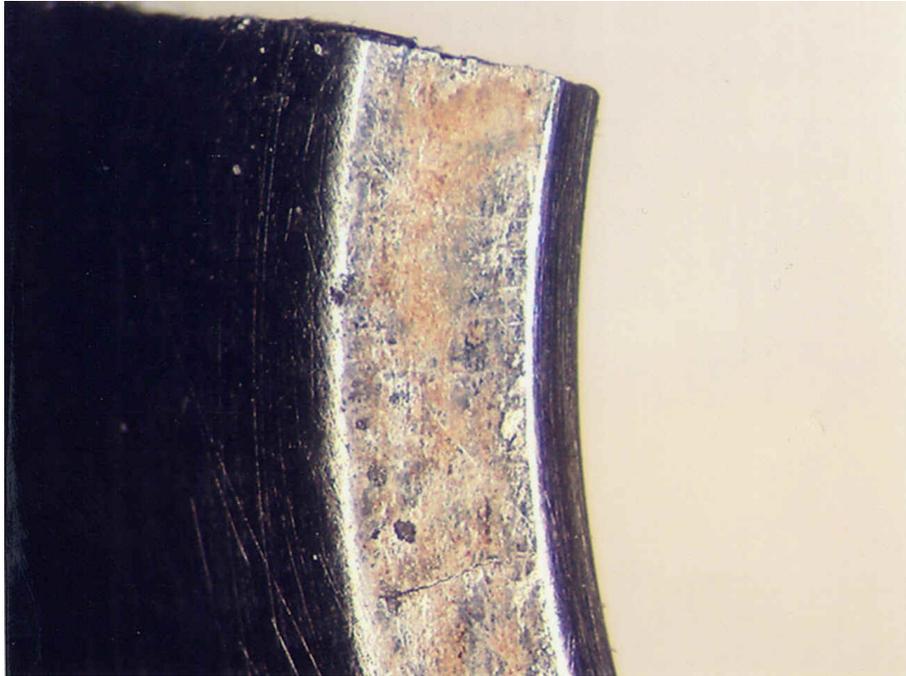
The corroded regions were uniform in neither size nor frequency. Light optical examination only revealed this condition on the exterior surface of the ball. The interior bored hole through the ball was noticeably void of these areas of corrosion. Less than 5% of the exterior surface of the ball contained corrosion. Examination of the “B” fracture half revealed similar features as those noted on half “A”. In addition, significant secondary cracking was observed, which ran parallel to the fracture plane. One crack was 0.21 inch from the fracture plane and was more than 0.125 inch long, as shown in figure 13. Figure 14 shows the presence of a slightly smaller crack adjacent to the crack shown in figure 13.

Figure 13. Secondary crack noted adjacent to the fracture plane (mag ~20x).

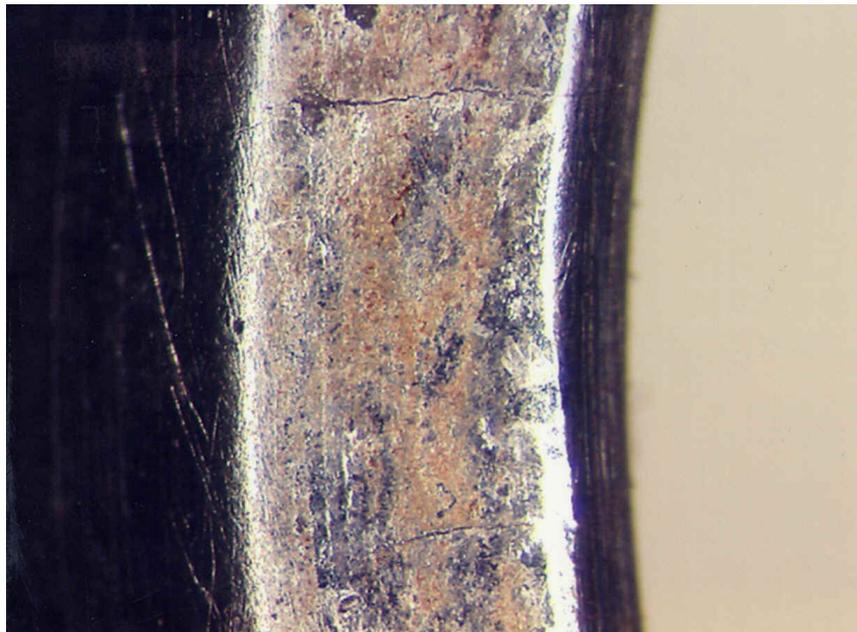
Figure 14. Small secondary crack adjacent to fracture plane (mag ~30x).

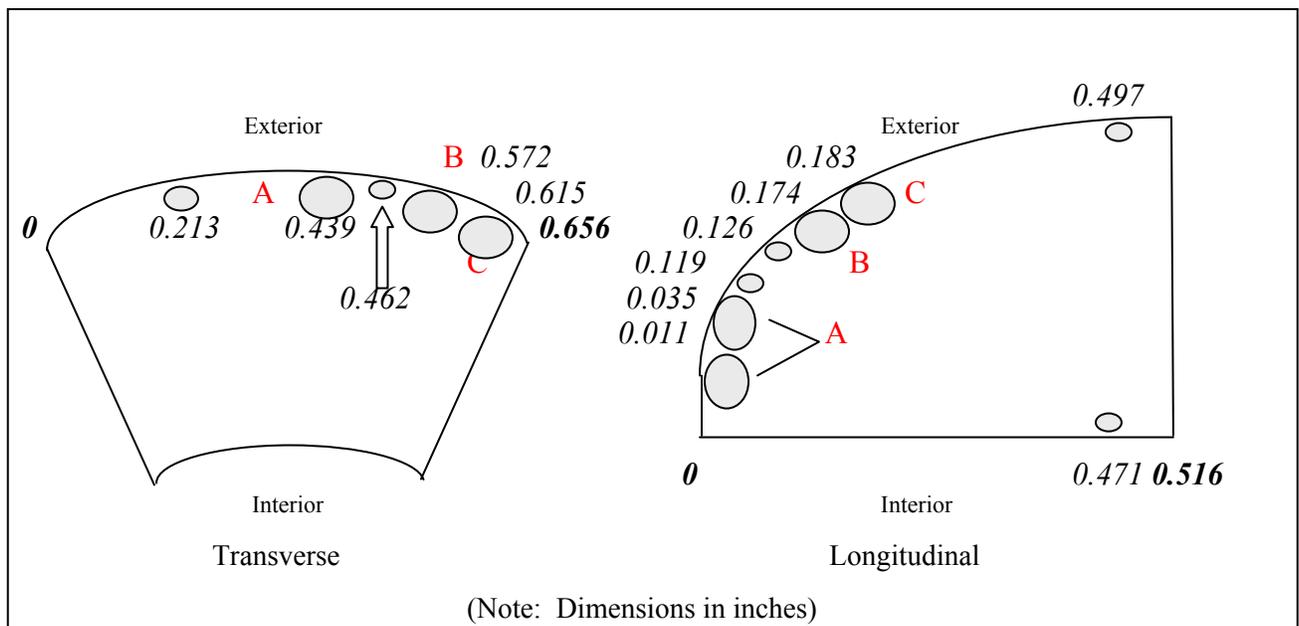
The specimens were examined in the as-polished condition. Localized regions of surface intergranular attack were noted in the areas shown in figure 16. The corresponding measurements were approximated with simple geometry. Except for one very small region on the interior of the longitudinal sample (see figure 16), each region of attack was noted on the exterior surface of the part. It was interesting to note that the bulk of the inter-granular regions observed on the longitudinal sample corresponded to the general location of the fracture origin.

Figure 16. Schematic of localized inter-granular attacked locations.

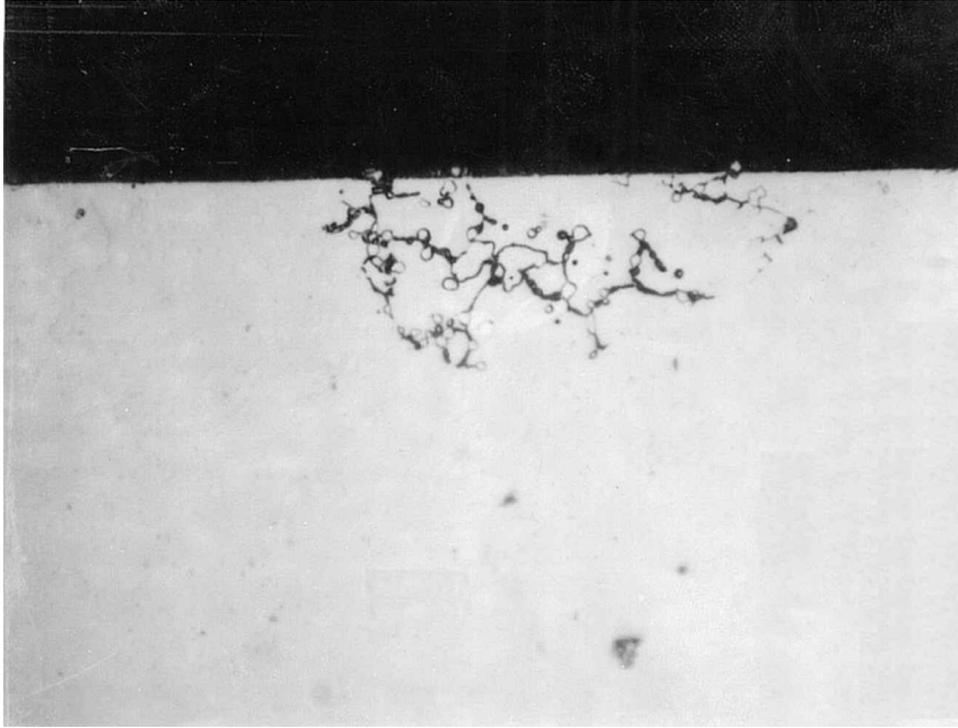
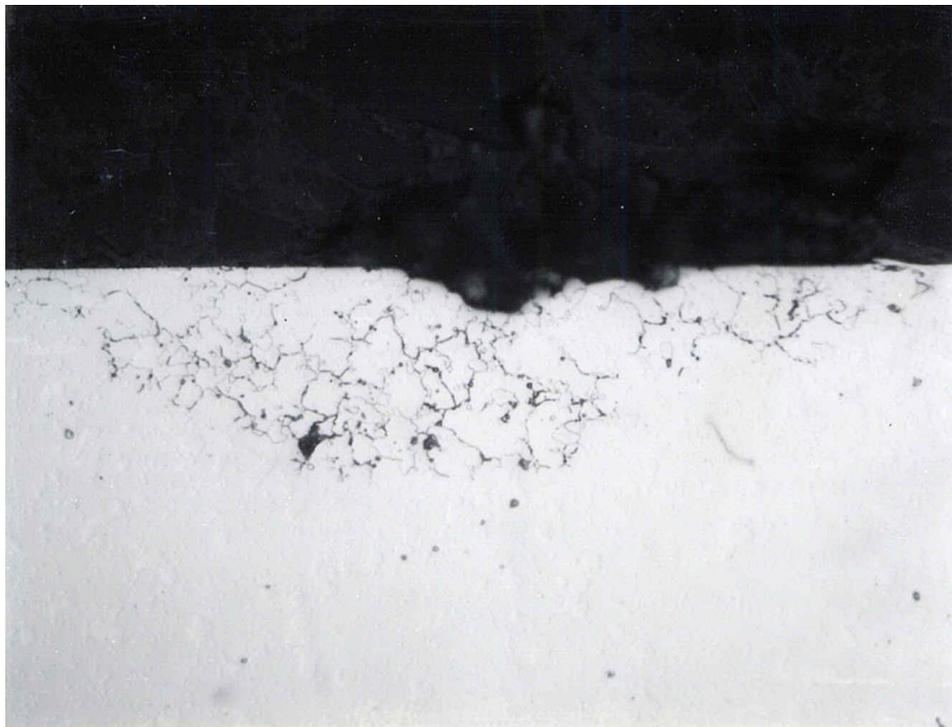
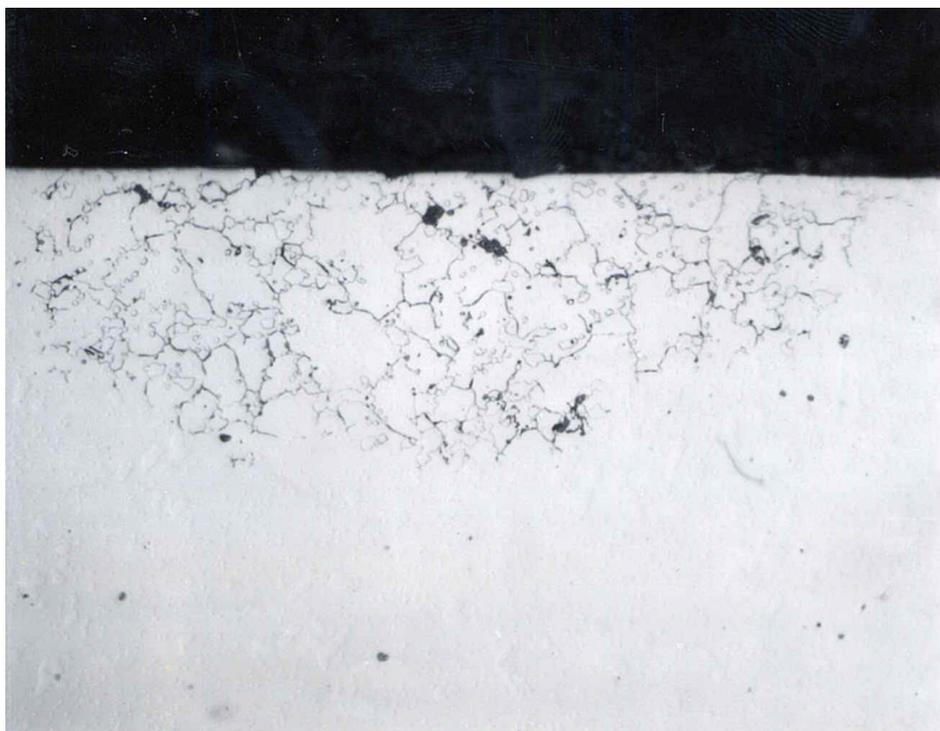
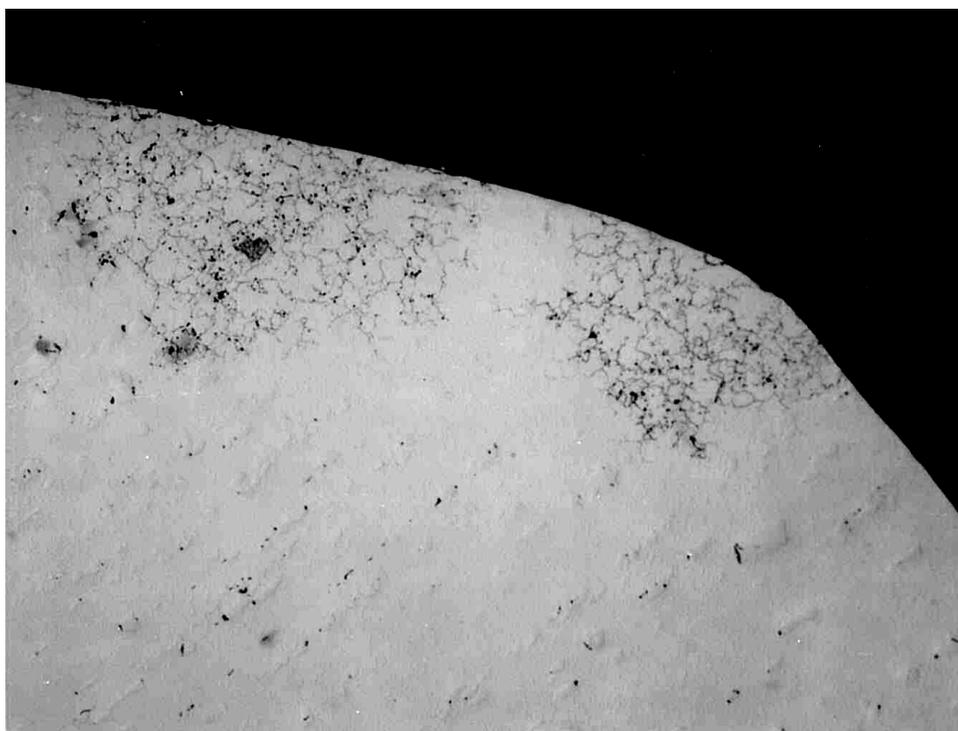
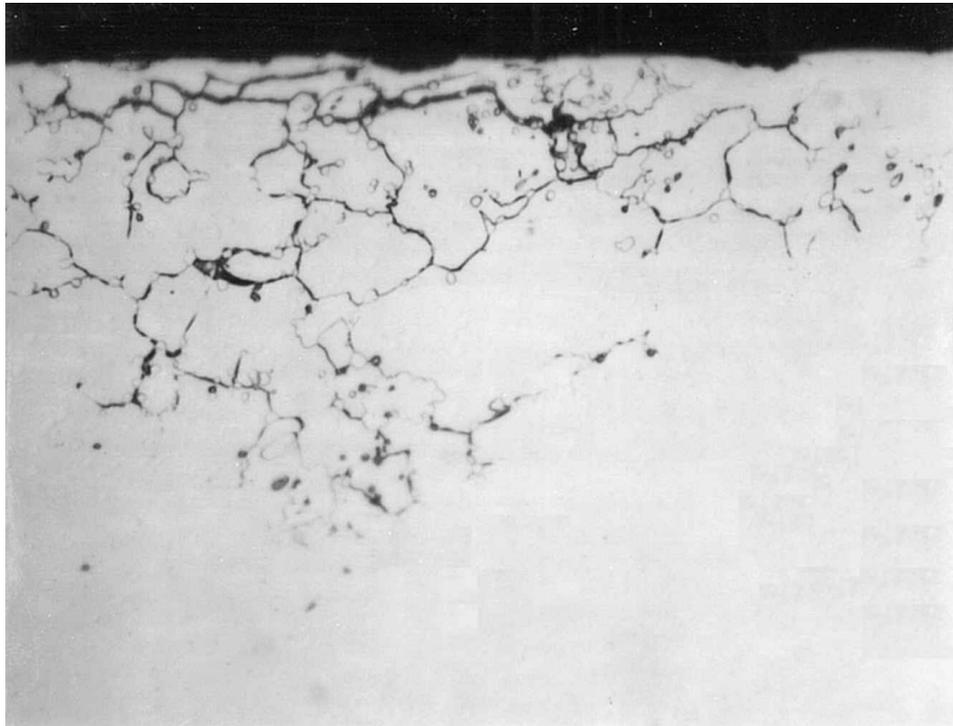
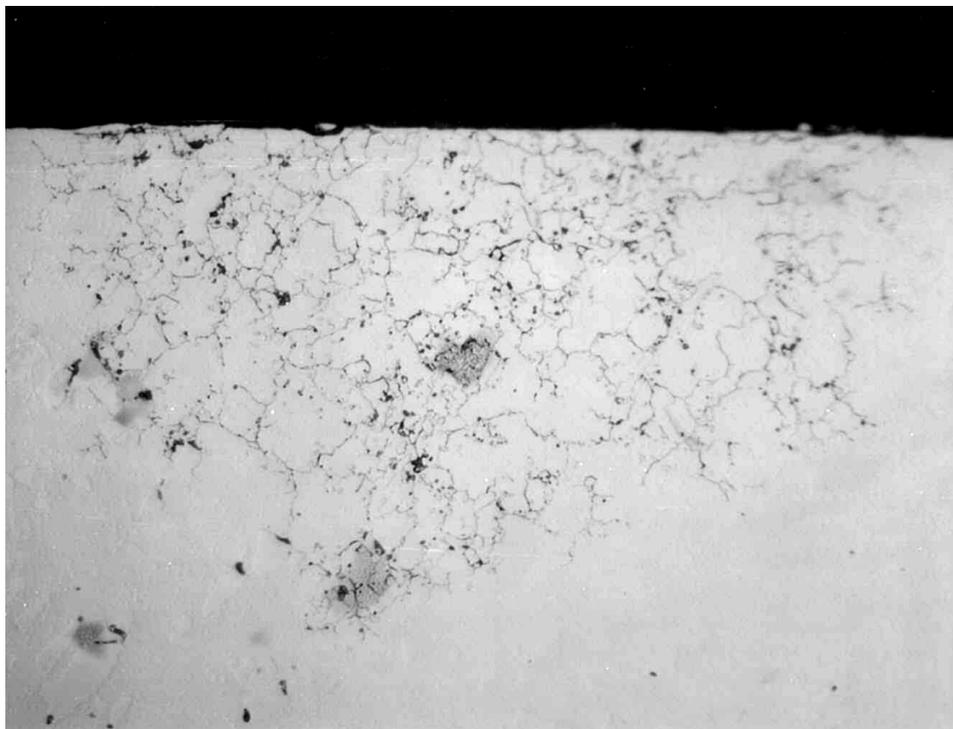
The regions of attack labeled “A,” “B,” and “C” in figure 16 are shown in figures 17, 18, and 19 for the transverse section and in figures 20, 21, and 22 for the longitudinal section, respectively. In these photomicrographs, it is apparent that inter-granular cracks progressed to and around the precipitates (figures 17 and 21, especially). This fact is intuitive when it is realized that the matrix is inherently depleted of chromium in these areas. Figure 18 shows that individual grains of metal have actually been dislodged from the network of inter-granular attack, forming a cavity or pit at the surface of the part.

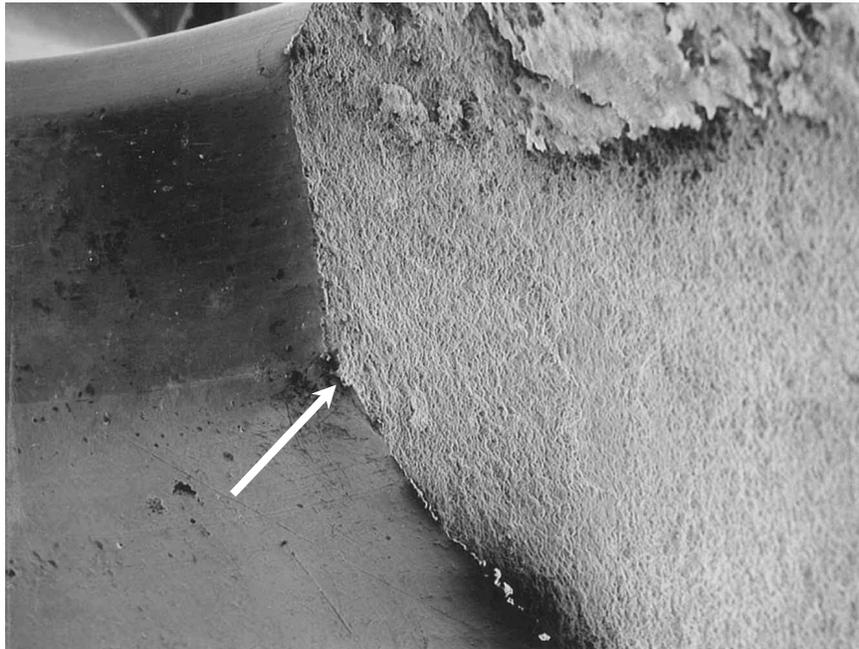
One half of the sectioned component was thoroughly cleaned and prepared for examination. The fracture half of the ball was examined with a Japan Electron Optics Laboratory JSM⁴-840A scanning electron microscope (SEM) and a Kevex SIGMA series energy dispersive spectroscopy (EDS) system. The failure origin (indicated by the white arrow) and surrounding area can be observed in figure 34.

Figure 34. Failure origin area of the 440C ball (mag. 30x).

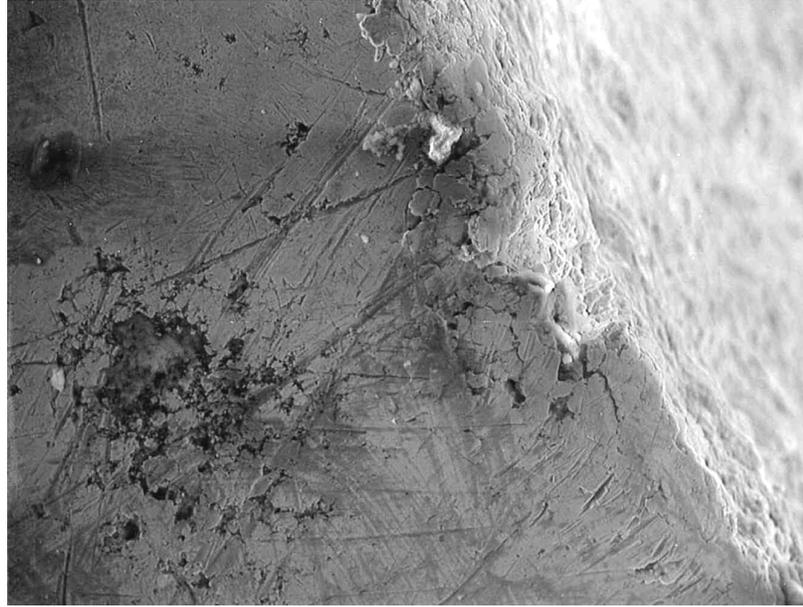
Closer inspection revealed inter-granular attack within and near the origin. Figure 35 depicts the likely fracture origin and the surrounding area at higher magnification at a 45-degree tilt angle with respect to the fracture surface. The large area of attack near the origin in figure 35 can be observed in figure 36.

Figure 35. Fracture origin at high magnification and 45° tilt (mag. 250x).

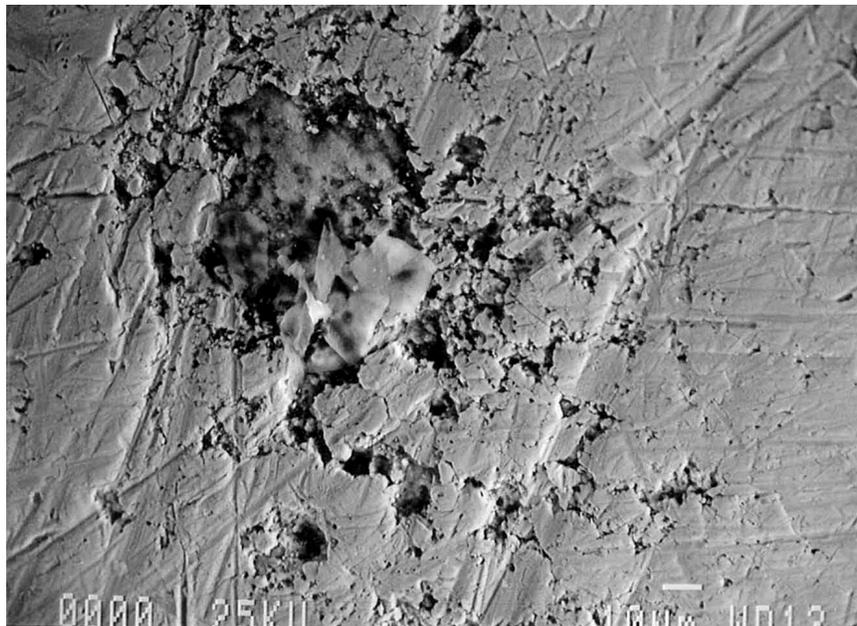
Figure 36. Area of inter-granular attack near the origin (mag. 500x).

The attacked area was filled with corrosion product. This product was analyzed with EDS. The EDS spectrum produced from this product can be observed in figure 37. It was similar in chemistry and composition to the other attacked areas on the ball. However, it was slightly different from the corrosion product on the fracture surface that is presented later.

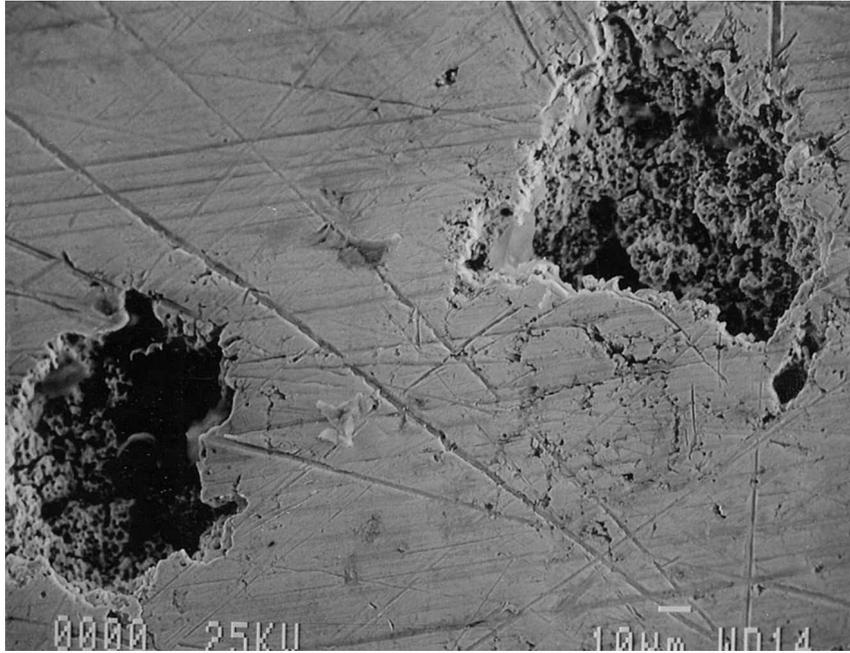
The inter-granular attack at the origin was neither the only nor the largest site of its kind on the ball. Several localized inter-granular attacked sites existed along the exterior surface. Overall, it was estimated that less than 5% of the exterior surface contained corrosion. The hole bored through the ball, however, was noticeably void of inter-granular attack. This would provide evidence that either the attack took place before the hole was made or the hole was somehow shielded from the attack. It is suspected that the combination of the inter-granular attack occurring at a concentrated stress site, the edge of the component, was likely the cause of failure even though much larger attacked areas existed. Two relatively large areas of the attack are observable in figure 35. These areas are depicted at higher magnification in figure 39. The corrosion sites measured approximately 0.0015 inch deep.

Both sites contained some corrosion product, and a noticeable distinction was discernible. The inter-granular attack was preferential to the precipitates at or near the grain boundaries. Closer examination of the region on the left in figure 39 revealed that the precipitates themselves are not

Figure 39. Two large areas of inter-granular attack near the origin (mag. 400x).

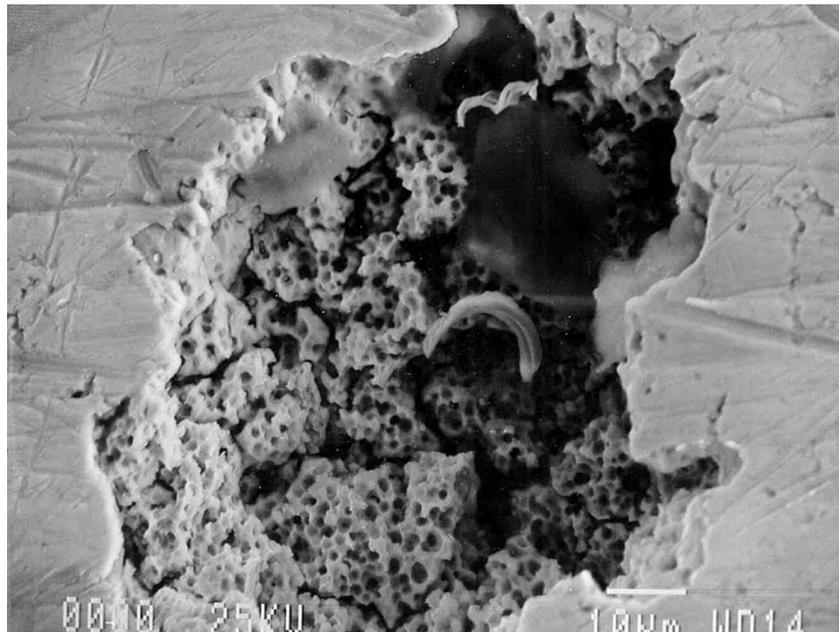
attacked. Conversely, they are dislodged by the attack. Figure 40 depicts this region. The depletion of chromium in the regions surrounding the precipitates makes this occurrence intuitive. The white arrows indicate the precipitates in advancing stages of dislodgment. Figure 41 presents the precipitates shown in figure 40 at higher magnification. Other inter-granular attacked areas demonstrated evidence leading to this conclusion.

Figure 40. Inter-granular attack site with dislodged precipitate (mag. 1kx).

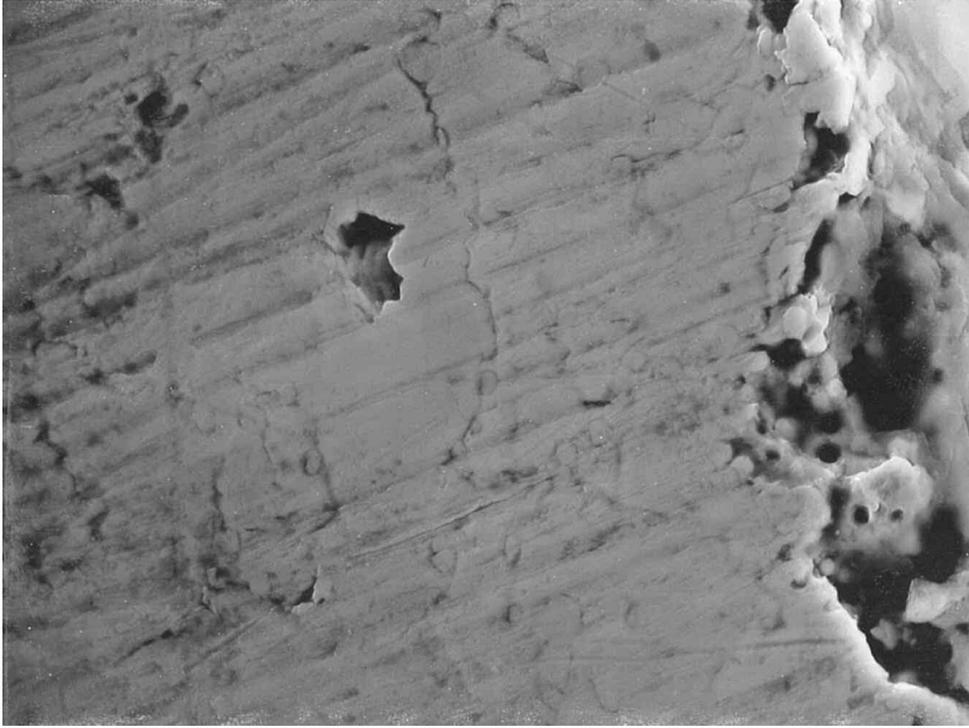
Figure 42 was situated approximately 1 mm from the origin along the fracture surface. Intergranular attack around precipitates near the surface is indicated by the arrows. Another region adjacent to the fracture surface, figure 43, depicts attack around precipitates as well as dislodged precipitates embedded within the corrosion product on the fracture surface. High magnification of another attacked area away from the fracture surface shows four distinct precipitates clearly dislodged from the matrix material. These precipitates are shown in figure 44. The EDS spectrum of the precipitates displayed increased levels of chromium and carbon compared with the matrix base material as might be expected with the formation of iron-chromium carbides of this material (see Metallography section). Figure 45 displays this spectrum and the corresponding increases in chromium and carbon compared with the base material. Note that no carbon was detectable by EDS within the base material. Table 16 shows the qualitative and quantitative results generated from the spectrum.

Figure 42. Inter-granular attack preferentially around precipitates (mag. 2kx).

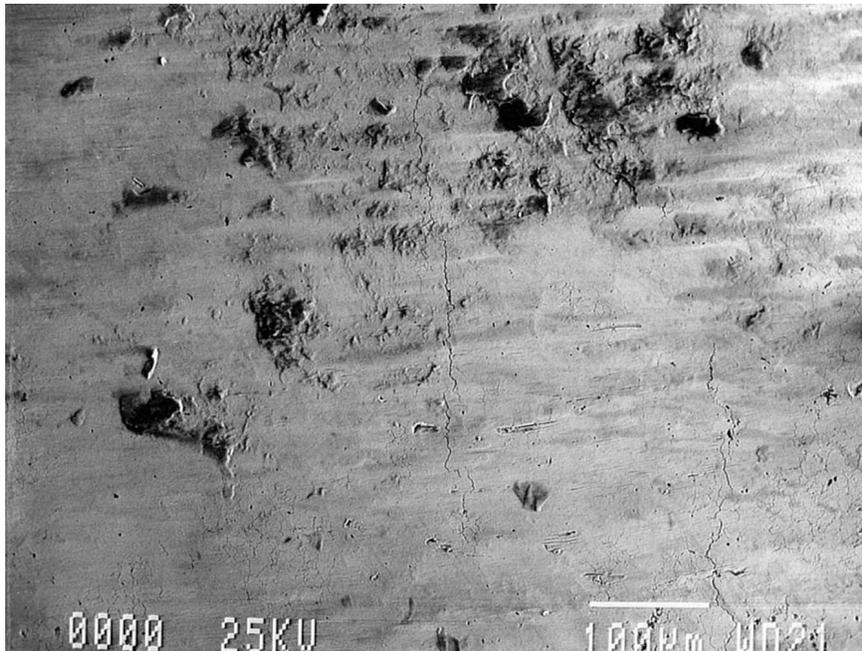
Secondary inter-granular cracks that propagated parallel to the fracture plane were observed within 2 mm of the fracture. These cracks were observed along the flat surface adjacent to the bored hole. Figure 46 depicts the multitude of these cracks highlighted with arrows. At higher magnification (see figure 47), an excellent example of inter-granular cracking preferentially around surface precipitates was observed.

Figure 46. Secondary cracks near and parallel to the fracture surface (mag. 150x).

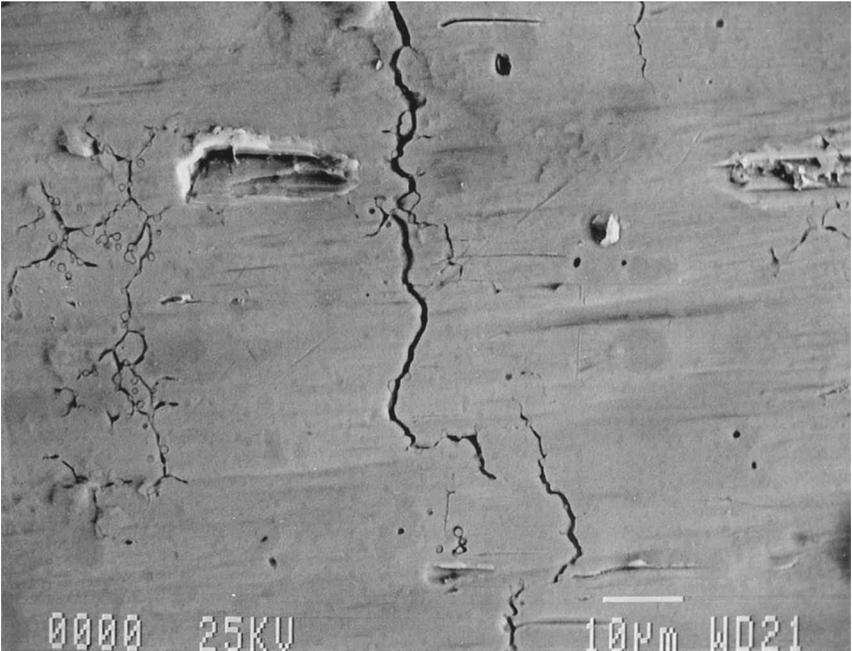
Figure 47. Preferential inter-granular cracking around precipitates (mag. 1kx).

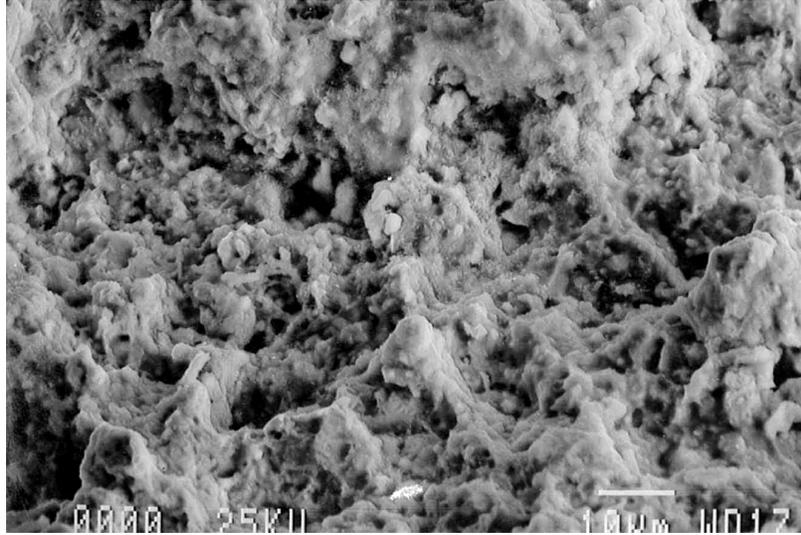
Figure 49. Fractograph 2 of 5, heavily corroded (mag. 1kx).

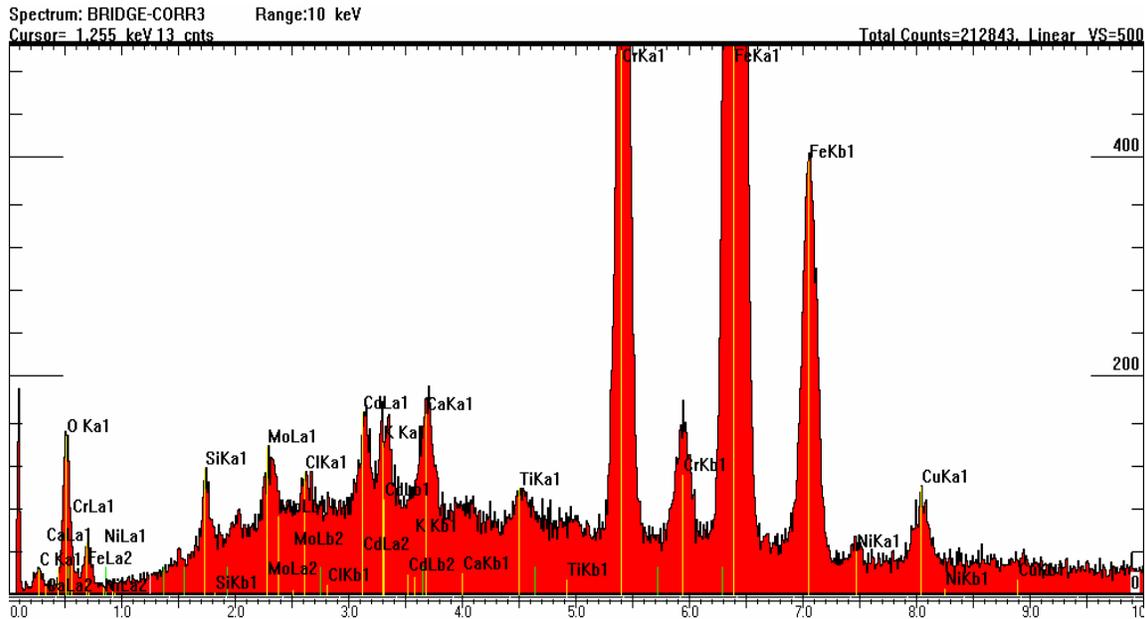
The corrosion observed coupled with the fact that noticeable fatigue beach marks were discernible, would lend evidence to corrosion fatigue being the failure mechanism. EDS analysis of the corrosion products on the surface proved slightly different from the corrosion products observed on the surface of the ball. Figure 53 presents the EDS spectrum of the corrosion products on the fracture surface. Table 17 presents the chemical analysis data acquired from that EDS spectrum.

Figure 53. EDS spectrum of the corrosion product on the fracture surface.

The additional elements of chlorine, potassium, and calcium can again be explained from typical chloride salts that are naturally occurring. Copper, nickel, and molybdenum were within the matrix, so it is reasonable that the corrosion product could contain these elements. However, titanium and cadmium are not alloying elements of this material, and their existence suggests
