ARMY RESEARCH LABORATORY

Final Report on Alternative Chromate-Free Wash Primers

ARL-TR-3932

September 2006

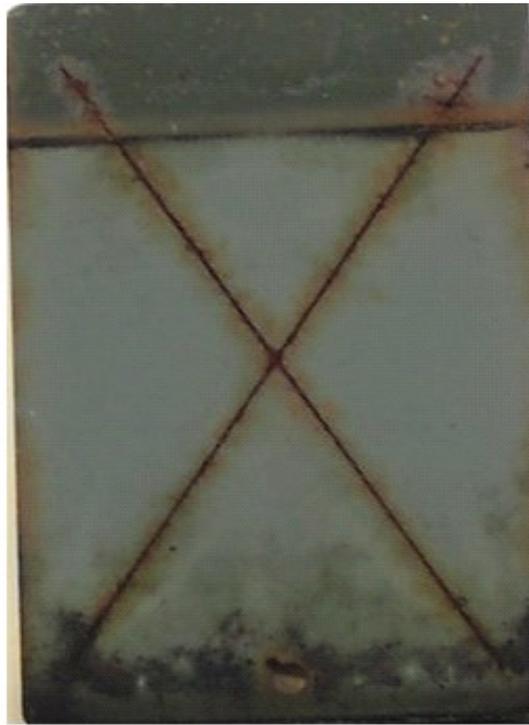
Figure 7. Vendor after 613 days, 1S2 F2.

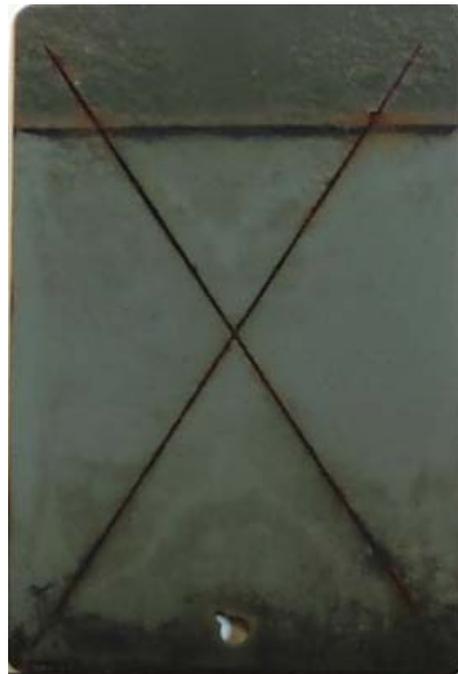
Figure 8. Control after 613 days, 1D4 F1.

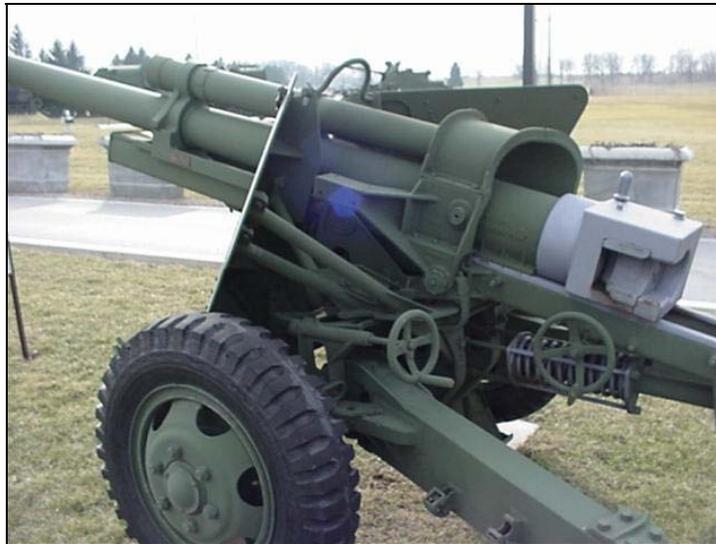
Figure 9 represents fielded DOD-P-15328 wash primer system, and figures 10–11 represent fielded water-reducible wash primer system. Both systems were coated 12-08-04.

Figure 9. DOD-P-15328 wash primer system; units were painted 8 December 2004.

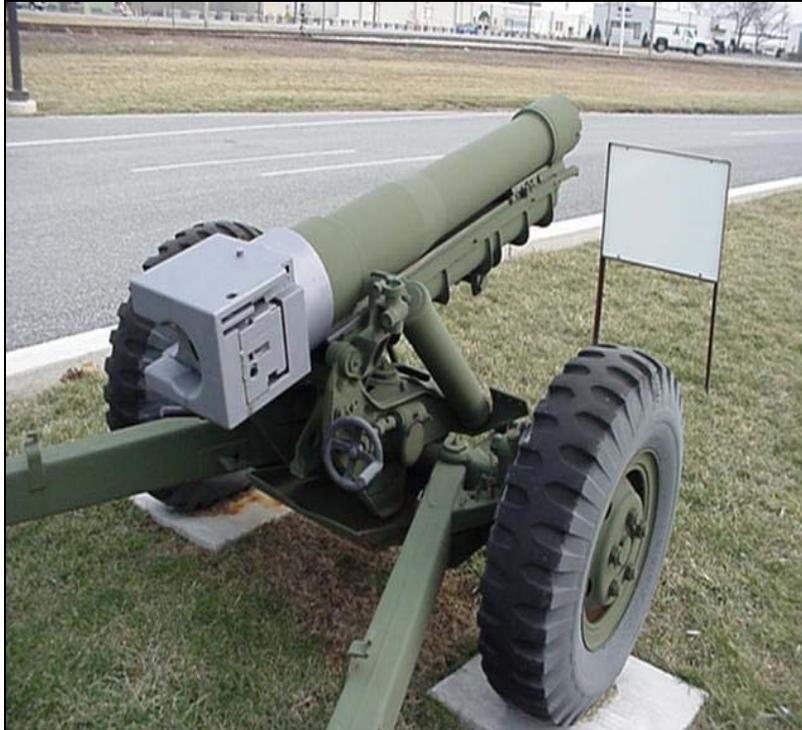
Figure 10. Water-reducible wash primer system; units were painted 8 December 2004.

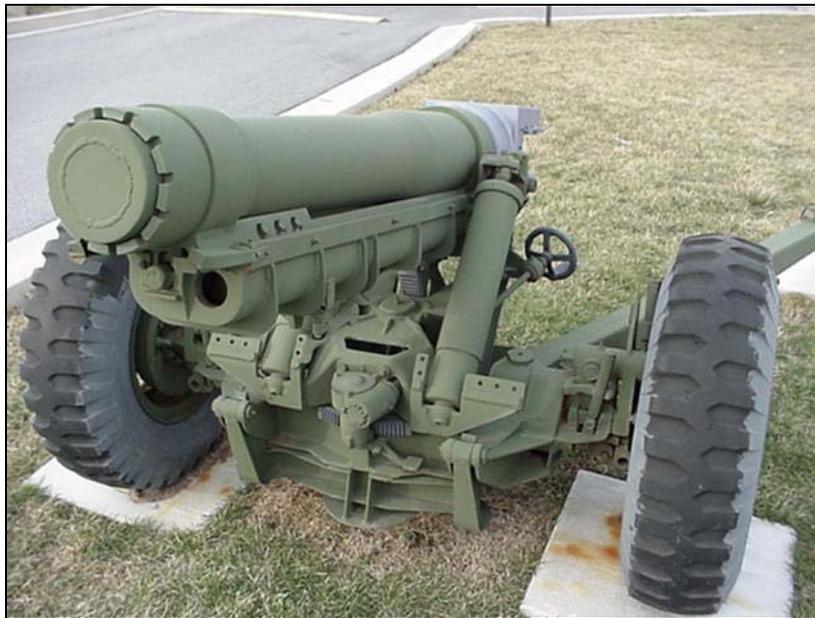
Figure 11. Water-reducible wash primer system; painted 8 December 2004.

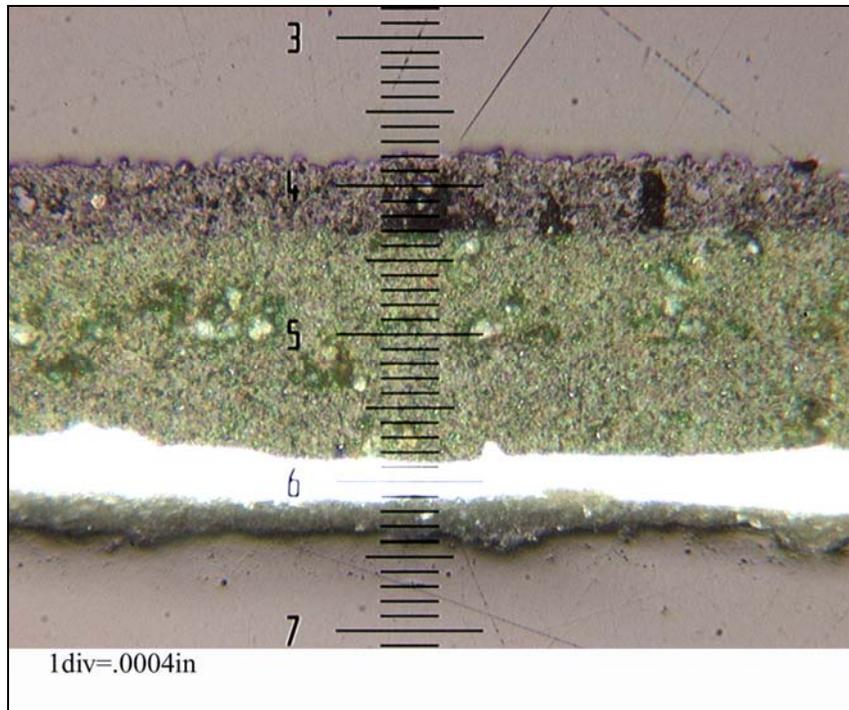
The micrographs presented in figures 22 and 23 depict the coating layers that are present on the paint chip. The top two layers appear to be black and green CARC topcoat. The third layer down

Figure 22. Micrograph of paint chip removed from Patriot ECS shelter with water-reducible wash primer.

appears to be a white primer, and the bottom layer appears to be the alternative wash primer (Sherwin Williams' Kem Aqua). No polyester filler appears to be present on the chip as noted by RDEC. In figure 22, each division of the ruler is equivalent to 0.0004 in. The average thickness of the alternative wash primer remaining on the chip is approximately 0.001 in.

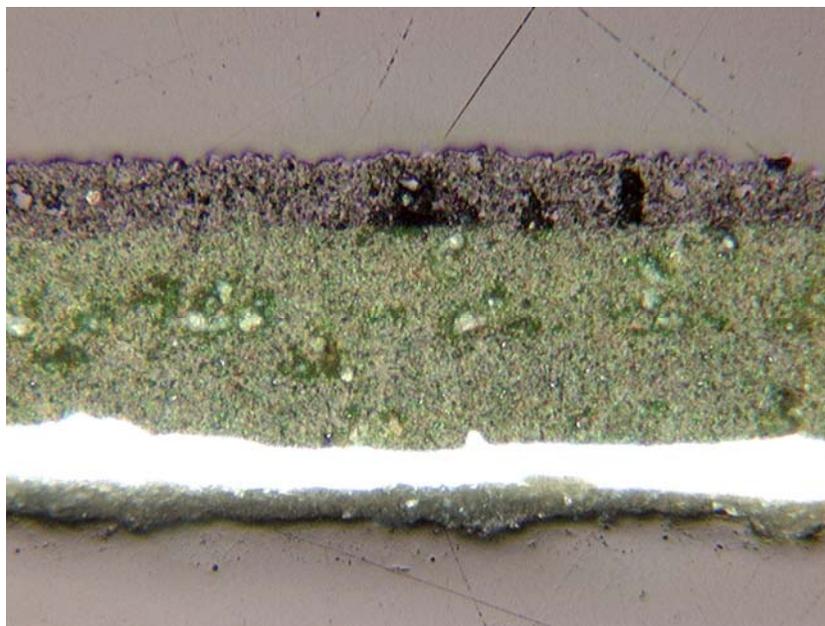
Figure 23. Micrograph of paint chip removed from Patriot ECS shelter with water-reducible wash primer.

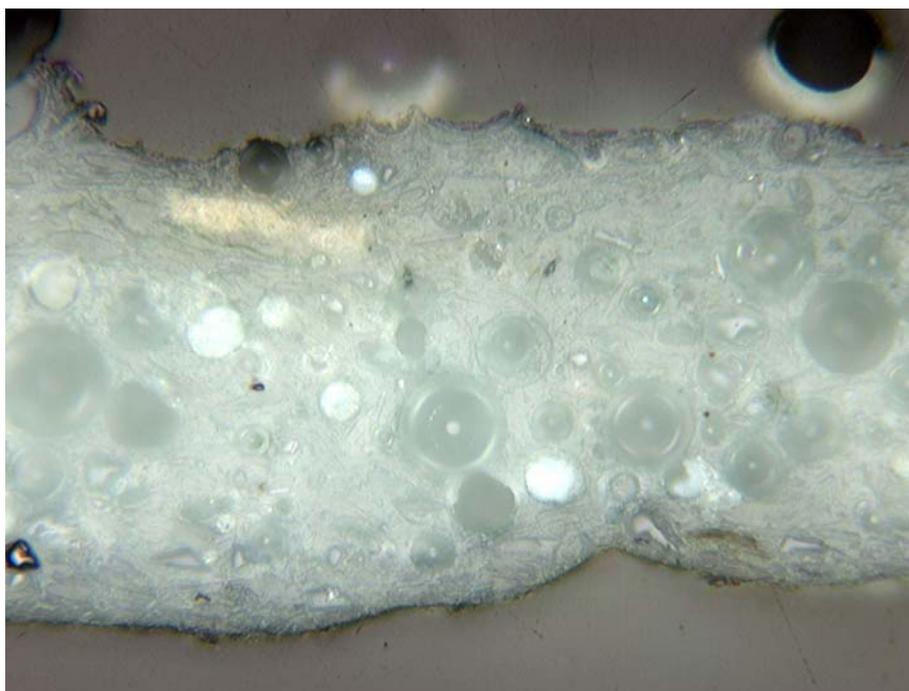
Figure 24 is a micrograph of the polyester filler. It does not appear that any of the polyester filler material shown in figure 24 is present underneath the wash primer layer on the paint chip. The absence of any polyester filler on the paint chip indicates a lack of adhesion between the alternative wash primer and the polyester filler material.

Figure 24. Micrograph of polyester filler removed from the Patriot ECS shelter with water-reducible wash primer.

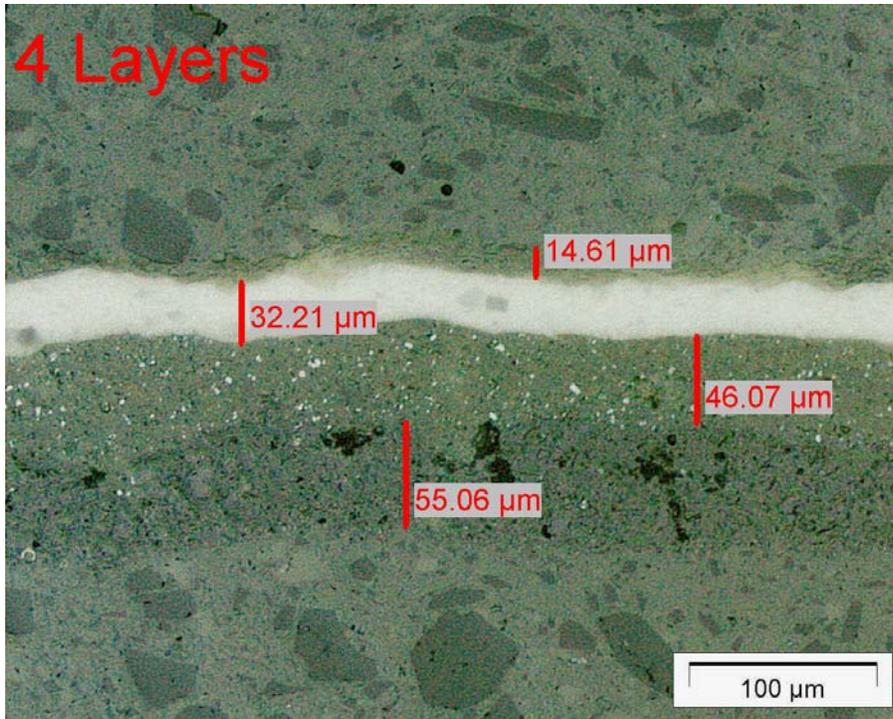
Figure 25. Micrograph of paint chip removed from Patriot ECS shelter with alternative wash primer.

The results of this analysis indicate an adhesive failure between the water-reducible wash primer and the polyester filler. Possible causes include material incompatibility between the water-reducible wash primer and the polyester filler or contaminants on the surface of the polyester filler prior to the application of the water-reducible wash primer. The paint chip from the new water-reducible wash primer showed four layers of coating while the control sample showed three coatings.

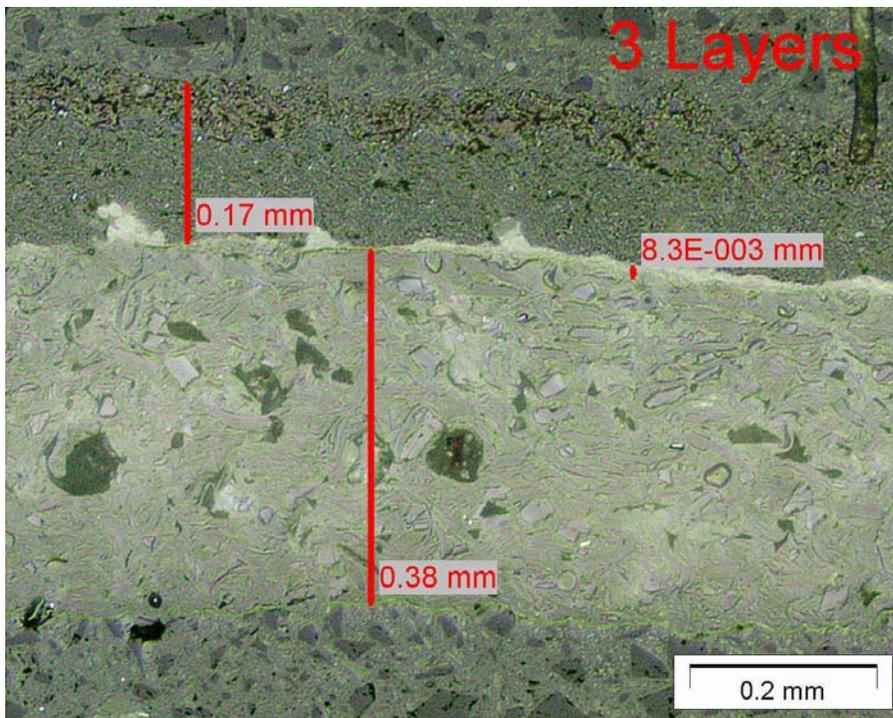
Figure 26. Micrograph of paint chip removed from Patriot CRG shelter with control wash primer.

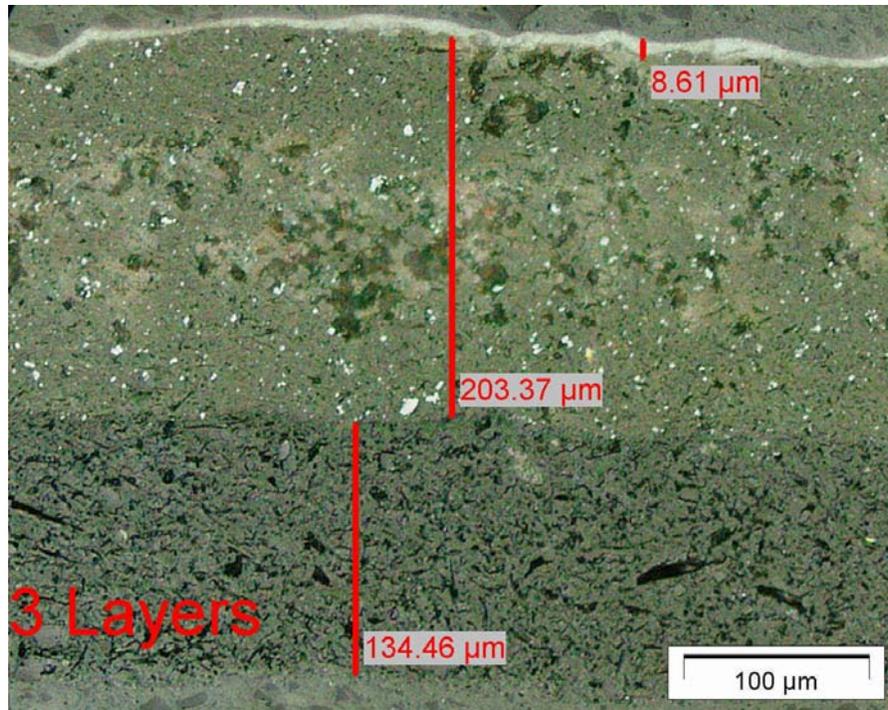
Figure 27. Micrograph of paint chip removed from Patriot ECS shelter with DOD-P-15328 wash primer.

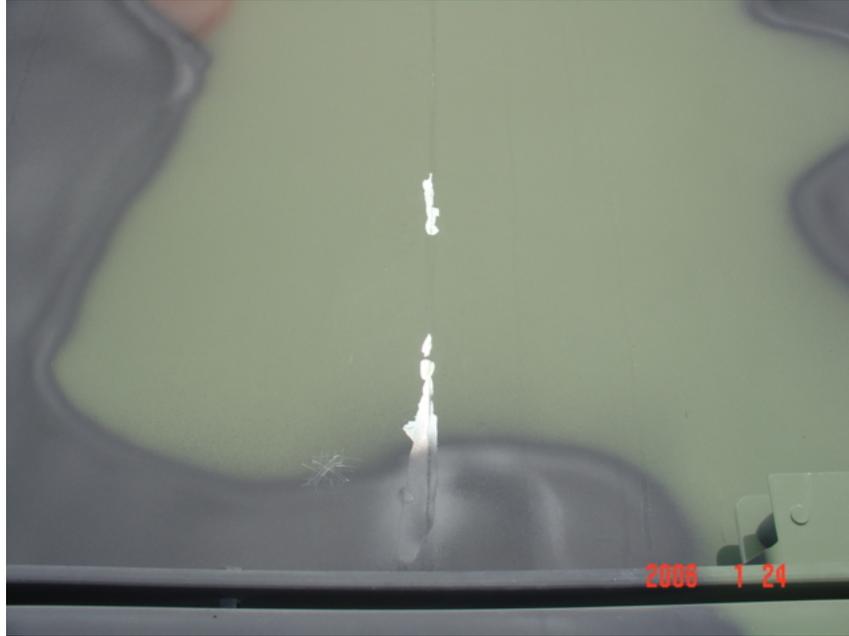
For the ECS serial no. 630106, overhaul date 05/05, there were two areas of paint adhesion failure on the outside of the vertical seam where the paint had peeled away or delaminated 1/4–1 in from the seam. Film delamination occurred only at the seam and only where the polyester filler was applied. Rivet head outlines could be seen along the entire seam. Expansion and contraction forces along the butt seam may be a contributing factor. This failure appears to be occurring at the weakest interface along the butt seam (i.e., between primer and body filler or substrate and body filler). Whatever forces are causing the flex of the substrate (evidenced by the rivet heads) distorts the coatings. The coatings are going to separate at the weakest interface, which appears to be the body filler/substrate interface (figures 28 and 29).

Figure 28. ECS before paint removal, serial no. 630106, overhaul date 05/05.

This Patriot ECS unit was painted using the low-VOC, water-reducible wash primer at Letterkenny, and fielded at Fort Bliss. The two areas of concern are sections of the shelter where the walls were replaced. The walls were bonded using a polysulfide sealer and polyester filler. The filler material appeared to have a heavy film. Dry film thickness measurements (1 mil = 0.001 in) were taken at four different areas. Data is recorded in table 42. Due to high temperatures, the shelter walls expanded causing the paint filler to crack and peel along the butt joints where replacement wall sections meet older wall sections. A knife blade easily removed painted filler along the edges for laboratory analysis.

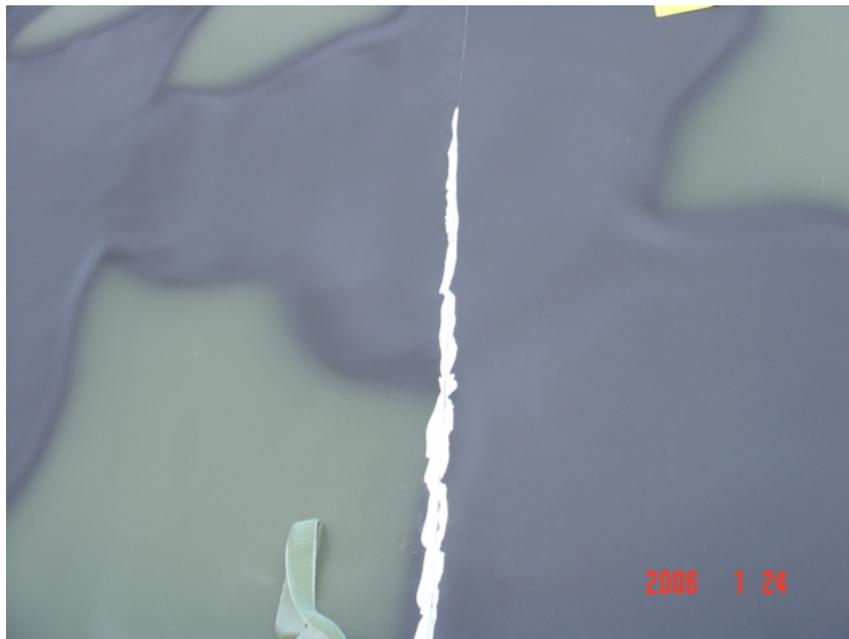
Figure 29. ECS after paint removal, serial no. 630106, overhaul date 05/05.

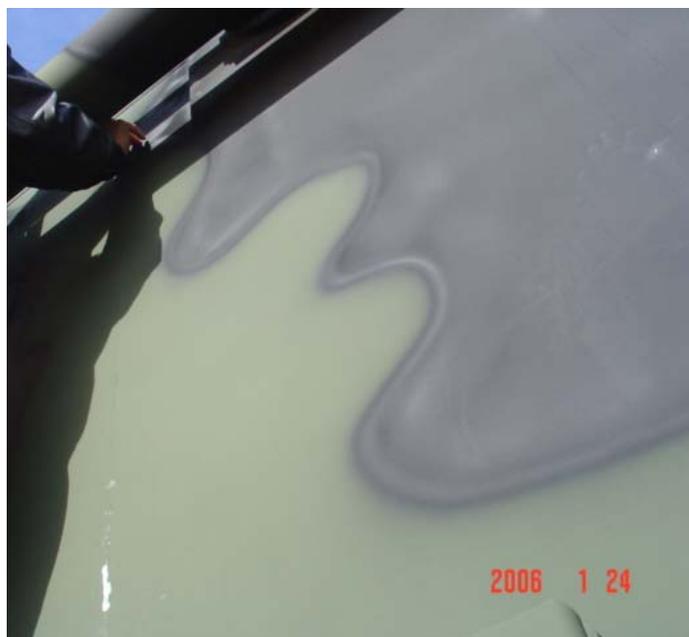
Figure 30. CRG serial no. 620454, overhaul date 05/05.

The Military Specification on CARC System Application Procedures and Quality Control Inspection, MIL-C-53072C, does not address the use of any filler material with the CARC coating systems. The original intent was to evaluate the new wash primer over the aluminum bodied ECS. Bondo and fillers were not included as elements of the coating systems. Bondo Corp. manufactures various grades of polyester fillers. In the communications, the word “bondo” has become generic; the real filler used for this operation was made by Everseal.
