**Examination of Spray-Applied Oxsilan 9810/2 Steel  
Pretreatment on a Mine Resistant Ambush Protected  
(MRAP) Vehicle**

**ARL-TN-578**

**October 2013**

**Jack Kelley and Tom Braswell  
Weapons and Materials Research Directorate, ARL**

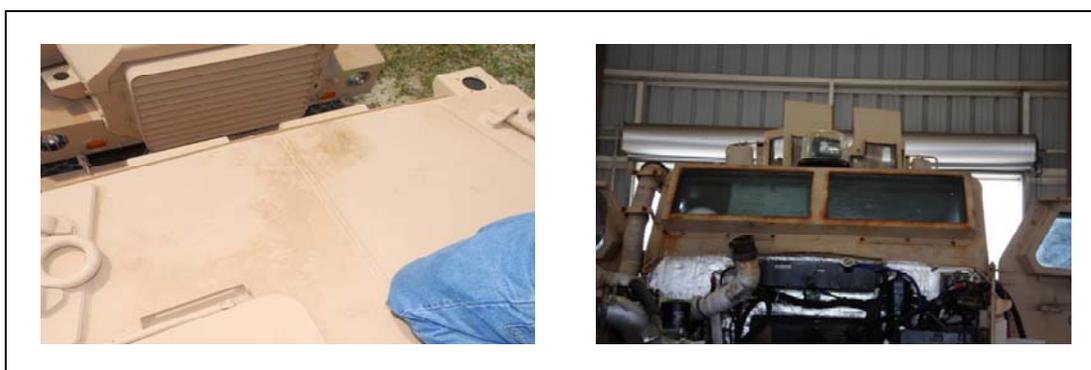
The high-hard armor (HHA) steels that are used for Mine Resistant Ambush Protected (MRAP) vehicles, and a wide range of other systems, provide good protection against armor piercing threats. However, without good corrosion protective coatings these steels corrode rapidly. Photos of newly fabricated, unfielded MRAP vehicles showing significant corrosion have circulated within the Department of Defense (DOD) community. While some may dismiss this rusting as merely cosmetic corrosion, the reality is that such corrosion on military ground vehicles increases the infrared signal from the vehicle that the topcoat camouflage usually inhibits, making the vehicle more vulnerable to detection by the enemy.

Figure 1. Two examples of CARC-coated MRAPs with pretreatment step omitted.

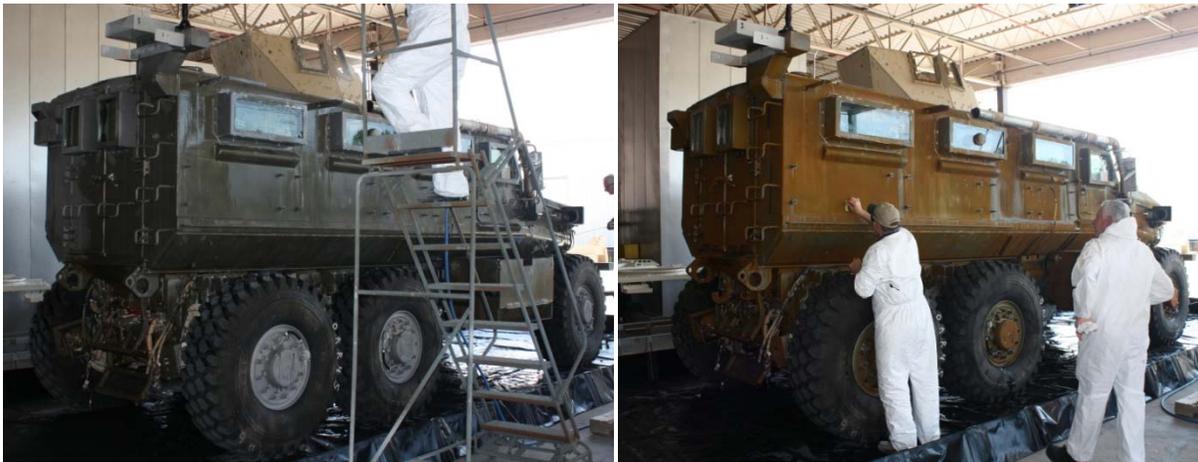
Figure 5 shows MRAP No.1 during and after the application of the Oxasilan 9810/2. These results were completely unexpected and bear no resemblance to the surface finish that was achieved on earlier test panels or the Stryker hatches treated at ANAD.

Figure 5. MRAP No.1 during application of Oxasilan 9810/2 pretreatment (left), and after application with the Oxasilan 9810/2 RTU from drums June 10, 2011 (right).

During a conference call meeting with Chemetall America's Product Manager on the evening of June 20, several possibilities for the unexpected results were discussed: (1) improper solution chemistry (2) application rate (not enough flow) (3) surface contamination because MRAP No.1 was abrasive-blasted 72 h prior to treatment, and/or blast media was contaminated. A sample of the Oxasilan 9810/2 was taken from the drums and sent to the Chemetall Laboratories for analysis. Chemetall Laboratory determined that the solution chemistry was within their acceptable range. As a result, further tests by ARL were conducted to attempt to duplicate the

The results of the ARL HHA test panel experiments indicate that the unusual MRAP result was caused by multiple factors. The brownish-red color of the MRAP was most likely the product of both surface contamination, and insufficient flow and rinsing of the Oxsilan 9810/2. The surface may have been first contaminated by the blast media, which may have contained soluble salts, and/or by the bare freshly blasted steel being exposed to the uncontrolled environment near the Atlantic Ocean at Camp Lejeune, NC (figure 10) for 72 h. Ionogenic contamination from abrasives is transferred uniformly onto steel surfaces. This can turn the steel surface a homogeneous light-gray-to-black color, depending on the concentration (11). The trucks were light-gray with no noticeable corrosion before treatment. But once the pretreatment was applied (using insufficient flow rate in this case), the reaction produced a corrosion-like color on the vehicle. Laboratory tests also indicate that it is possible for optimum flow of the Oxsilan 9810/2 to perhaps compensate for the contamination by essentially washing away the contaminants quickly enough to allow the Oxsilan 9810/2 organo-silane polymers to react with the cleaned metal, leaving a clean-gray finish behind. In addition to the panel testing, evidence of the advantage of the greater flow rate can be seen in the MRAP picture in figure 11. The light-gray streaks occurred at locations where there was a higher flow rate of Oxsilan 9810/2 (i.e., continuously running down the side).

The results indicate that a combination of events contributed to the corrosion-like appearance of the MRAP. With the upscale from laboratory sized and smaller hatch-sized parts to full-sized parts, the scope of the MRAP was underestimated, resulting in inadequate flow of the applied Oxsilan 9810/2. We also believe that the 72 h the bare surface of the vehicle was exposed to the environment led to some surface contamination, which likely would affect the reaction of the Oxsilan 9810/2 with the steel surface. We cannot rule out the possibility that the grit used for abrasive-blasting the vehicles may have contained chlorides or other salts that would have also served to contaminate the steel surface. The laboratory tests and the previous demonstration of Strykers indicate that the Oxsilan 9810/2 must be applied to a freshly clean abrasive-blasted surface as soon as practical, preferably within 2–4 h of abrasive-blasting. The flow rate used for the Oxsilan 9810/2 should be sufficient enough to keep the vehicle wet throughout the treatment. Rinsing with clean water should be done, again using adequate flow rate to thoroughly remove the unreacted Oxsilan 9810/2. We are confident that the desired results can be achieved by following these recommendations.

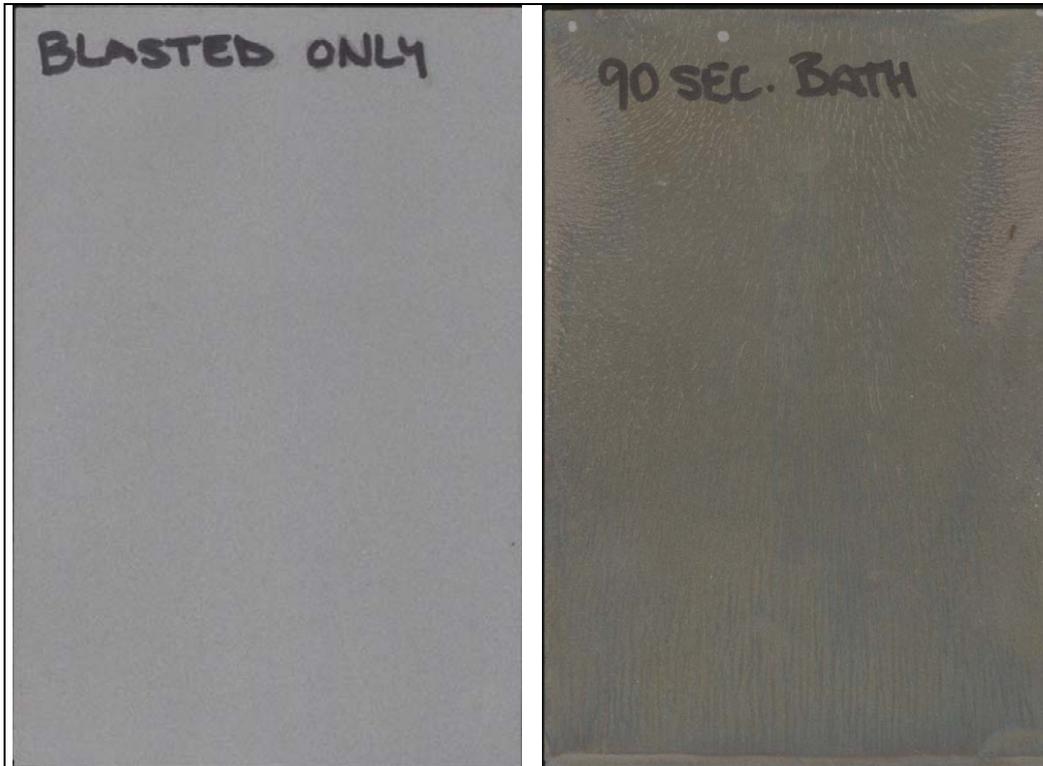
Panels sprayed with maximum flow and maximum dwell time showed a color change. In this case, the colors of the panels were uneven and blotchy with streaks of orange, pink, gold, blue, and dark gray. Figure 6 shows two contrasting panels. On the left is a freshly abrasive-blasted

HHa panel with no pretreatment. A noticeable color change was evident and did not resemble the color seen in either the MRAP demonstration, the samples discussed earlier in the previous laboratory validation, or that of the Stryker demonstration.

Figure 6. A freshly abrasive-blasted, untreated HHA panel (left). A panel “bathed” in Oxsilan 9810/2 for 90 s dwell (right).

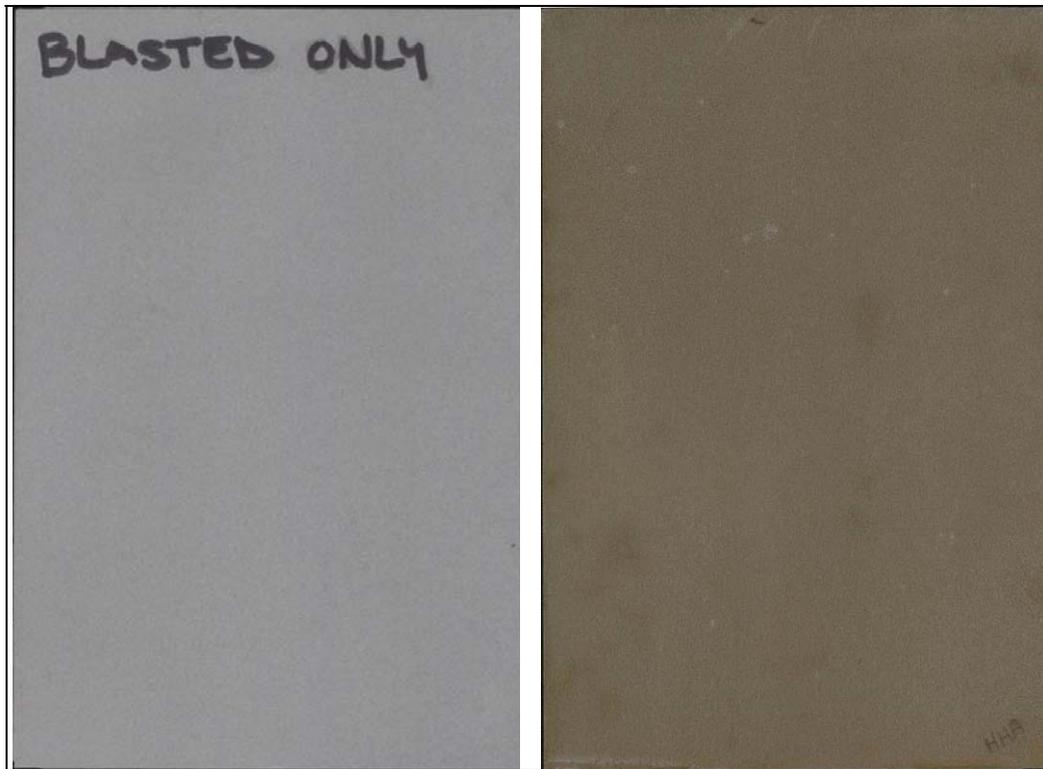
The worst-case for flow and dwell time is represented by the panel on the right in figure 7. The panel was sprayed with the minimum flow allowable to keep the panel wet for 30 s and subsequently rinsed with DI water. As seen, there is an obvious color change compared to the clean abrasive-blasted panel on the left. The panels represented by figure 7 were a bright gold. The color was relatively even, but the color change was dramatic and again did not resemble the color seen in either the MRAP demonstration, previous laboratory validation, or the Stryker demonstration.

Figure 7. A freshly abrasive-blasted, untreated HHA panel (left). A panel sprayed with Oxasilan 9810/2 for 30 s dwell (right).

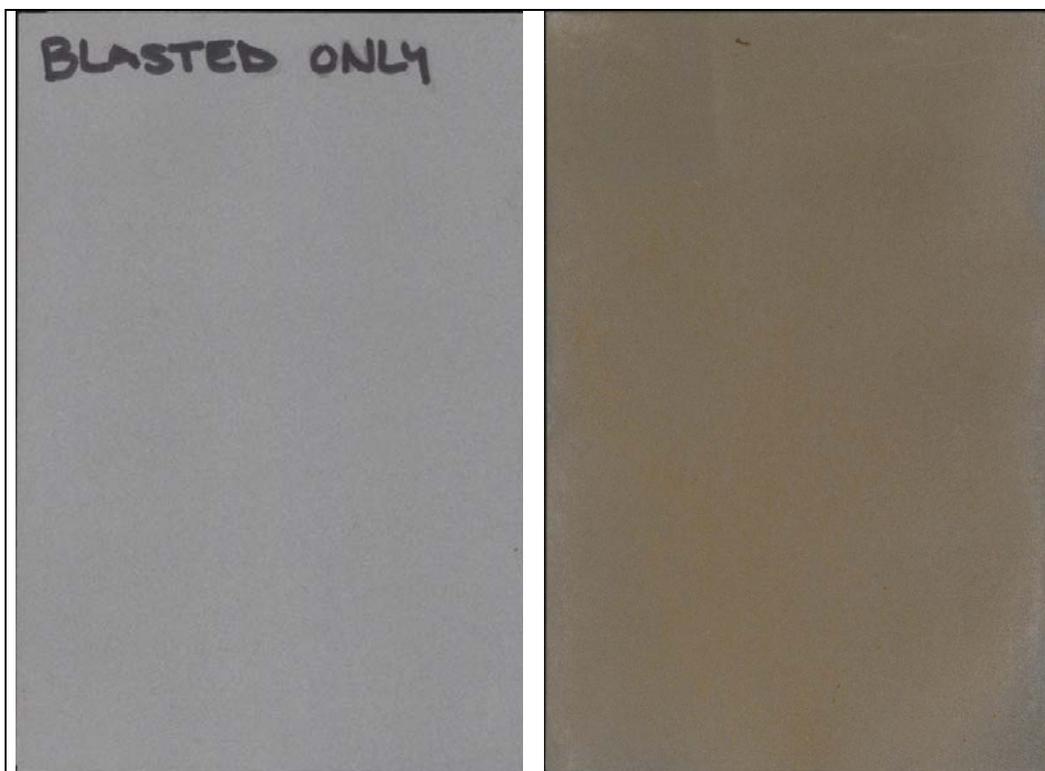
After the HHA test panels were sprayed with 3.5% NaCl solution they were allowed to dry completely. No red rust was evident at this time. These panels were subsequently spray-treated with Oxasilan 9810/2. The pretreatment was sprayed on and allowed to dwell for 90 s as recommended by the manufacturer. After the 90 s dwell, the panels were rinsed thoroughly with DI water and allowed to dry. Figure 8 shows the NaCl spray contaminated panel after the Oxasilan 9810/2 treatment in the photo on the right. The panel appeared to have an orange hue similar to the appearance of “red” rust. This color was slightly more orange in color than panels that were not contaminated with NaCl.

Figure 8. A freshly abrasive-blasted, untreated HHA panel (left). A panel first sprayed with NaCl solution, then treated with Oxsilan 9810/2 (right).

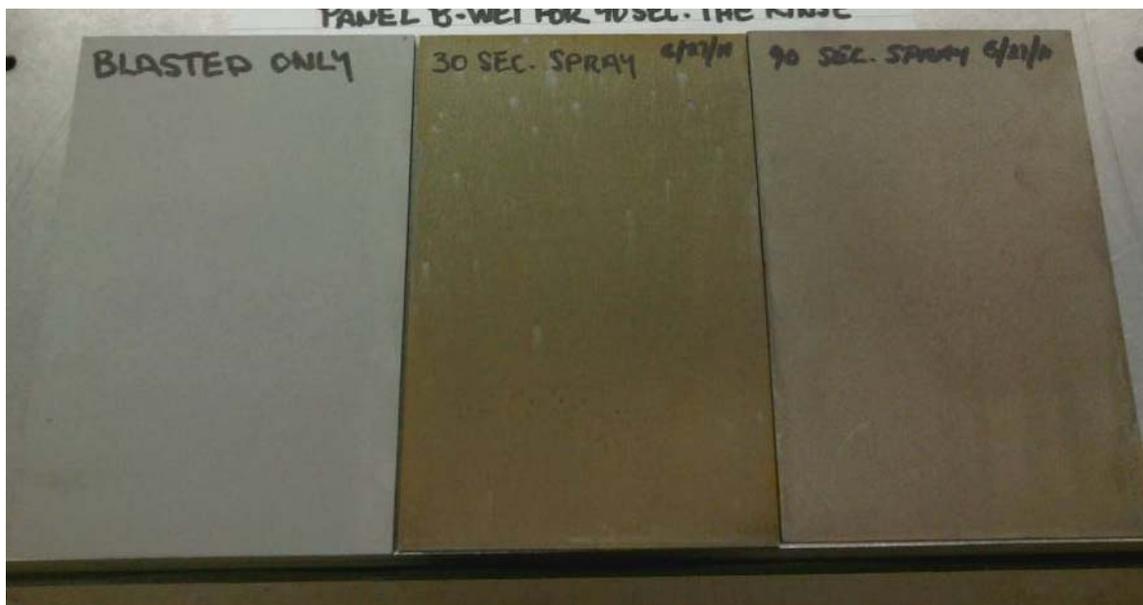
A significant change in the color was evident in these panels as seen in figure 9. The color is very similar to what was seen on the MRAP during the demonstration at Camp Lejeune. Unique to these test panels versus all of the others, was the spotting and streaking of the panel that was only allowed 30 s of dwell for the Oxsilan 9810/2; again, similar to the MRAP. The surface was clearly contaminated, and the contamination appeared to have an effect on the consistency of the ability of the Oxsilan 9810/2 to react with the steel substrate. There was also a color change with the panel treated for 90 s, but it did not resemble the MRAP results.

The color change in the 90 s dwell panel was far less dramatic. In some respects, it resembled the earlier “best-case scenario.” The results of this experiment indicated that more than one factor may have affected the MRAP results. As demonstrated, the pre-exposed panel with the lower dwell time created a similar color as the MRAP at Camp Lejeune.

Figure 9. Example of a freshly blasted HHA panel (left). The panel in the center and right were treated with Oxsilan 9810/2 following 72 h in an outside environment. The center panel was treated using minimal flow for 30 s, and the right panel was bathed for 90 s.

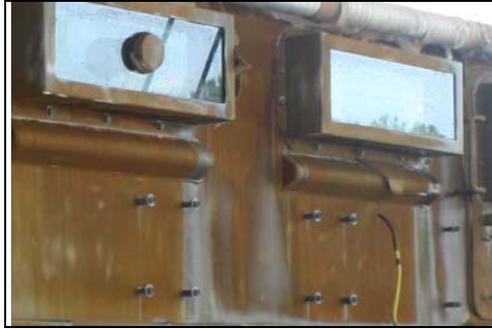
Figure 11. Gray areas along edges of windows where there appeared to be a higher flow rate of Oxsilan 9810/2.
