## **FPI and MPI of Cracks Under Coatings**

**by Scott Grendahl and Benjamin Hardisky**

**ARL-TR-4033**

**January 2007**

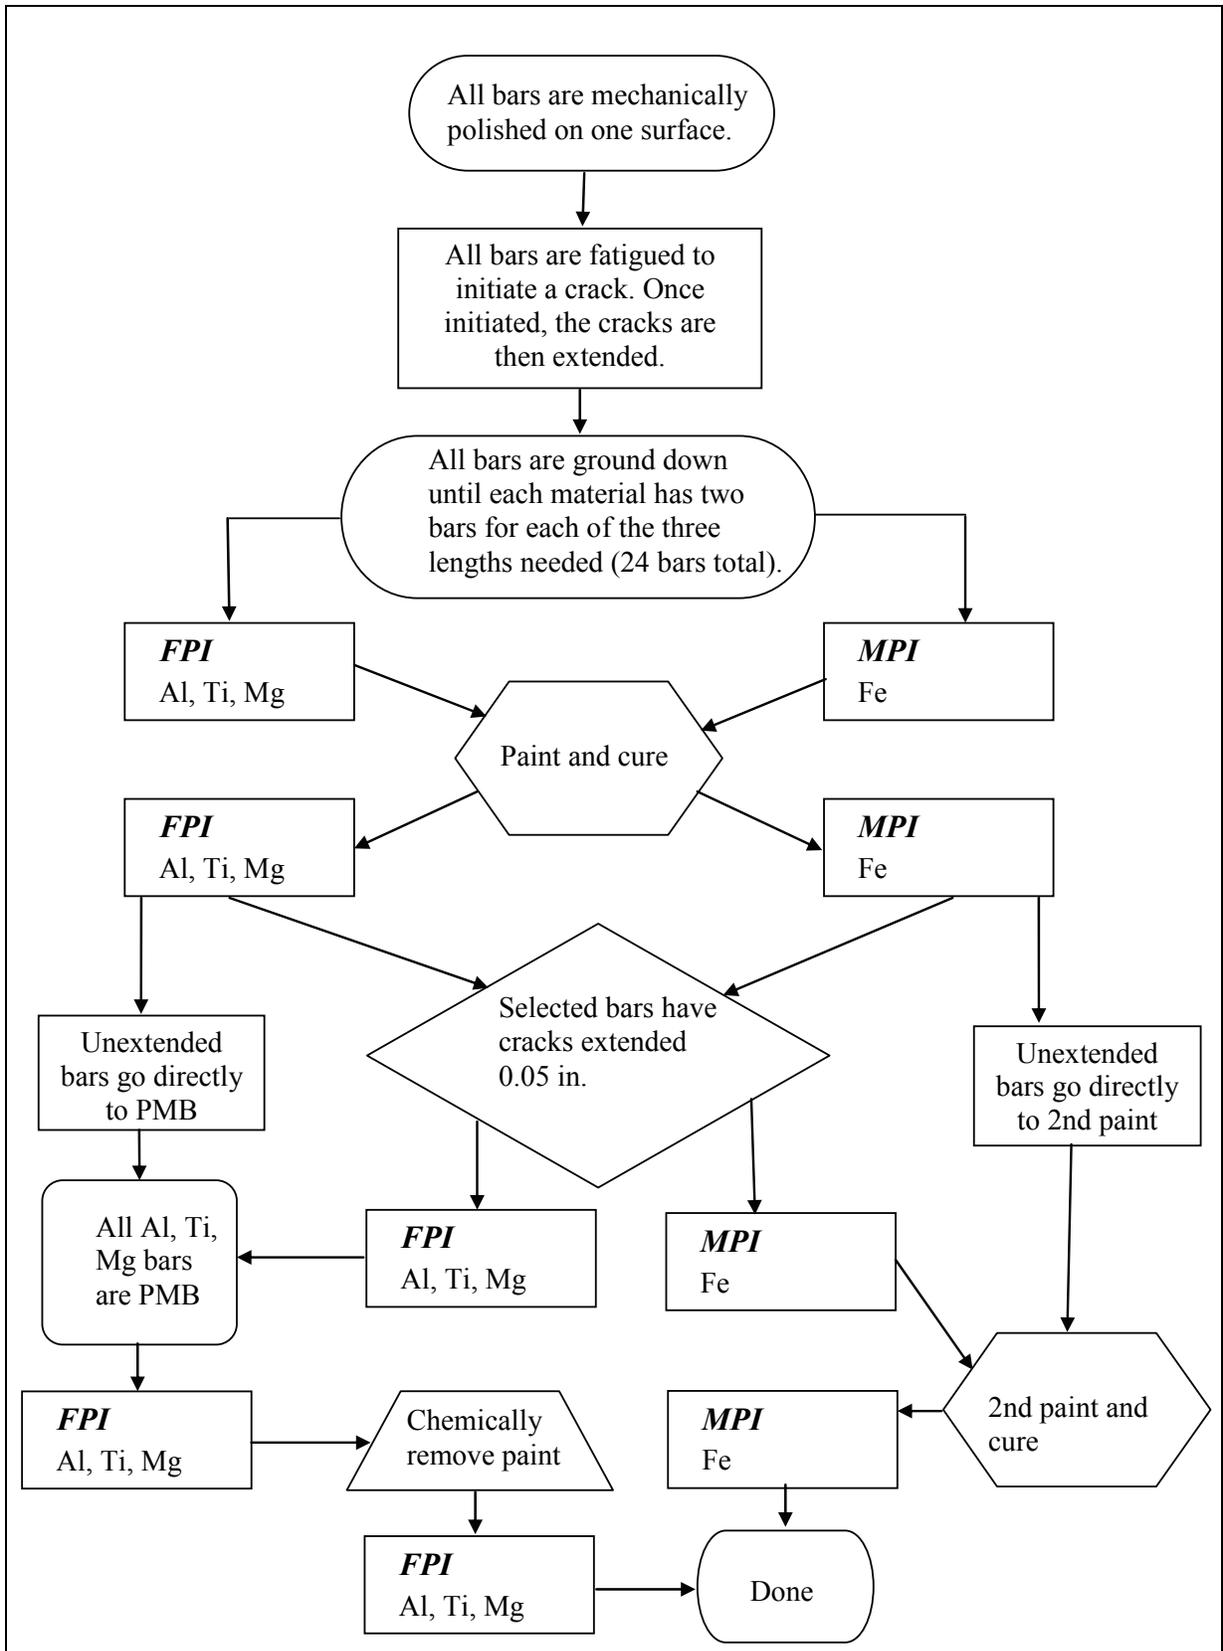
Figure 1. Flow diagram for evaluating FPI and MPI of cracks under coatings.

The test plan was developed by utilizing the prior research and development of Aeronautical Design Standard 61, ADS-61-PRF (1), specifically those sections dealing with fluorescent penetrant inspection (FPI) method, the creation of standardized cracks in specific sizes, and nonbiased, quantitative, light photometer measurement. A flow chart is provided for reference purposes (figure 1) and the test matrix is summarized as follows:

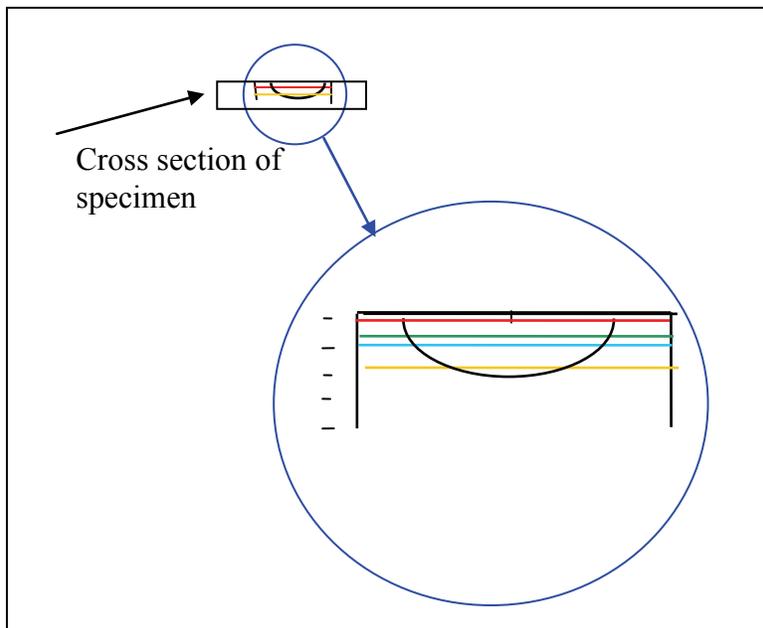
Figure 2. Schematic of the cross section of a typical fatigue-cracked test specimen depicting the incremental removal of material from the top surface and its corresponding effect on crack-length reduction.

with silicon carbide paper. Then, the specimens were examined with optical microscopy and scanning electron microscopy in conjunction with FPI to determine the actual crack length. This procedure was repeated incrementally until all the specimens had the correct crack lengths. In all, six specimens of each material were precracked, with two specimens for each crack length. Testing the lower limit of detectability of FPI and MPI (0.025 in) proved extremely difficult. Quite often, the 0.025-in cracks were polished away in an attempt to reduce the size of a longer crack. The removal of even minute amounts of material at the crack front of a thumbnail crack has a considerable impact on crack length. The final stage in specimen fabrication proved to be even more disconcerting. It is important that the specimens do not have a polished smooth surface. Instead, they should have a surface consistent with the components they represent, i.e., typical aviation parts. Therefore, the final step was to provide the specimens with a typical 125 root-mean-square surface finish. This surface finish was applied with a Buehler belt grinder with 225-grit paper. The application of this surface finish removes a great deal of material and must be accounted for before finalizing the crack size. If it isn't, the smallest cracks are completely removed during this process. Once the cracks had the correct lengths, nondestructive inspection (NDI) was performed on the bars, and fluorescent light measurements were taken to get baseline values. FPI was performed on the aluminum, magnesium, and titanium, and MPI was performed on the steel. Subsequent to the baseline measurement, all bars except the titanium were pretreated with their respective coatings. Schematics of the incremental grinding and polishing for each of the specimens can be found in the appendix. The schematics in the appendix represent only the crack plane and are an enlargement of the cross section of the component (figure 2).

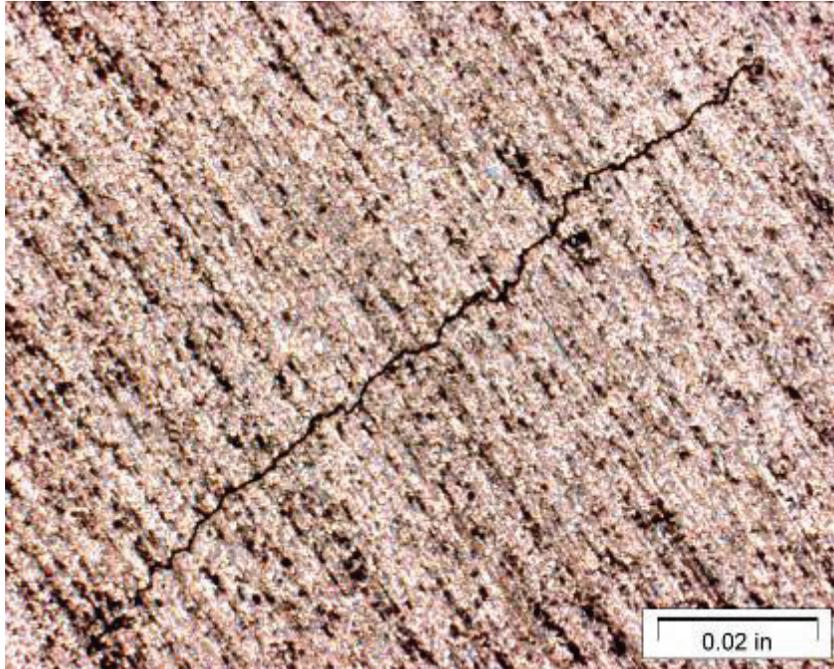
Figure 3. Al bar no. 7 after initiation and extension (shows crack at its final length).

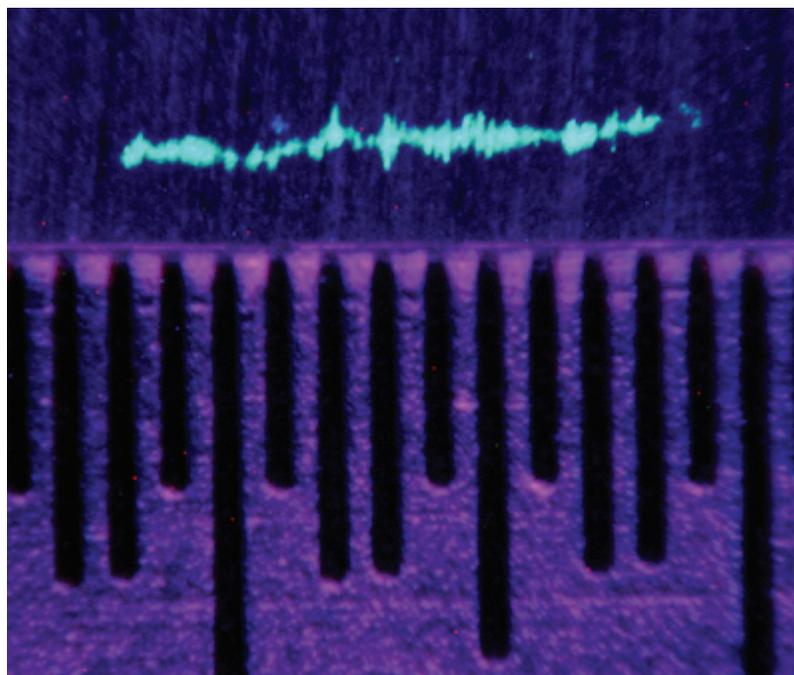
Figure 4. FPI of Al bar no. 7 after initiation and extension.

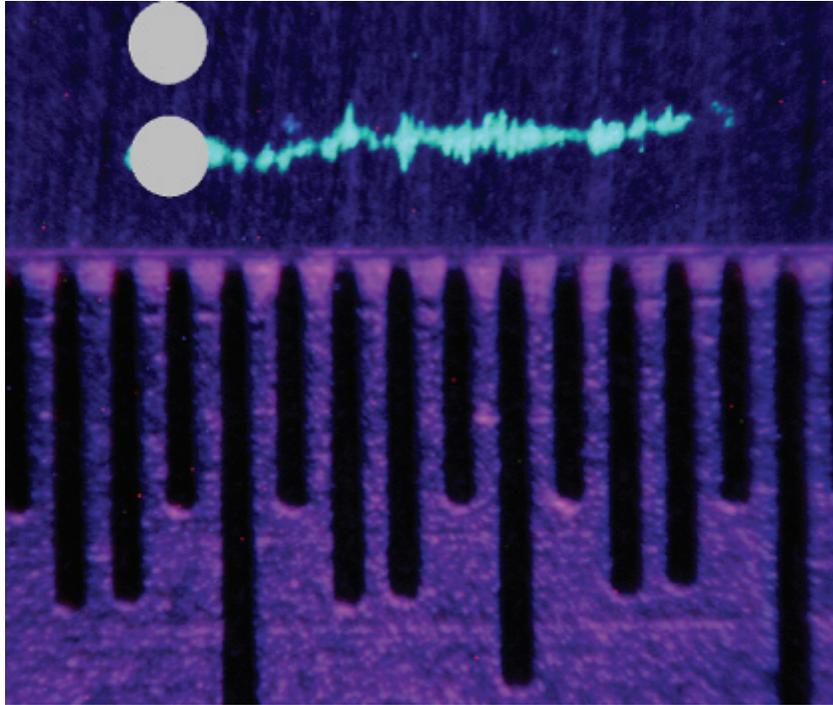
Figure 5. Al bar no. 7 illustrating the manner in which the brightness measurements were acquired. The top dot represents the area the spotmeter was focused for the background measurement, and the bottom dot represents the area from which the crack measurement was acquired.

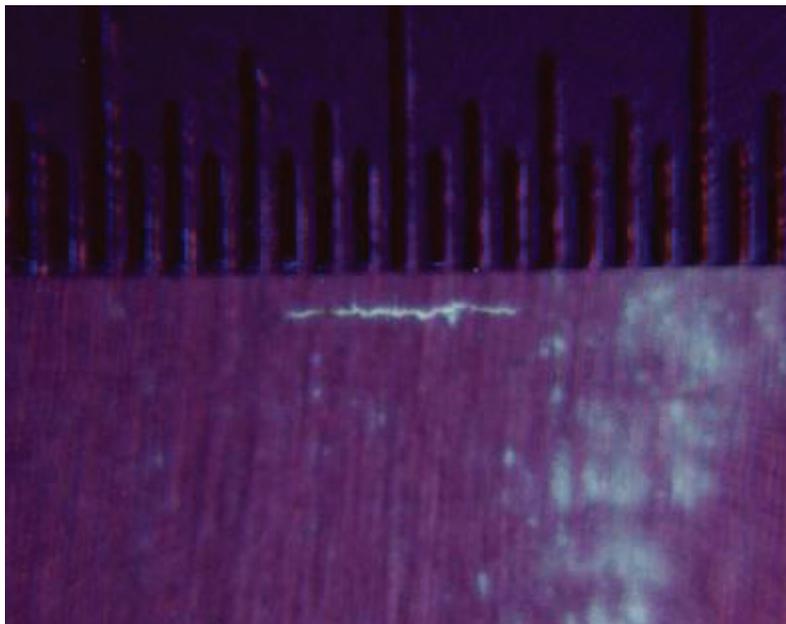
Figure 6. FPI of Al bar no. 7 crack after anodizing.

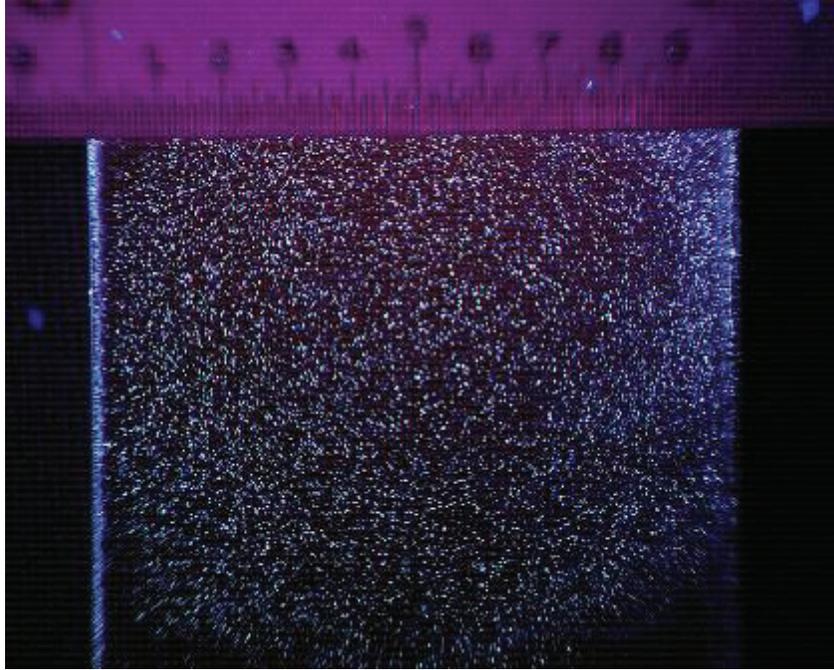
Figure 7. FPI of Al bar no. 7 crack after painting.

extreme background fluorescence from the paint absorbing the penetrant is evident. No brightness measurements were taken after PMB because zero indications were observed during FPI. The typical results are shown for specimen no. 7 (figure 8). Note how the crack has no visible infiltration of the penetrant. After the bar was processed in paint stripper and mechanically flexed, the crack was again apparent (figure 9). The brightness measurements taken for bars 8, 9, and 10 after chemical paint stripper processing were recorded after the cracks were flexed on the mechanical testing machine. Before they were flexed, no indications were visible. The resulting indications for cracks 8, 9, and 10 after this process can be observed in figure 10. Note again the extreme background fluorescence, resulting in low contrast between the background and the indications.

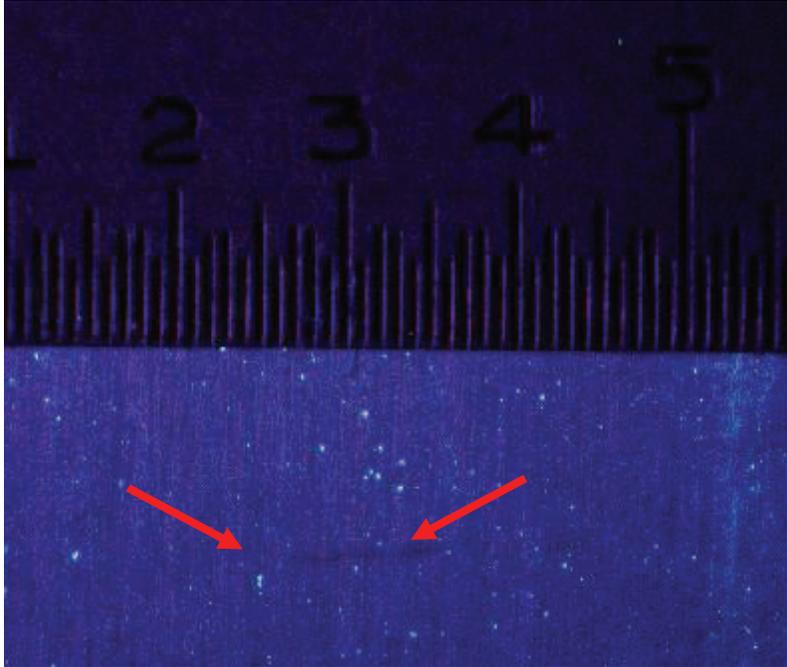
Figure 8. FPI of Al bar no. 7 after PMB. The crack can be observed visually, but no indication can be observed.

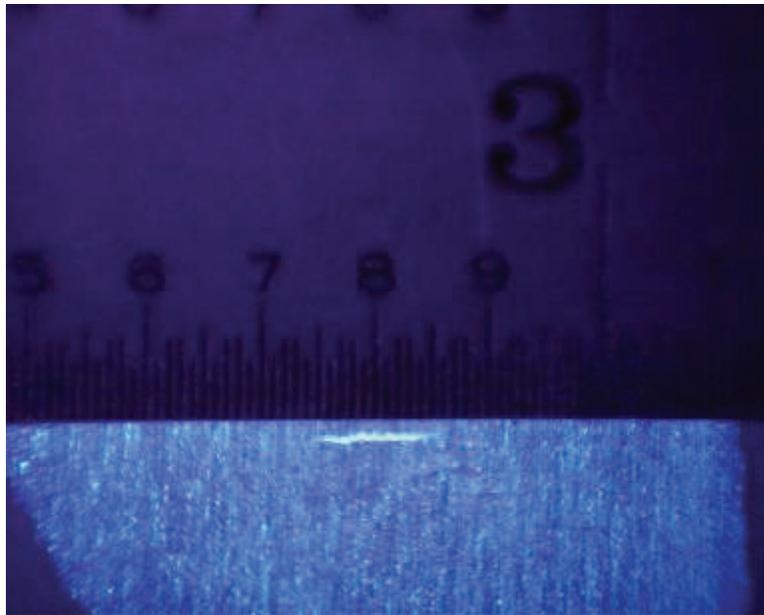
Figure 9. FPI of Al bar no. 7 performed after the bar had been processed in paint stripper and after the bar had been mechanically flexed.

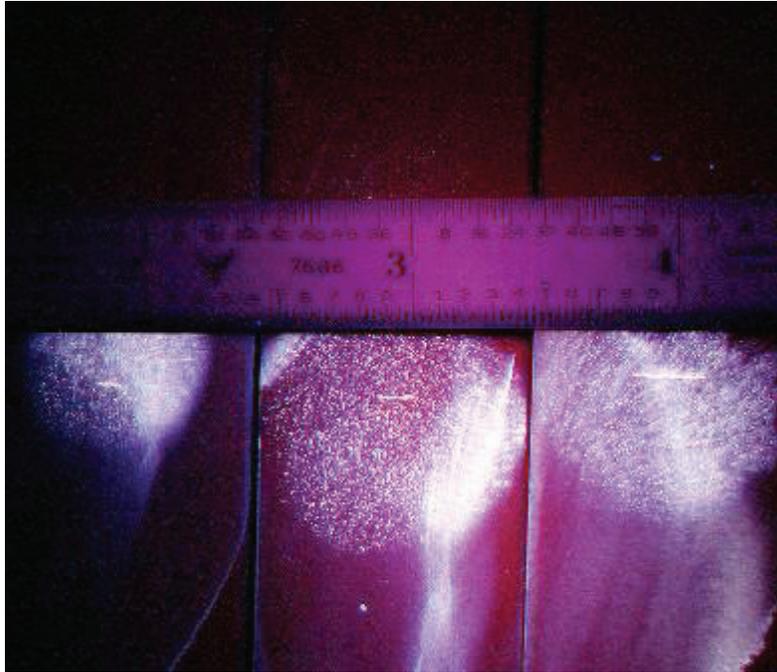
Figure 10. FPI of Al bar nos. 8, 9, and 10—the bars with cracks extended  $\sim 0.050$  in after painting—performed after the bars had been painted and the cracks mechanically flexed.

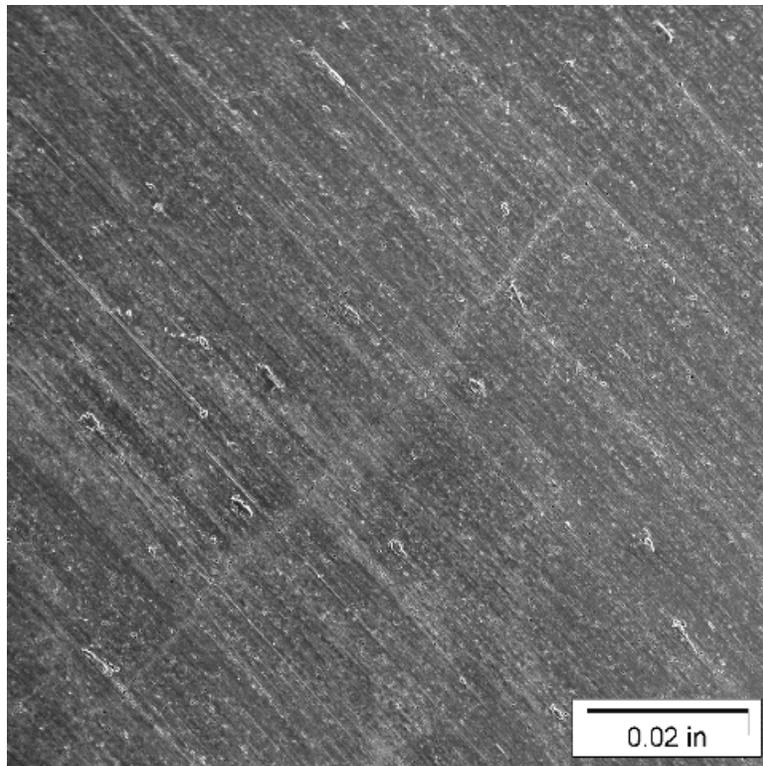
Figure 11. Titanium bar no. 6—0.1-in crack after initial crack extension.

Figure 11 presents an SEM micrograph of a typical bare titanium crack after initial extension. The corresponding brightness measurements for titanium can be found in table 11. The initial baseline measurements yielded the highest values of any category, and the difference between the crack intensity and the background intensity for this group yielded the highest contrast. The typical resultant FPI is visual depicted in figure 12. Figure 13 shows the typical areas where the light measurements were recorded. No indications were observed after the paint was applied, so no readings were recorded. Figure 14 presents the typical visual FPI results after paint was applied. The brightness measurements taken after the painted bars were extended were much

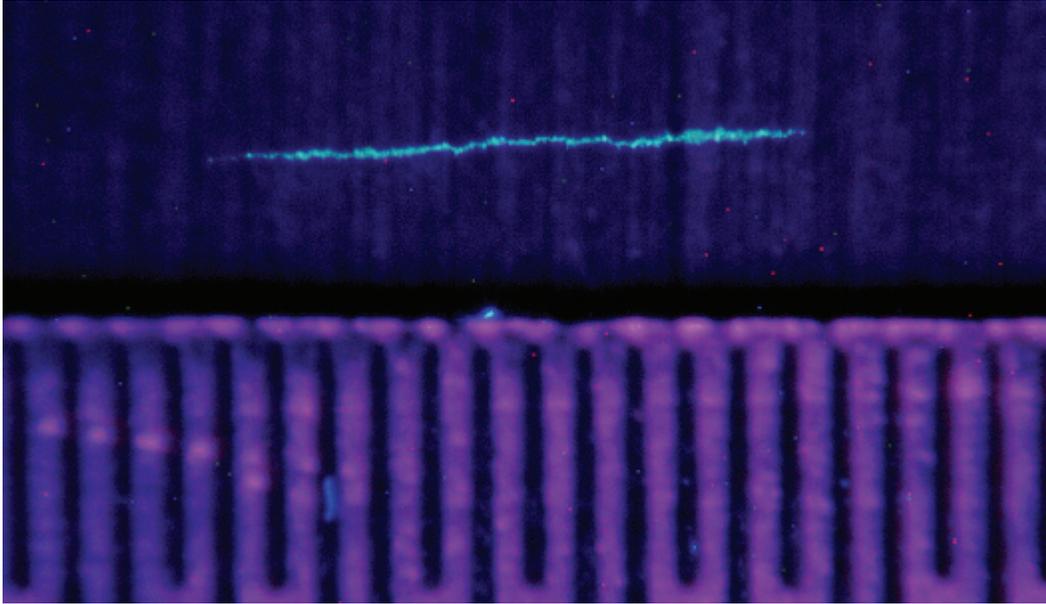
Figure 12. FPI of titanium bar no. 6—0.1-in crack after initial crack extension.

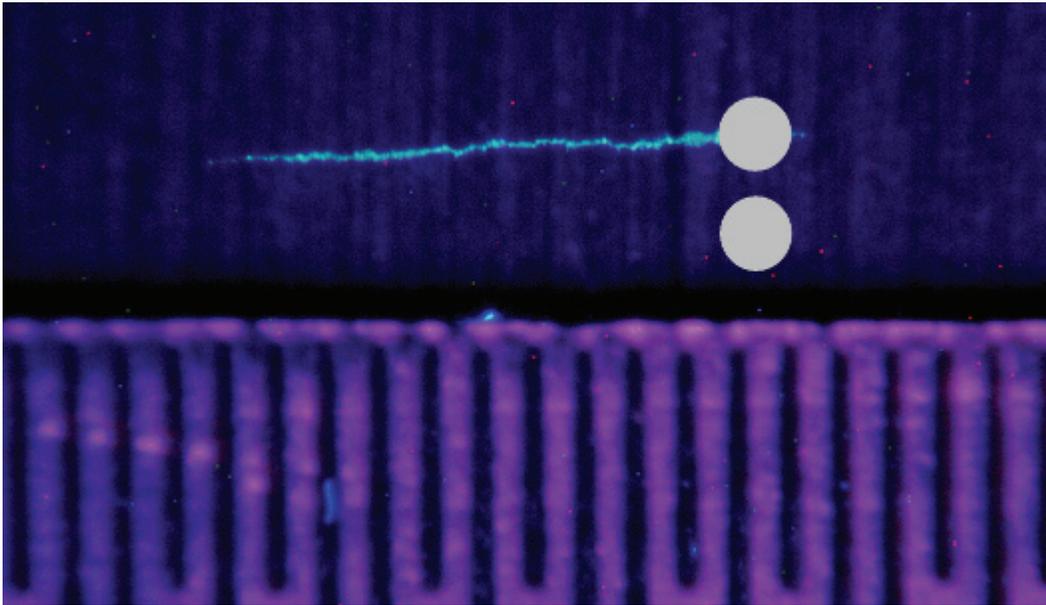
Figure 13. FPI of titanium bar no. 6 showing areas where brightness measurements were taken. The top spot is the brightness of the crack, and the bottom spot (below the crack) is where the background reading was taken.

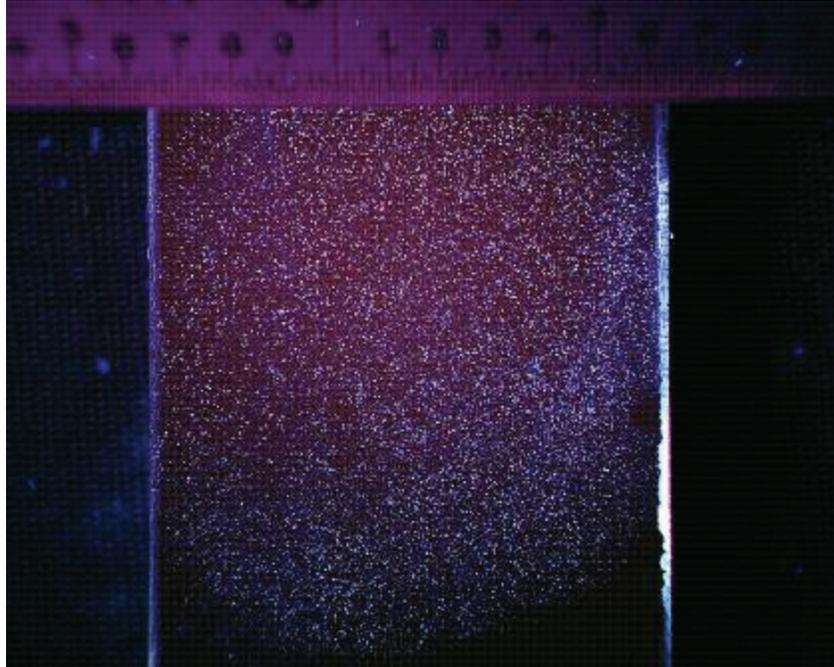
Figure 14. FPI of titanium bar no. 6 after painting.

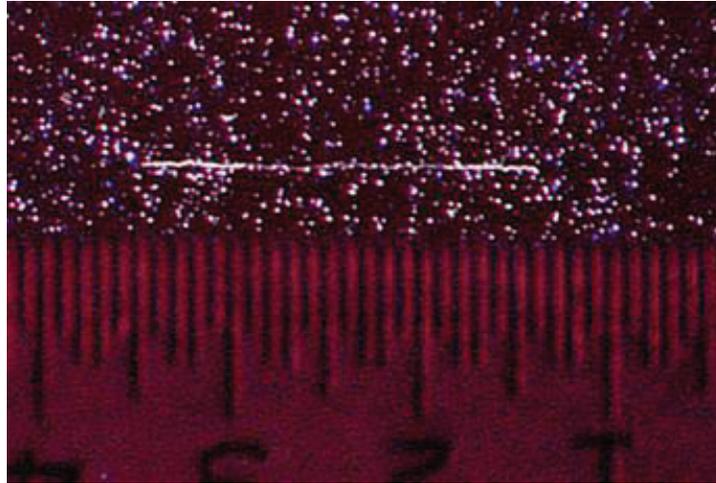
Figure 15. FPI of titanium bar no. 6 after the painted bar had been extended by 0.5 in.

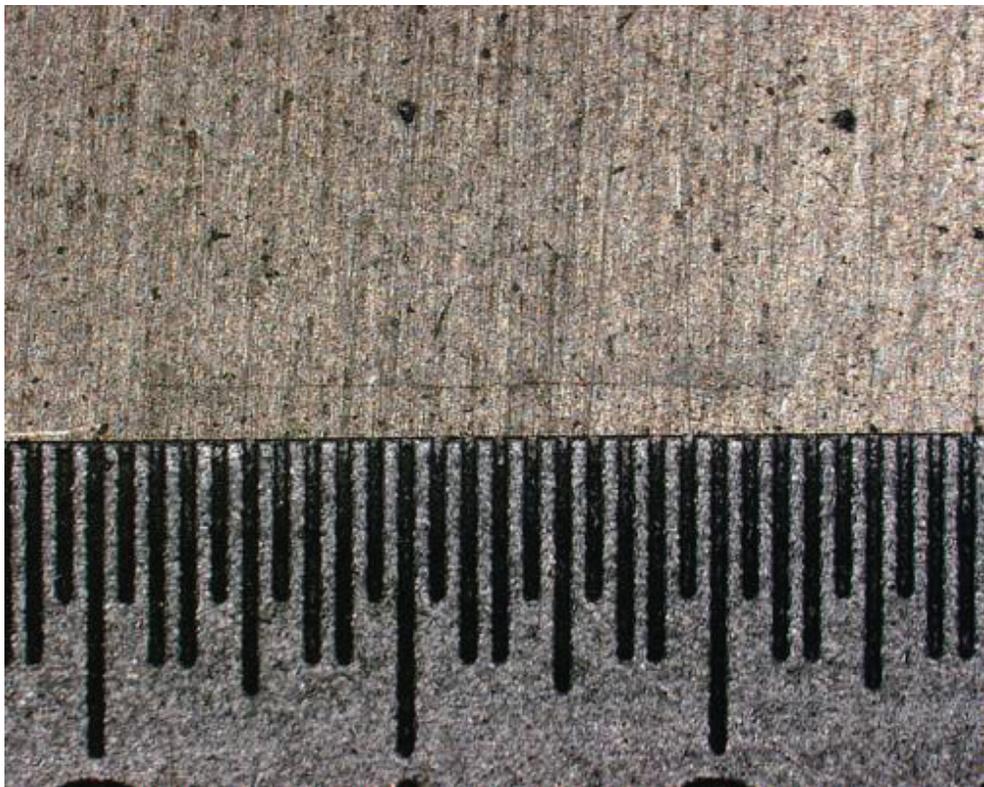
Figure 16. Optical micrograph of titanium bar no. 6 showing the extended crack after PMB.

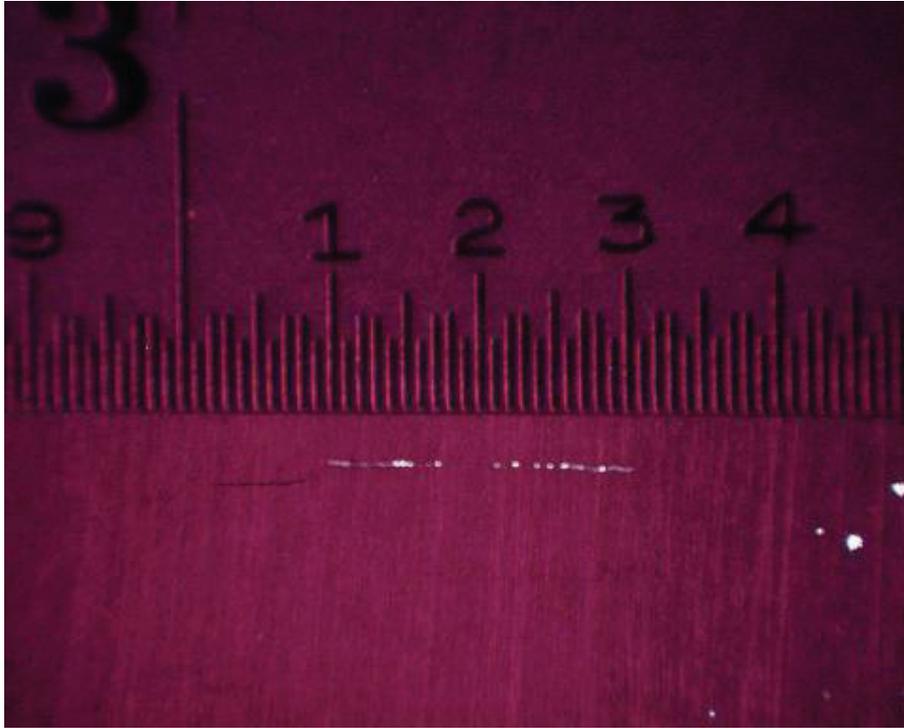
Figure 17. FPI micrograph of titanium bar no. 6 after PMB and mechanical flexing. Initial FPI produced no visible indication after PMB.

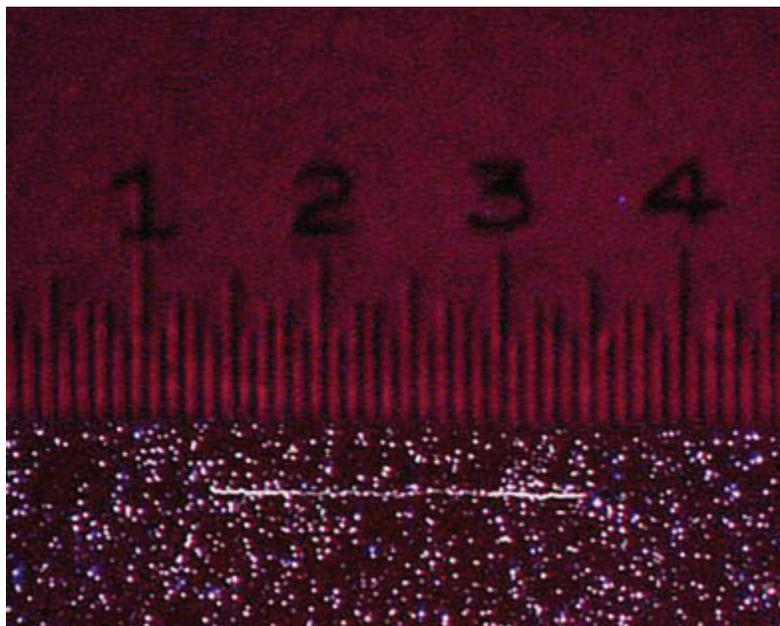
Figure 18. FPI micrograph of titanium bar no. 6 after PMB and chemical-stripper processing. The results are similar to those after painting and crack extension.

dimmer than the initial measurements. The difference between the crack measurement and the background measurement was also greatly reduced. During FPI, only faint indications could be visually observed (figure 15). Titanium was the only material out of the three that demonstrated visible indications after PMB. Figure 16 shows an optical micrograph depicting the crack in titanium bar no. 6 after PMB. The indications were faint compared to the baseline measurements, and in some cases, portions of the crack length were masked completely. Ultimately, the titanium bar cracks required mechanical flexing on the mechanical test frame (like the aluminum and magnesium). Figure 17 shows the resultant visual FPI of titanium bar no. 6 after PMB and mechanical flexing. After chemical-stripper processing, the results were similar to those after the crack extension of  $\sim 0.05$  in. These results are depicted in figure 18.

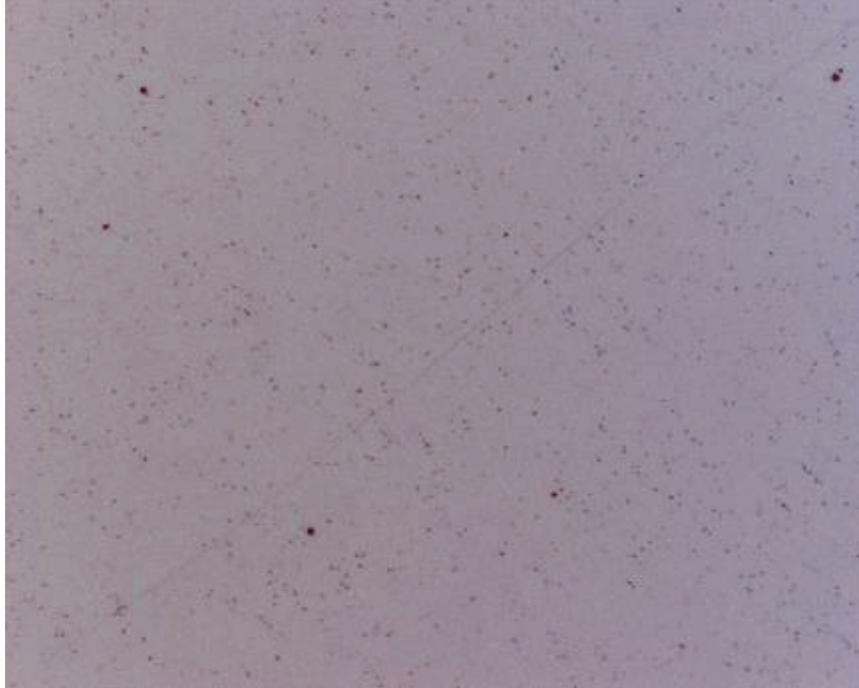
Figure 19. Magnesium bar no. 2 with a 0.2-in crack length.

The magnesium bar brightness measurements can be found in table 12. An optical micrograph of the bare magnesium crack no. 2 is shown in figure 19. This is typical of the cracks in the magnesium material utilized in this work. The typical results for the FPI indications in the baseline condition are shown in figure 20. Figure 21 depicts the typical location of the spotmeter in relation to the cracks. The Tagnite pretreatment process tended to increase dramatically the brightness of the indications. Figure 22 presents the visual FPI results on bar no. 2 after Tagnite pretreatment. This pretreatment also absorbed a considerable amount of penetrant, which resulted in high background brightness values. This could be due to the characteristics of the Tagnite in the vicinity of a crack. The pretreatment was visibly nonuniform in this area, which

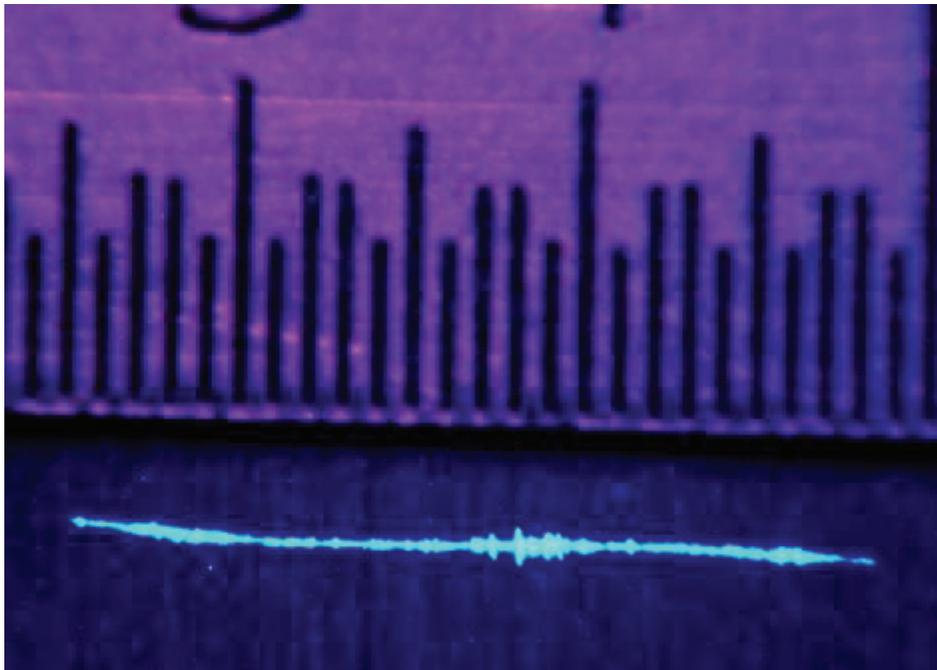
Figure 20. FPI micrograph of cracked Mg bar no. 2 after the crack was initiated and extended to the desired length.

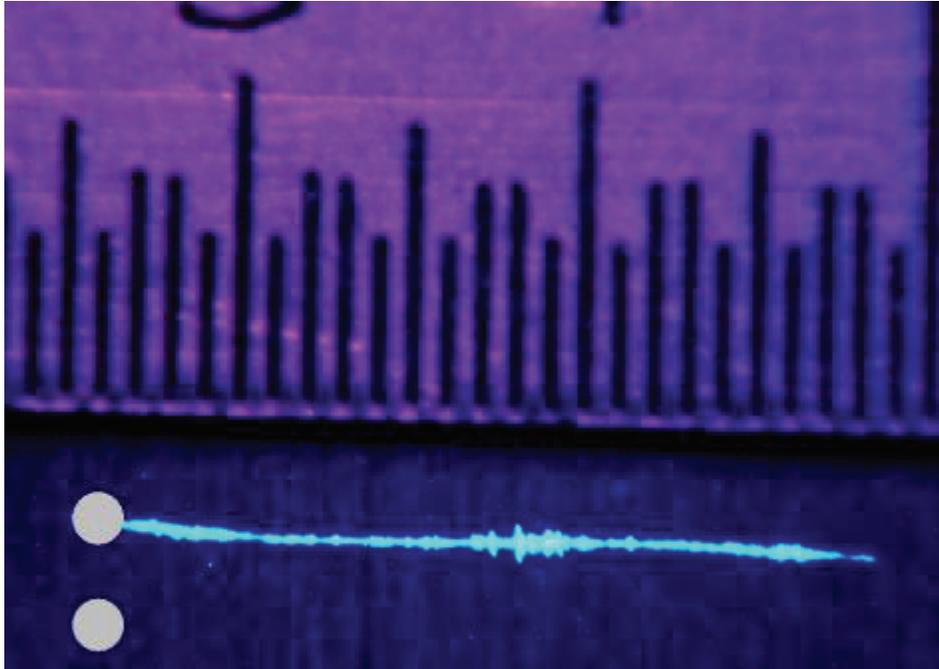
Figure 21. FPI micrograph of cracked Mg bar no. 2 depicting the typical locations of the light measurements. The top spot is the brightness of the crack, and the bottom spot (below the crack) is where the background reading was taken.

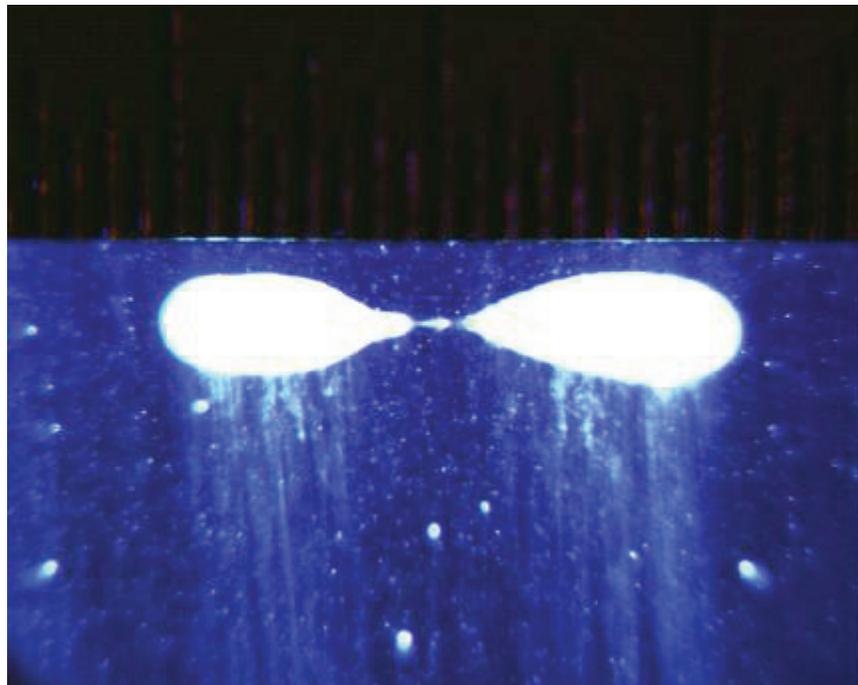
Figure 22. FPI micrograph of cracked Mg bar no. 2 after the Tagnite coating.

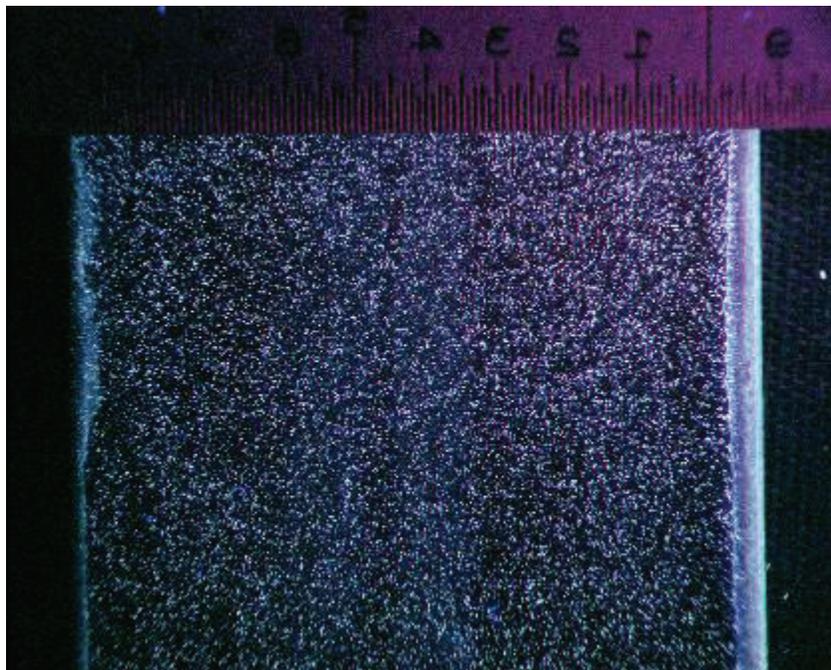
Figure 23. FPI micrograph of cracked Mg bar no. 2 after the application of the coating system. No crack can be observed, and the absorption of the penetrant by the coating is evident.

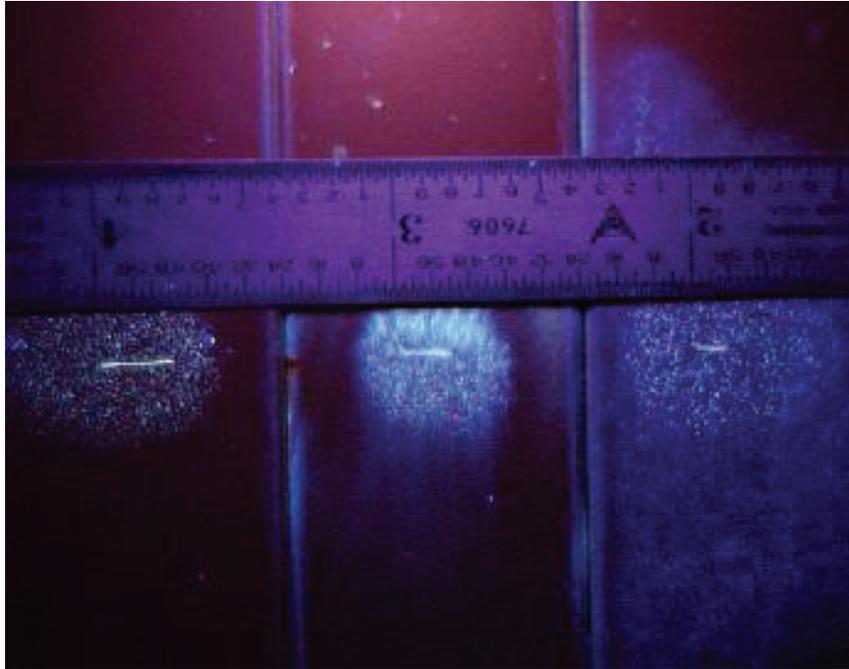
Figure 24. FPI micrograph of cracked Mg bar nos. 3, 6, and 7 after crack extension under the coating system. Cracks can be observed; however, the absorption of the penetrant by the coating is still evident.

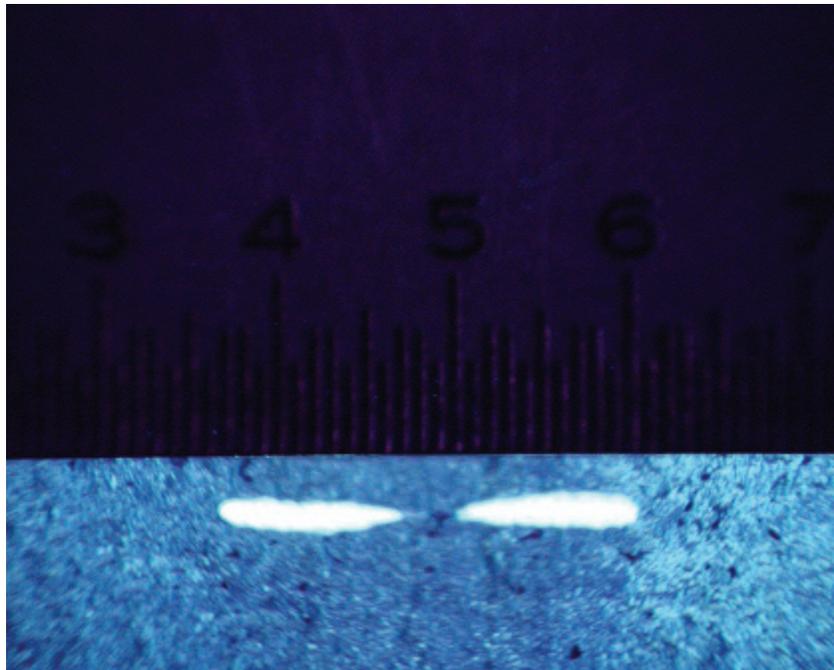
Figure 25. Typical FPI results after PMB, chemical processing, and mechanical flexing to remove the plastic media from within the cracks. Results shown for Mg bar no. 2 after soaking in paint stripper ~24 hr.

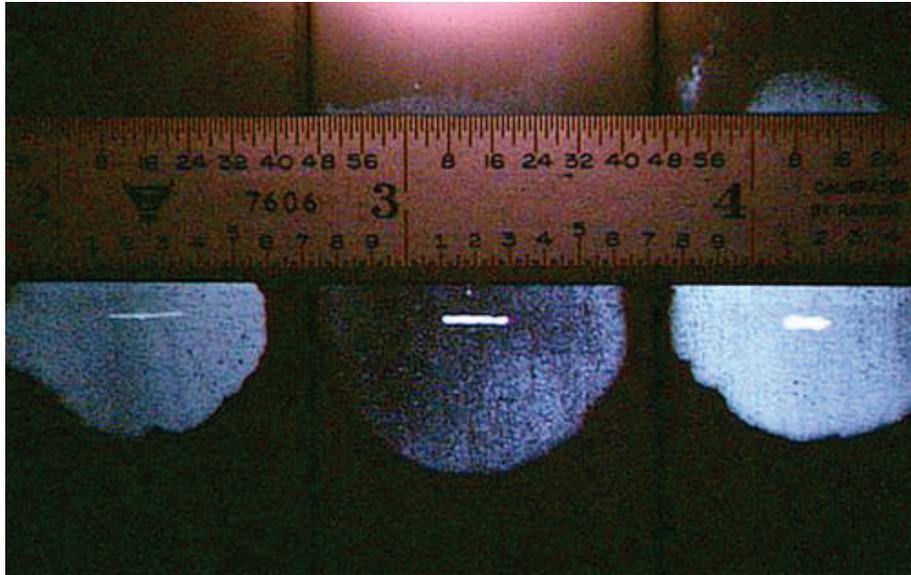
Figure 26. Typical FPI results after crack extension under the coating, PMB, mechanical flexing, and chemical-stripper processing. Results shown for Mg bar nos. 3, 6, and 7 after soaking in paint stripper ~24 hr.

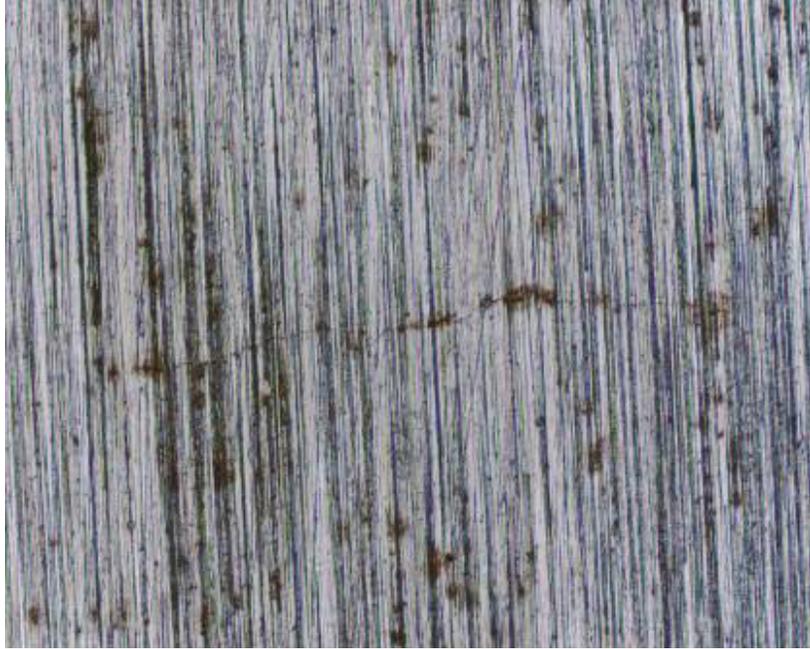
Figure 27. Bar no. 3 after initiation and crack extension—typical fatigue crack generated in steel.

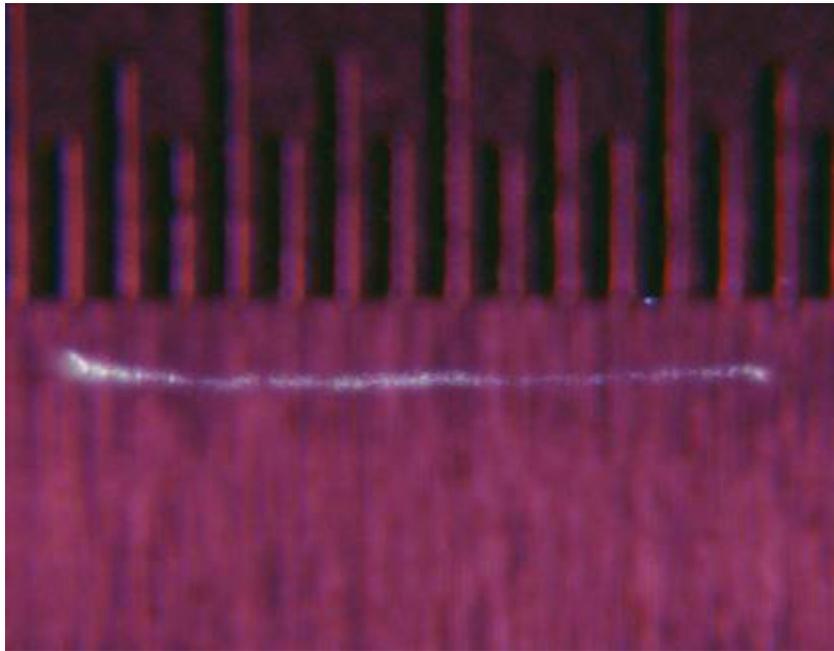
Figure 28. Steel bar no. 6 after initial crack extension—0.2 in crack. Typical FPI visual results on steel fatigue cracks.

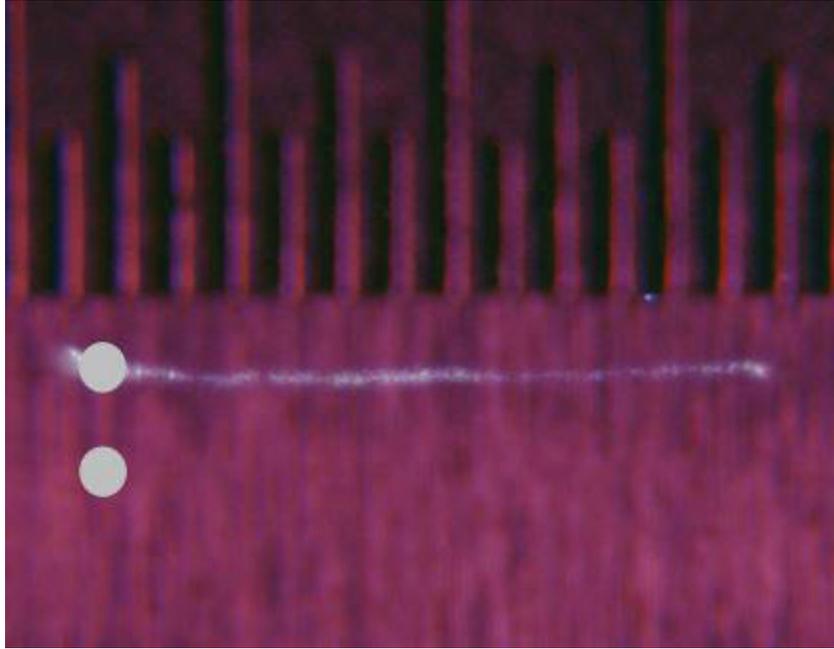
Figure 29. Typical FPI micrograph of steel showing the areas where brightness measurements were taken on this bar. The top dot (on the crack) is the crack brightness measurement location. The bottom dot (below the crack) is the background measurement location.

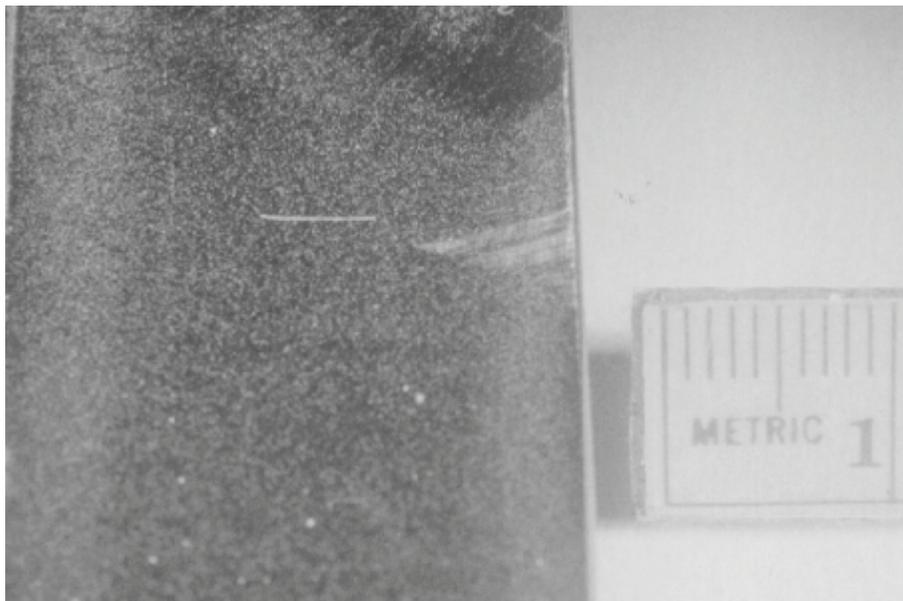
Figure 30. Bar no. 6 after the initiation and crack extension. Typical baseline visual MPI micrograph on steel.

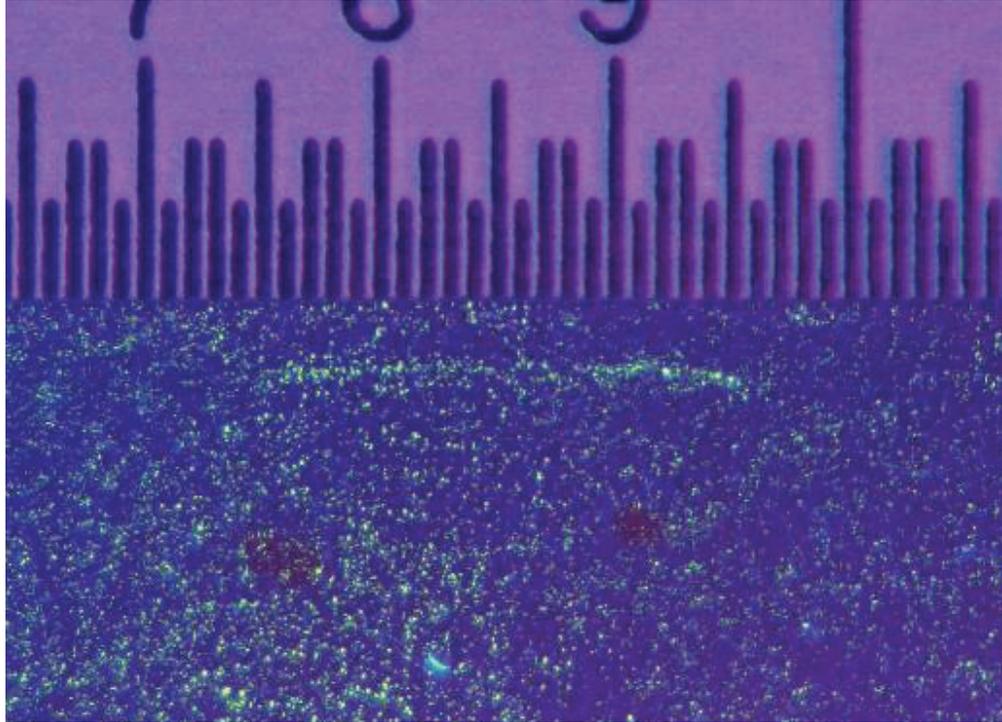
Figure 31. Bar no. 6 after the 0.050-in crack extension. Typical visual MPI micrograph after crack extension.

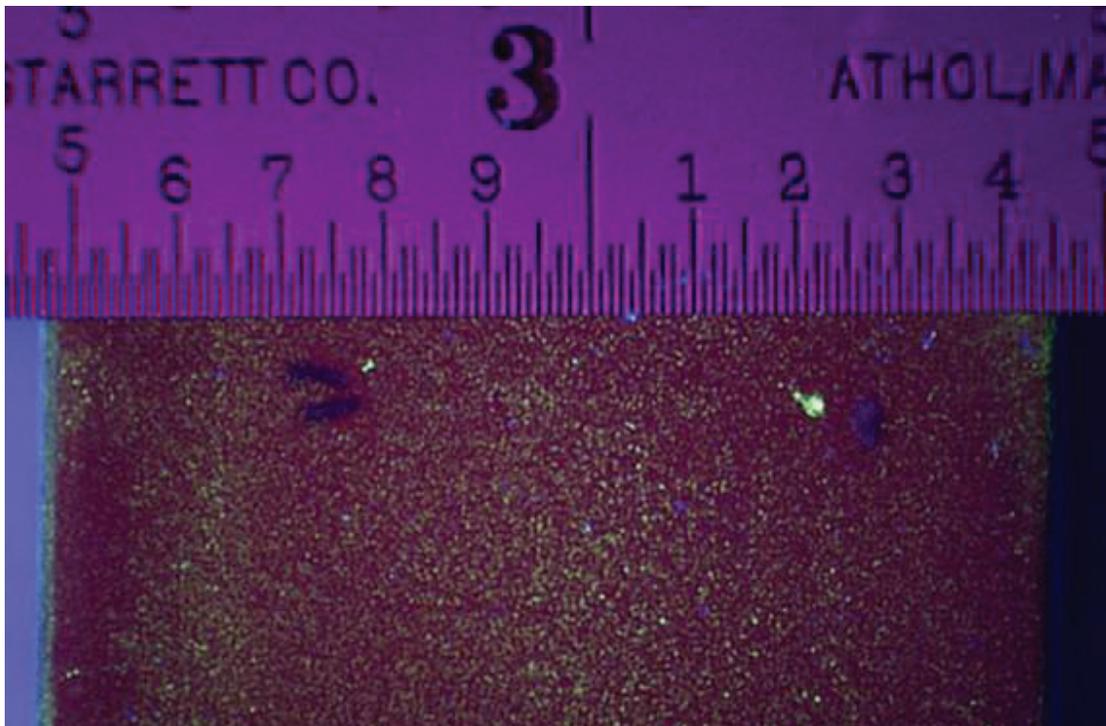
Figure 32. Typical visual MPI micrograph after the application of the second layer of paint. All traces of the crack indication are gone.
