Sand Erosion Test Method for DOD Unique Environments

ARL-RP-229

A reprint from the Proceedings of the 2007 Tri-Service Corrosion Conference, paper 1783, Denver, CO, 3–6 December 2007.

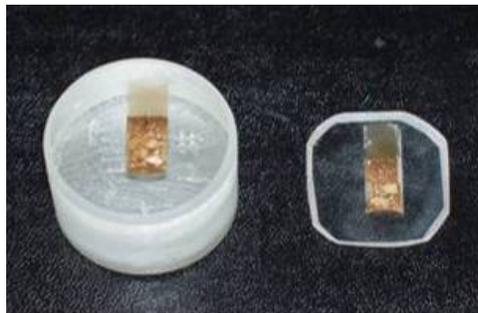
FIGURE 1 - Polished Puck and Petrographic Thin Section Specimens

The specimens were mixed with an optical epoxy fixative and cast into small round slugs. These slugs were approximately 0.25 inches in diameter by 0.5 inches long. It is possible for the material to settle and become size sorted during casting. For this reason, each formed billet was placed on its side in a 1 inch diameter mold to accommodate this behavior by using a second optical epoxy casting step. The resulting pucks (Figure 1) were then sectioned to expose a cross sectional area from the base to the top of the billet. The thin slice of sample cut from the puck was used to prepare a petrographic, thin section (Figure 1) for each of the specimens. The pucks were then polished to provide polished mounts for each of the specimens.

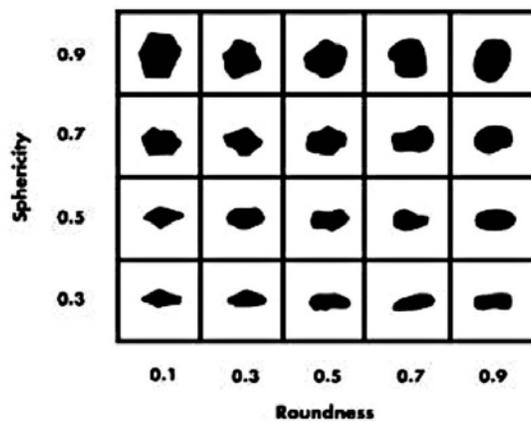
FIGURE 2 - Krumbein Scale for Particle Roundness/Sphericity

The analysis of the sand data can take several forms from simple side by side comparison to statistical size distributions. The measurements of greatest concern for this study were the ratio of the apparent circumferential radius (R_C) to the apparent area radius (R_A), as well as the aspect ratio of the grain. A large circumferential to area radius ratio value (R_C/R_A) declares that the average roughness or angularity of a grain is very large meaning that the grain is pointy. However, this number is mediated by the degree of elongation of a particular grain. The most elongated, pointy grains are those with the largest R_C/R_A ratio *and* the greatest aspect ratio. This resulting plot is a direct analytical measurement of the Krumbein Scale (Figure 2) without having to visually guess what the actual Krumbein value is for a

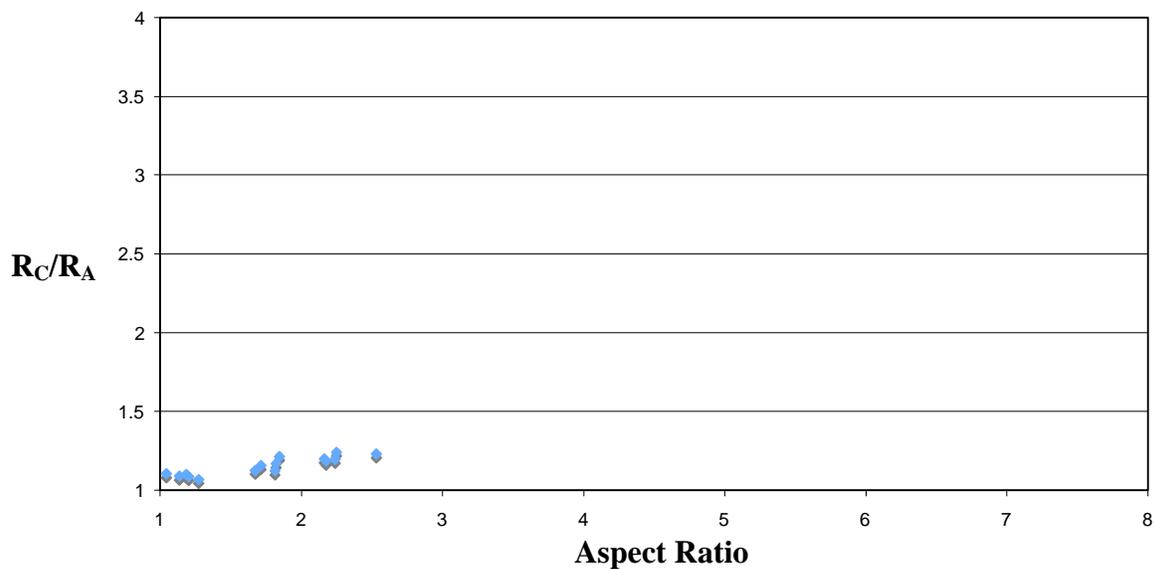
FIGURE 3 - Krumbein Scale Quantified Using Image Java

particle. The Krumbein scale is shown in Figures 3 and 4 after having been evaluated using Image Java. Note that in Figure 4, the R_C/R_A ratio was expanded for illustration purposes.

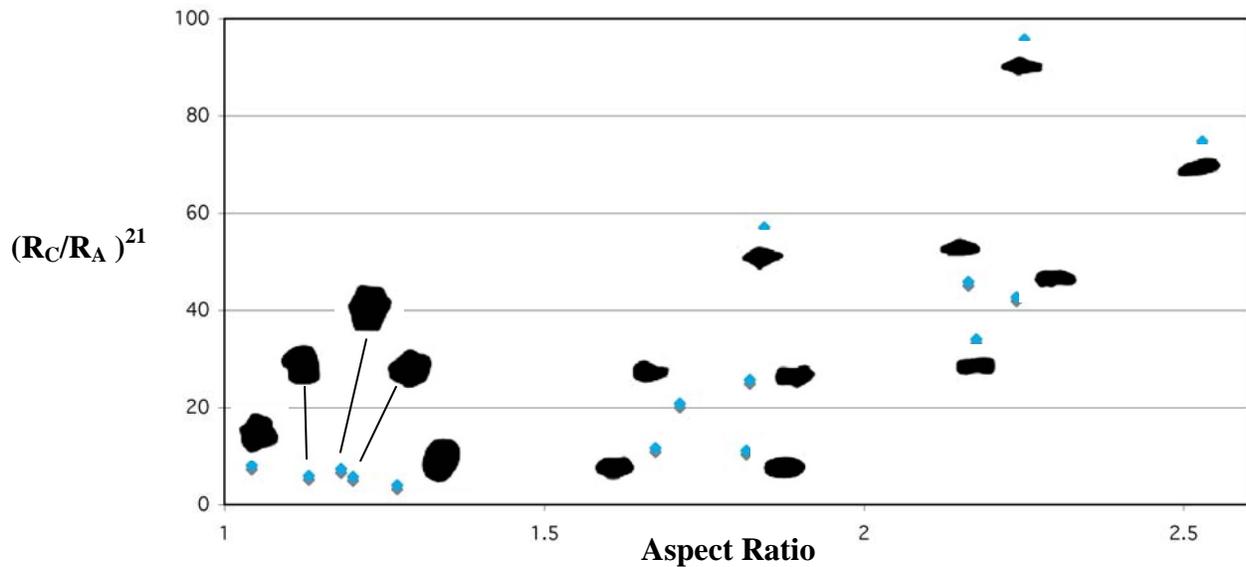
FIGURE 4 - Zoomed in Krumbein Scale Quantified Using Image Java

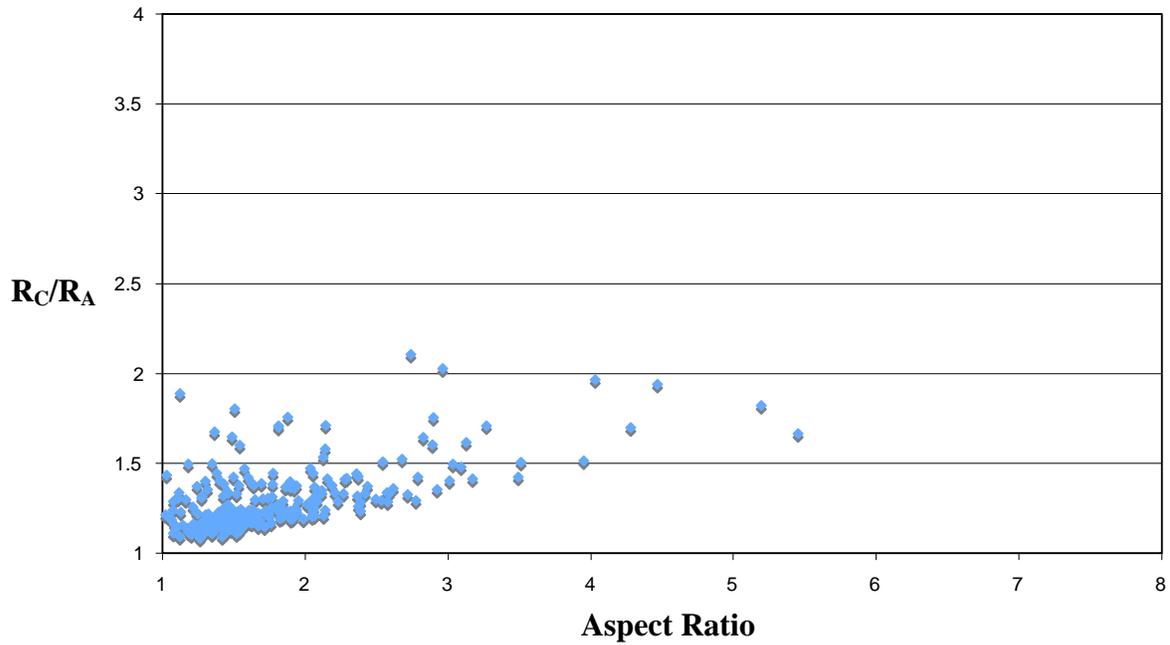
FIGURE 5 - Distribution of 144 to 177 μm Commercially Available Foundry Sand Sample

All of the grains in Figure 8 are quartz. A comparison of the plots in Figures 5 and 7 show different distributions, particularly for R_C/R_A values greater than 2.5. The reflected light images in Figure 8 are markedly more angular than those in Figure 6. The grains in Figure 8 are moderately sorted.

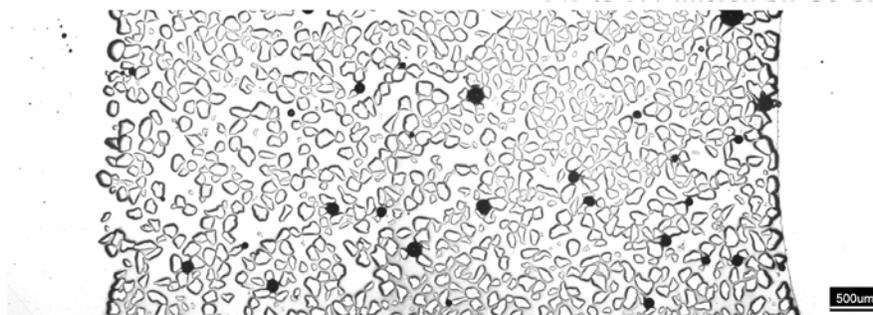
All of the grains in Figure 6 are quartz. The black circular features seen in this image, in addition to all of the reflected light images, are air pockets typical of the sample preparation process and not a feature of the sand samples. The grains in Figure 6 are very well sorted.

FIGURE 6 - Reflected Light Image of 144 to 177 μm Commercially Available Foundry Sand Sample

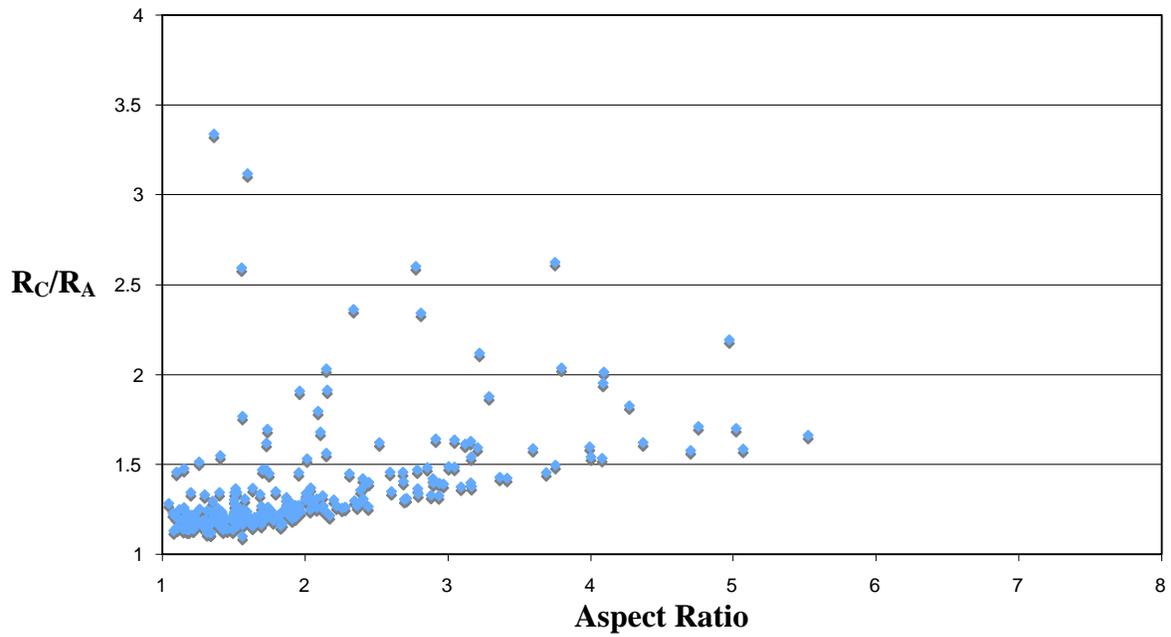
FIGURE 7 - Distribution of 500 to 850 μ m Commercially Available Golf Sand Sample

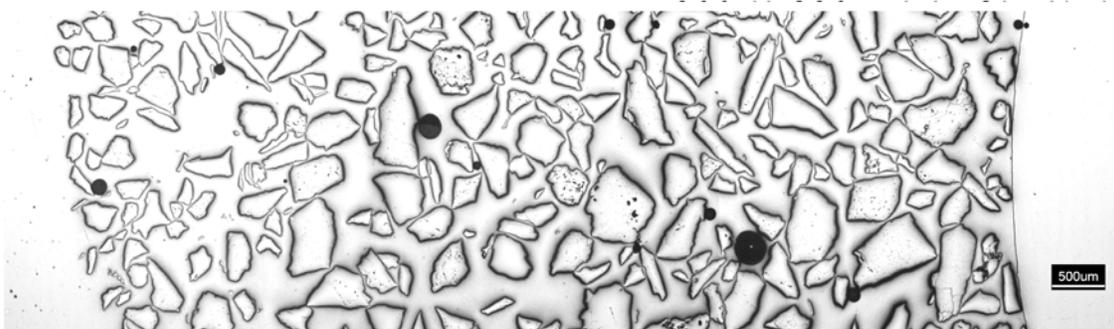
FIGURE 8 - Reflected Light Image of 500 - 850 μ m Commercially Available Golf Sand Sample

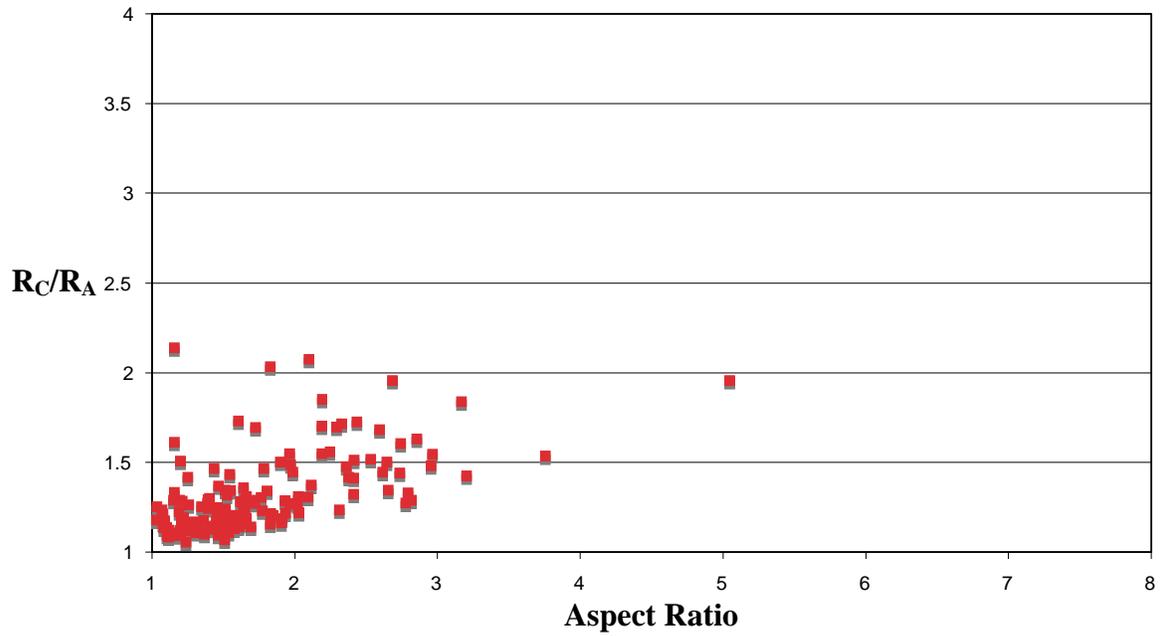
FIGURE 9 - Distribution of YPG Sand Sample

The distribution plot for Figure 9 is similar to Figure 5. However, the mineral grains in Figure 10 are quartz, feldspars, pyroxenes and amphiboles, black oxide minerals, and a large quantity of silt and clay particles. The large circular black feature is an air pocket. The grains in Figure 10 are poorly sorted.

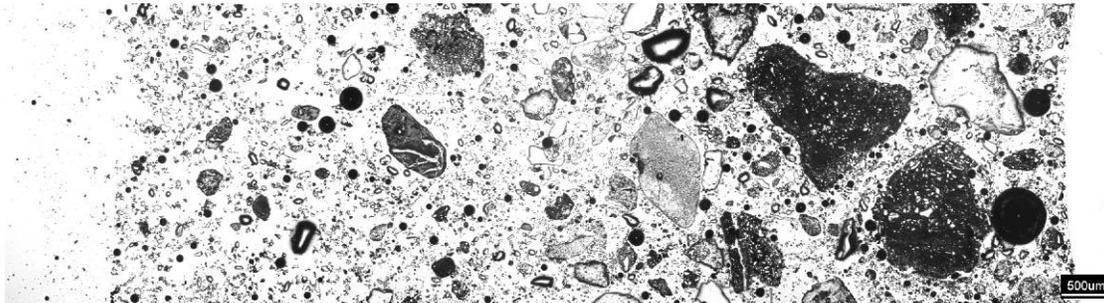
FIGURE 10 - Reflected Light Image of YPG Sand Sample

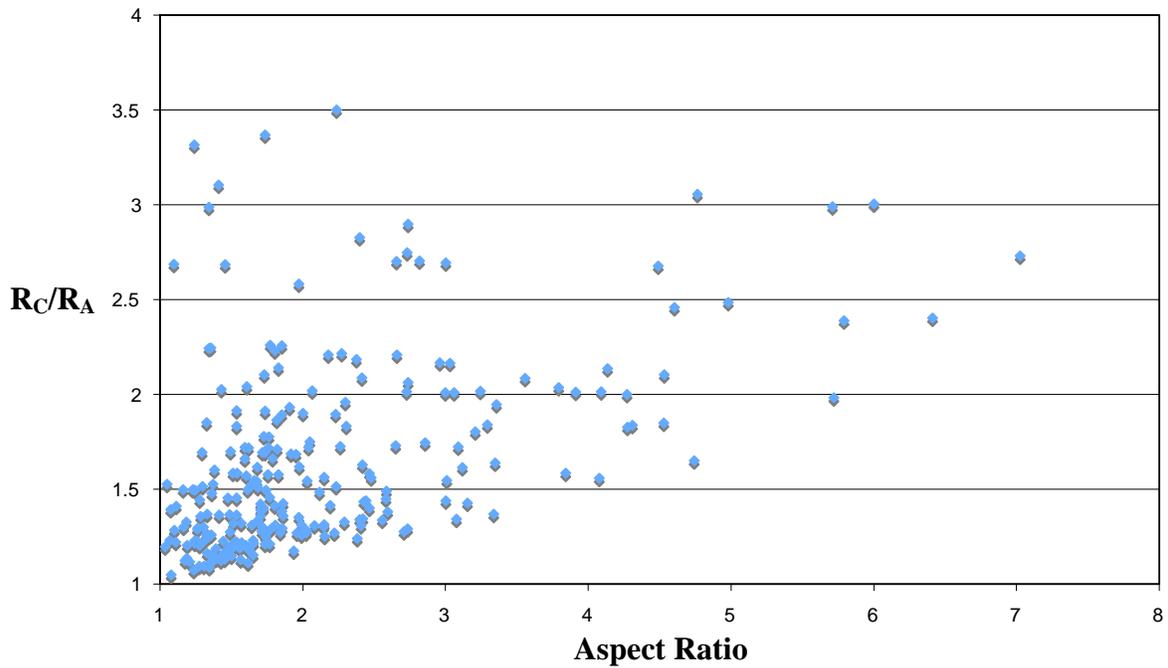
FIGURE 11 - Distribution of Iraq Sand Sample

A comparison of the distribution plot of Figure 11 with standard sand erosion test media of Figure 5 or YPG sand in Figure 9 shows different R_C/R_A and aspect ratios. The mineral grains in Figure 12 are quartz, carbonates, and sparse amounts of feldspar and black oxide minerals. The grains in Figure 12 are poorly sorted.

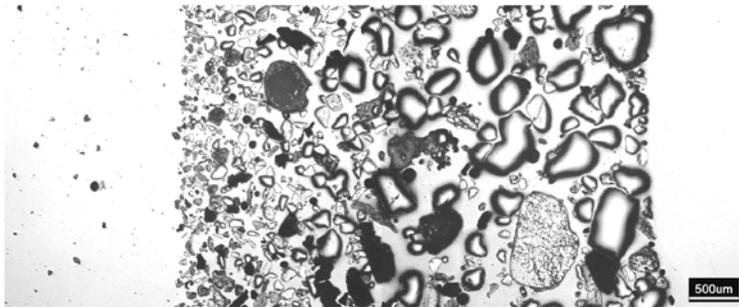
FIGURE 12 - Reflected Light Image of Iraq Sand Sample

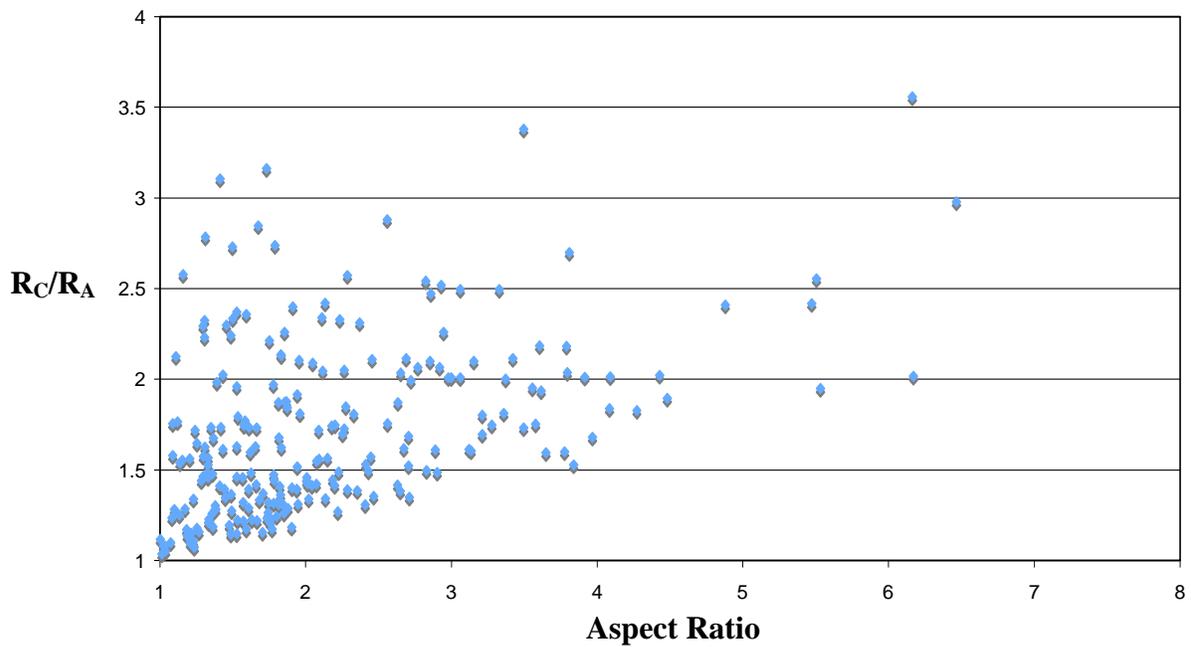
FIGURE 13 - Distribution of Afghanistan Sand Sample A

Like Figure 11, a comparison of the distribution plot of Figure 13 with standard sand erosion test media of Figure 5 or YPG sand in Figure 9 shows different R_C/R_A and aspect ratios. The mineral grains in Figure 14 are a textbook-quality example of poor sorting found in young sediments. The very large degree of grain angularity and the variation in grain sizes indicates that this material was only (geologically) recently introduced into the soil profile. The sample has the dominant polycrystalline quartz grain with other quartz grains as well as some prominent pyroxene grains. Clays and silts comprise the remainder of the material in this specimen.

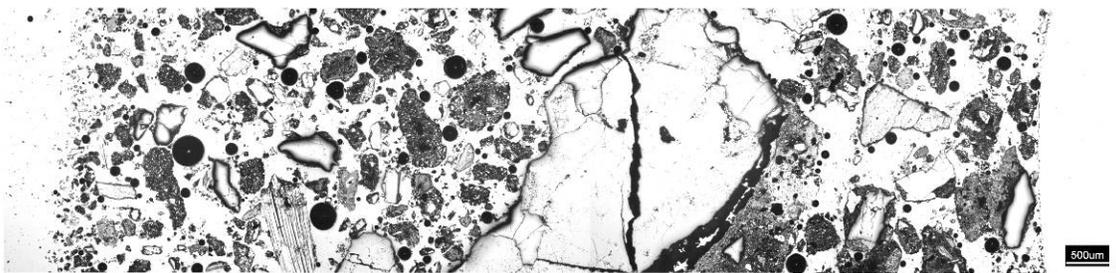
FIGURE 14 - Reflected Light Image of Afghanistan Sand Sample A

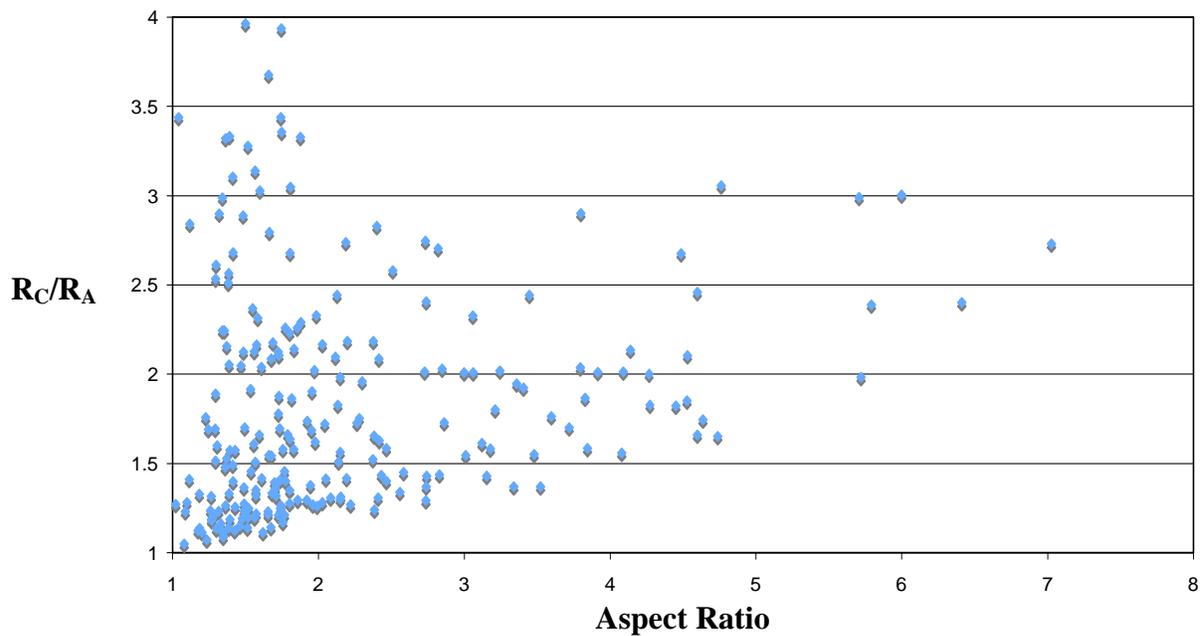
FIGURE 15 – Distribution of Afghanistan Sand Sample B

Once again, Figure 15 shows different R_C/R_A and aspect ratios when compared to Figures 5 and 9. Figure 16 is dominated by clays and silts presented in this image as the mottled grains that are obviously made of many other smaller grains. The large dark grain in the lower middle of the image has a feldspar grain at its center but has weathering products surrounding the core that are contained within the relic mineral outline. This type of morphology is termed “psuedomorphous” after the parent mineral grain. This grain would normally become fractured and the weathering products would disperse into the environment as clays and silts. Some pyroxene grains that have undergone partial alteration are also present with minor amounts of quartz grains.

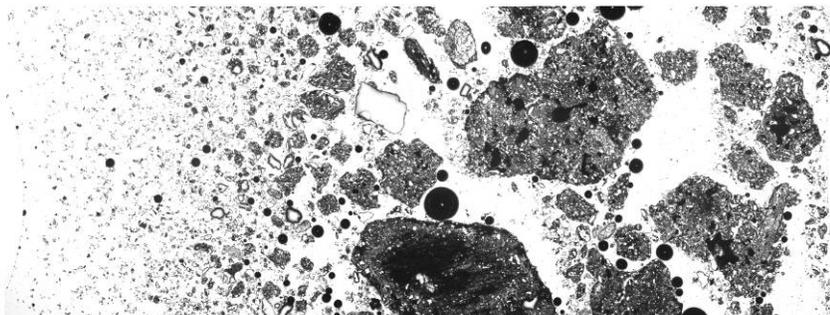
FIGURE 16 - Reflected Light Image of Afghanistan Sand Sample B

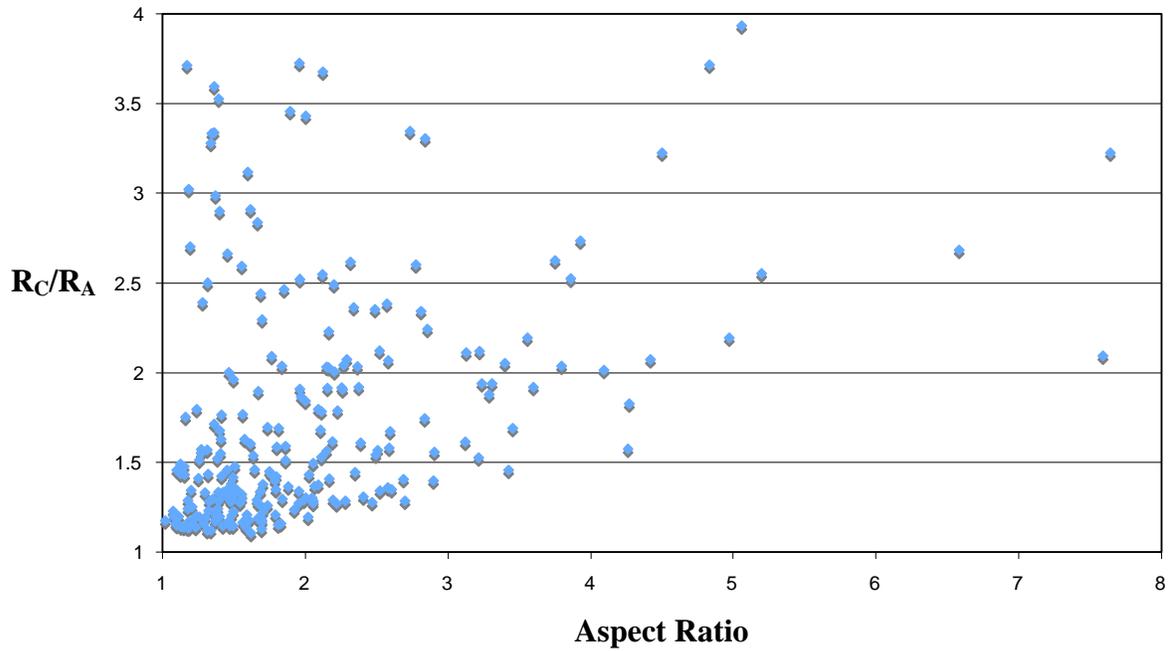
FIGURE 17 – Distribution of Kuwait Sand Sample

The last SWA sand sample in Figure 15 repeats the trend of showing different R_C/R_A and aspect ratios when compared to Figures 5 and 9. A large quartz grain dominates the image in Figure 18, however, the sample also includes numerous quartz grains, some moderate feldspar content, no visible pyroxenes or amphiboles, and some black oxide minerals. The grains in Figure 18 are very poorly sorted.

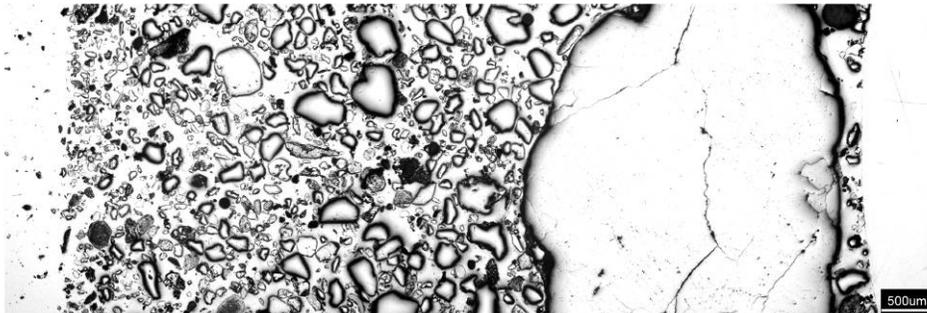
FIGURE 18 - Reflected Light Image of Kuwait Sand Sample

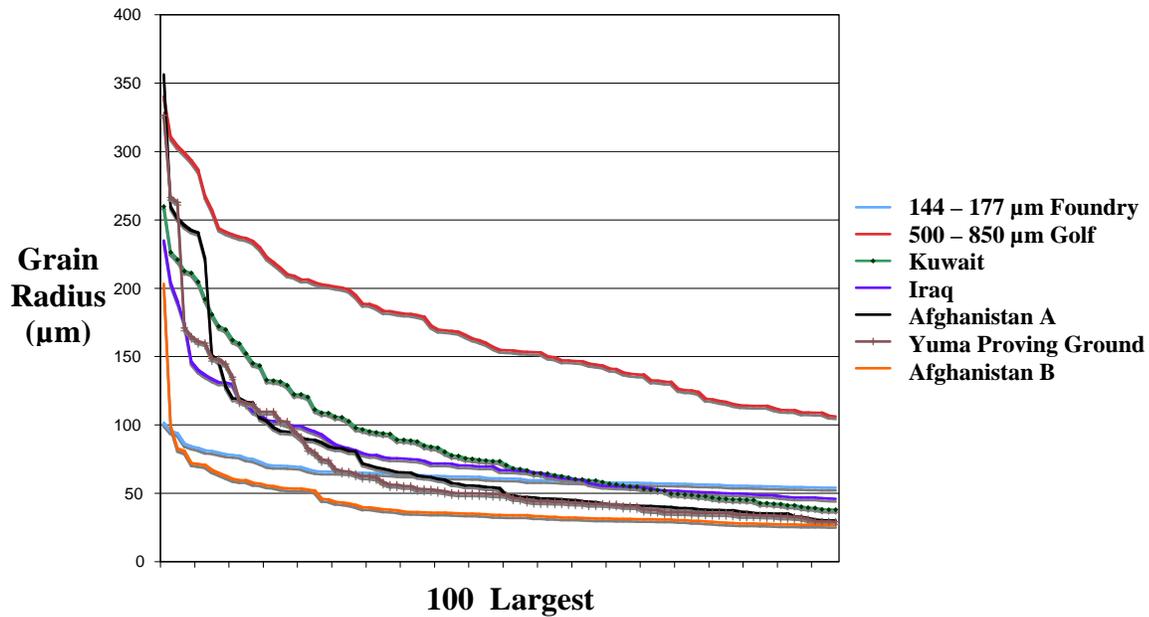
The plots of grain radius in Figures 19 and 20 are of the calculated radius R_a determined from the actual area of each grain. These sizes are on par with grain sizes determined by sieve and other image

FIGURE 19 – Grain Size Distribution of 100 Largest Particles from Sand Samples

analysis techniques. The single largest radius value for each sample was eliminated. The typical size profile of these samples is clear from looking at the 25 largest grains in Figure 20. The validity of this analysis is shown with the curves in Figures 19 and 20 for the two lab sieved foundry and golf sand samples for 144 R_A and 500 R_A, respectively. Both of these curves are relatively uniform across the distribution as would be expected for sieved samples. The sample designated Afghanistan B shows that the average size is very small (it is, in fact, mostly clay) but there are a number of very large grains. The sample from Kuwait is much more uniform in size with an average grain size larger than the Yuma sample, as well as the 144 to 177 micron commercially available foundry sand.

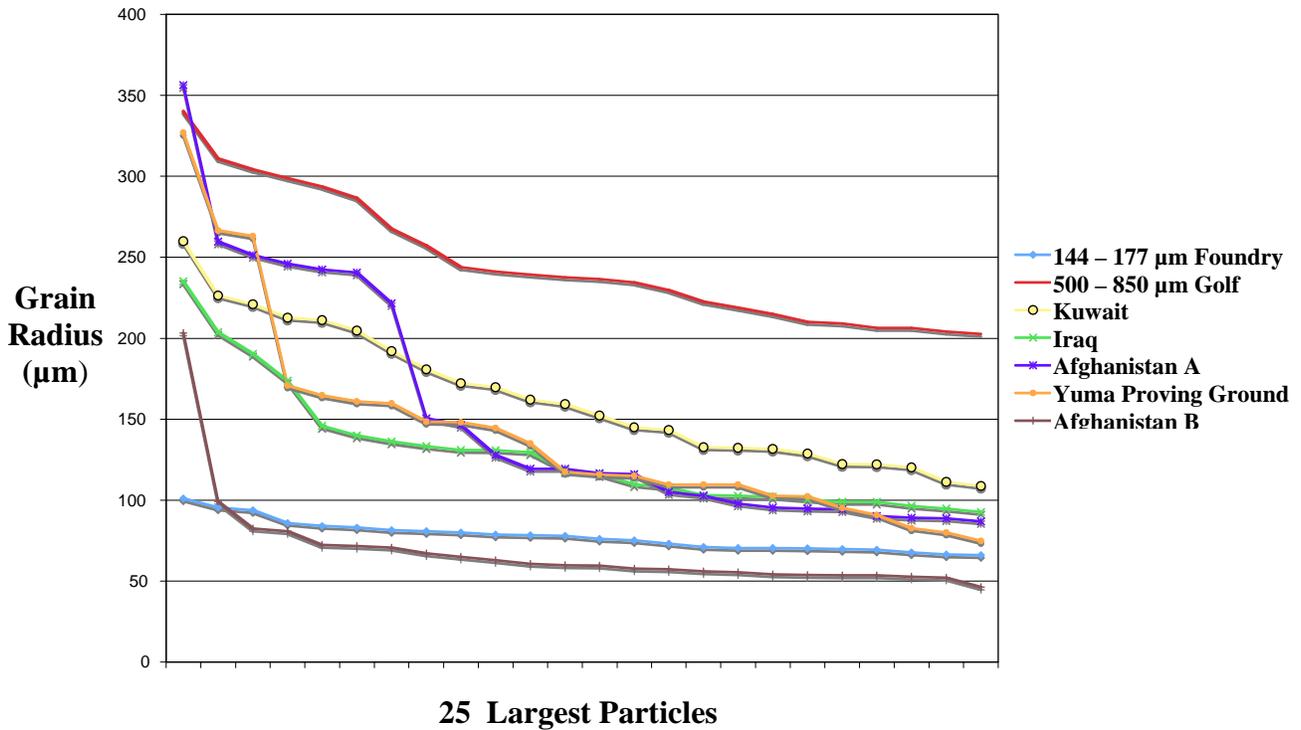
FIGURE 20 – Grain Size Distribution of 25 Largest Particles from Sand Samples

Figures 20 and 21 indicate the need to quantify both the grain size of the particles, in addition to roughness and elongation when specifying media for sand erosion testing. Although the YPG sample can be interpreted as having similar particle sizes to those found in SWA, its R_C/R_A and aspect ratios are far less than any of the SWA samples.

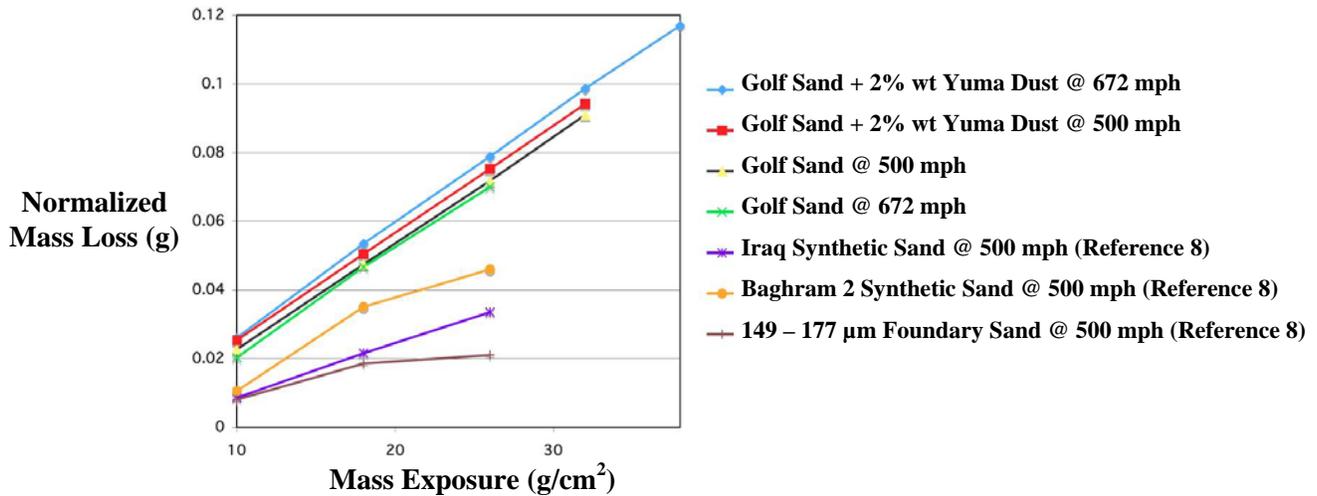
FIGURE 21 - The Relationship of Mass of Sand Exposure to Normalized Mass Loss for a Series Polyurethane Tape Samples at 30 Degree Incident Angle

Sand erosion test results are illustrated in Figure 21. Speed, media type, and presence of YPG dust were varied. Normalization was applied to the golf sand samples to compare them to data collected on smaller specimens from the ARL testing (Reference 8), in addition to foundry 149 to 177 μm sieved media. This proof of concept data shows that the effect of grain angularity coupled with size is more important than speed for equivalent mass exposures at 30 degrees incident angle for polyurethane tape. The exposure area normalized data shows that the synthetic Bagram 2 sand was more aggressive than the synthetic Iraq or the foundry 149 to 177 μm sieved media. However, the much larger and more angular golf sand sieved 500 to 850 μm was far more aggressive than any of the earlier erosion media. The data for the two different speeds of golf sand are indistinguishable at the same mass loading. Substantially slower speeds would reduce the slope of the mass-loss-to-exposure curve.

The addition of 2 weight percent of YPG dust (smaller than 100 μm) produced an enhanced material loss at both 500 and 672 mph and the loss scaled with relative speed. This data suggests that the presence of the fine YPG dust reduces the erosion resistance of the polyurethane tape and enhances the attack of sharp golf sand grains. Earlier lab results suggested that smaller diameter erosion media enhanced erosion rates in a non-intuitive manner. The above results show that much smaller powdery material added to the erosion media in a very limited amount (2 percent by weight) had a very large effect on the rate of erosion of the polyurethane tape. The tape failure is seen in the Figure 22. The width of the field of view is about 1 inch. The uniformly mottled grey area is the bulk middle of the tape. The dark spot with the lighter interior spot highlighted by the oval is the area of tape failure. The interior spot is the same color as the Yuma dust used in this test. The dark spot is the inside of the rear tape surface and the brown spot is clay caught in the adhesive backing between the tape and the aluminum substrate.

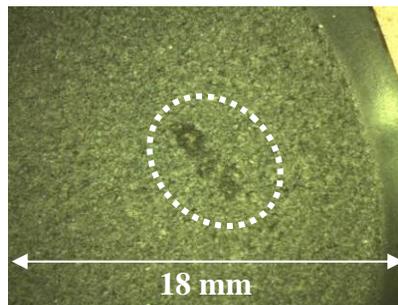
FIGURE 22 - Erosion Punch-Through in Polyurethane Tape from Exposure to 38 g/cm^2 of 500 - 850 μm Golf Sand (2X Magnification)
