ARMY RESEARCH LABORATORY

Dynamic Pressure Testing of a 155-mm Howitzer Ballistic Window Using a Closed Bomb Vessel

ARL-TR-5266

August 2010

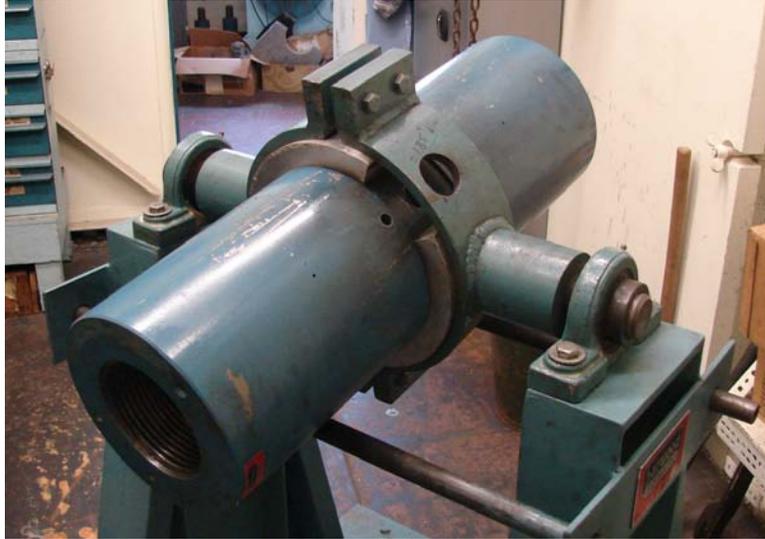
Figure 1. Double-ended closed bomb apparatus.

The equipment used for testing consisted of a Harwood Engineering double-ended closed bomb vessel (figure 1), a Kistler Type 607C high pressure sensor, a Kistler model 5100B1 dual-mode charge amplifier, fffg black powder, electric matches, M232A1 MACS propellant, and the XLCB data acquisition and reduction program (3, 4). However, in this experiment the only function of the XLCB program was to record a pressure-time history for each shot. Propellant properties and characterizations were irrelevant for this set of experiments.

This particular experiment was unique in the fact that a double-ended bomb was needed in place of the standard 200-cc bomb. The primary differences between the two apparatuses is that the 200-cc bomb has a closure plug on one end to accommodate the firing mechanism and a venting valve on the other end of the bomb, while the double-ended bomb has a closure plug on each end and is vented through the center portion of the vessel body. The double-ended vessel was necessary in order to exploit one of the chamber closures to accommodate the test window, as shown in figure 2. The other chamber closure would be used in its standard fashion as the location of the ignition source.

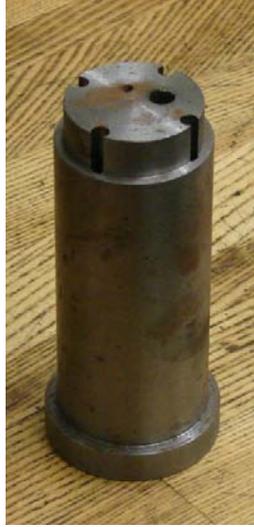
Figure 3. Modified closure cap/steel slug insert for closed bomb volume reduction.

The double-ended bomb had a chamber volume of ~465 cc and closure components identical to the Harwood 200-cc closed bomb, which is widely used for standard propellant testing (5). Because the chamber volume was much larger than needed, we designed and implemented a modified face plate/steel plug (figure 3) in order to take up volume inside the bomb, thus reducing its effective volume. This modification reduced the amount of propellant needed to reach desired pressures, and in turn, reduced the amount of stored energy in the closed bomb, therefore reducing associated safety risks. The appendix provides detailed drawings of the closed bomb modification needed in order to satisfy the testing requirements.
