**Embedded Carbon Nanotube Networks for Damage  
Precursor Detection**

**ARL-TR-6773**

**January 2014**

**Asha Hall and Michael Coatney  
Vehicle Technology Directorate, ARL**

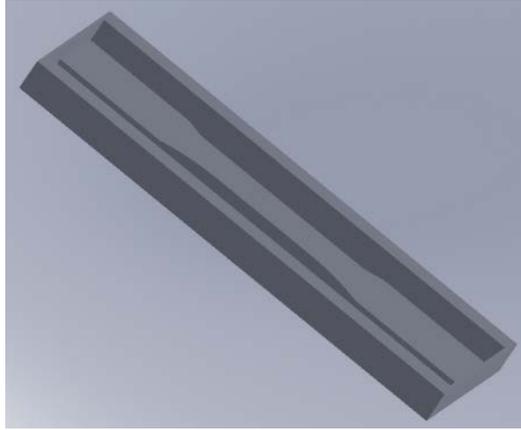
Figure 1. Solidworks rendering of inverted cast.

In order to create tests samples an inverted dogbone cast was fabricated (figure 1) on an Objet Eden260V\* three-dimensional printer using a Fullcure<sup>†</sup> 850 VeroGray polymer material. The inverted cast was then filled with Dow Corning 3120 room temperature vulcanizing rubber to create the final mold. The rubber was mixed with Tin NW Catalyst at a 10:1 ratio. The viscous liquid rubber mixture was poured into the inverted cast and cured for 7–12 h, after which time the rubber solidified (figure 2). The resin material consisted of two parts: Epon Resin 863 (part A) and an amidoamine curing agent (Epikure Curing Agent 3072, part B). The agents were mixed to a 100:38.5 ratio of Epon 863 to Epikure curing agent 3072. This was the resin used to create all of the samples. To prevent injury, specific steps were taken to carefully measure and mix the materials in a chemical hood. Once part A was measured out and poured into a beaker, the beaker was then placed on a hot plate 80 °C for 10–15 min while mixing with a magnetic stirring rod. Next, part B was slowly added to part A in the beaker for an additional 10 min while still on the hot plate reducing the temperature to 75 °C while continuously stirring to degas the mixture of any trapped air bubbles. It is important that all the air bubbles have been completely degassed from the mixture in order to ensure that porosity from air pockets do not weaken the structure. After all the bubbles were gone, the mixture is then poured into the rubber mold to create a pristine sample (figure 3). The resin cured within 24 h at room temperature.

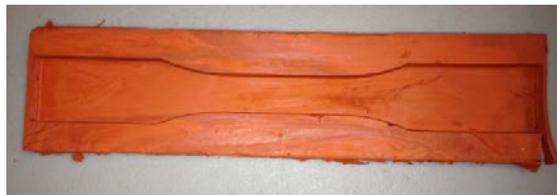
Figure 2. Rubber dogbone mold.

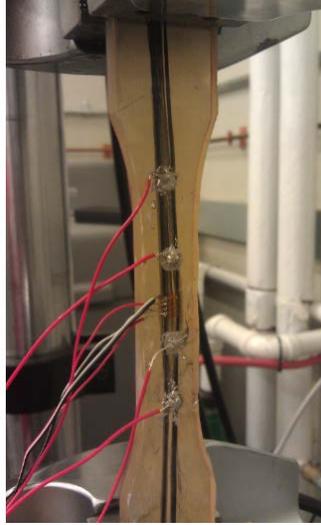
Figure 4. Super-aligned epoxy sample wired up in four-point probe configuration.

For the embedded super-aligned multiwall carbon nanotube (MWCNT) sample, 50 strands of 15-cm-long MWCNT were placed on the top surface of a pristine resin dogbone sample and cured for 24 h (figure 4).

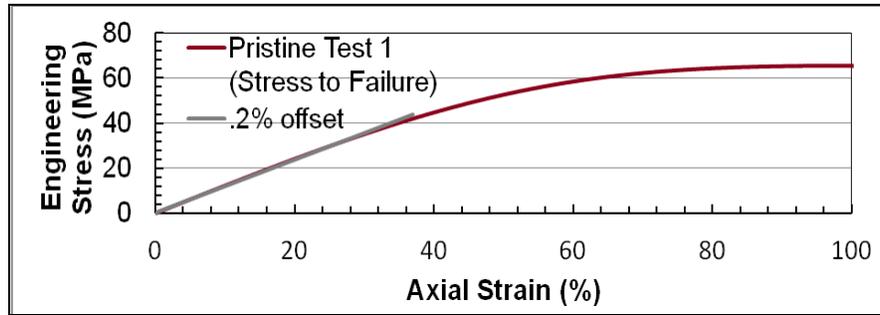
Figure 5. Stress-strain curve of the pristine sample during stress-to-failure test.

The stress-to-failure testing was done using an MTS load frame. Figure 5 contains the stress-strain curve of the pristine sample tensile test. The average Epon 863 dogbones had an elastic modulus of 5.806 GPa and an ultimate tensile strength of 65.64 MPa. The 0.2% offset yield strength was determined to be 32.078 MPa. From this stress-to-failure test, the cyclic fatigue load was determined to be 50% of the value of the failure load. Next, the specimens were tested in fatigue using load control and the direct loading approach. An R-ratio of 0.1 with a maximum load of 4 kips was chosen for the fatigue test. The procedure consisted of, first, ramping the load to 400 lb; second, cycling the load on the specimen at 5 Hz for the desired number of cycles or until failure occurred; and third, ramping the load down to 0 lb.

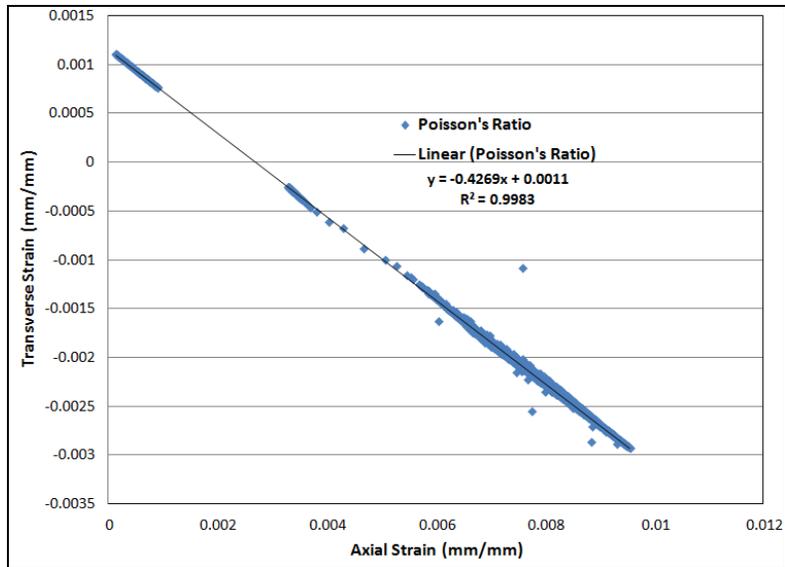
Figure 6. Transverse strain vs. axial strain indicating Poisson's ratio during 1000-cycle fatigue test.

Monitoring the change in resistance measurements through a noninvasive electrical technique offers capability to identify the progression of damage. Initial resistance measurements were taken at different input voltages across the outer silver electrode dots. The specimen was loaded in tension, and the Poisson's ratio was recorded as 0.4269 for the MWCNT-embedded specimen prior to testing (figure 6). The corresponding inner silver electrode dot voltage drop was then recorded in table 1, as was the current across the inner silver electrode dots. For the 1000- and 10,000-cycle fatigue test, 400 mV was passed through the outer dots. As previously discussed, the voltage experienced a drop of 295 mV at the inner dots, and so for calculation purposes, this constant voltage was used in equation 1.

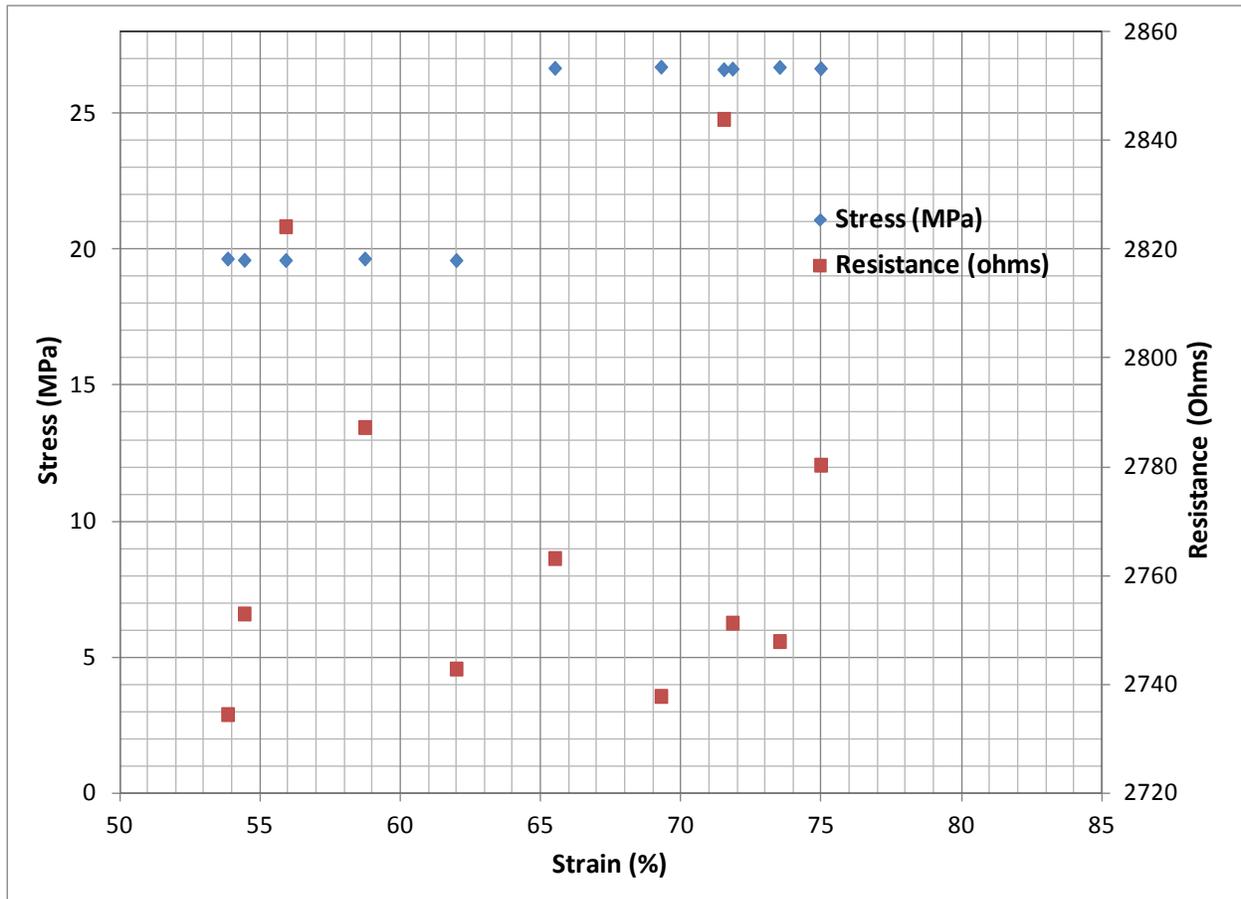
Figure 7. Stress and resistance values for the 1000-cycle fatigue test vs. strain percentage.

The super-aligned MWCNT sample was fatigue tested to 1000 cycles at a rate of 5 Hz. Figure 7 shows how the stress and current both changed versus percent axial strain as the sample went through the 1000 cycles that ranged from 19 to 28 MPa. The resistance plotted below the stress varies through a high and low range as each cycle is completed, ranging between 2735 and 2844 mA. Equation 1 is used to calculate resistance, as seen in figure 7. With the increase in stress or

strain, there are sharp spikes in resistance. The variation of resistance could be contributed to the cyclic nature of the testing, as it goes from an increase in load back down to zero load. As depicted in figure 8, over time, as the strain on the sample changes, the resistance value increases or decreases with a maximum change in 109 ohm.

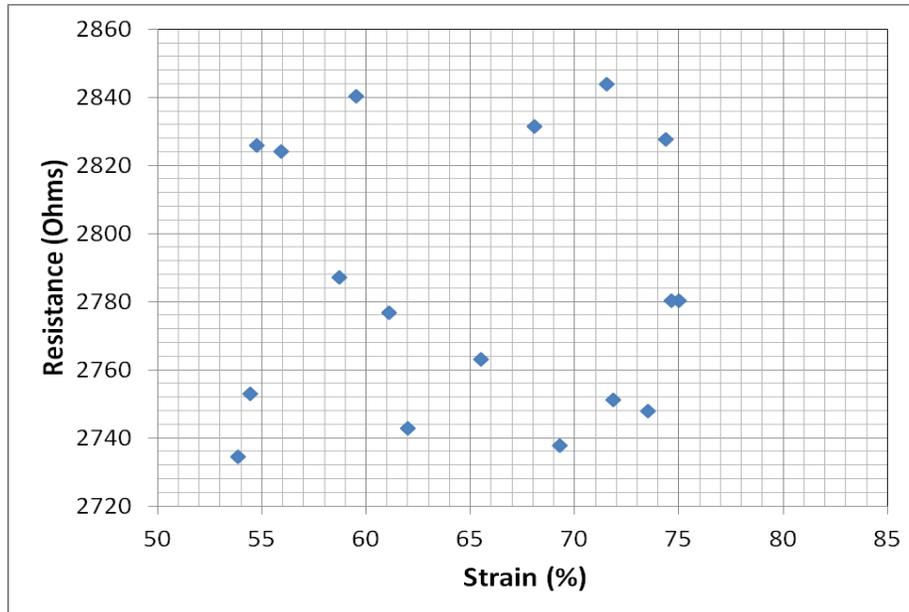
Figure 8. Resistance values for the 10,000-cycle fatigue test vs. strain percentage.

Figure 8 shows the change in resistance versus strain percentage. The observed stress in the 10,000-cycle test ranged from 17.5 to 28 MPa. The sample was fatigued for 10,000 cycles at a rate of 4 Hz. The fatigue test did not hit completion as the sample fractured near 3200 cycles. As shown in figure 9, there is an increase in resistance as the load is cycled; this increase indicates microcracking that may be oriented normal to the direction of the applied load. The difference is attributed to the lower cycling rate of the second fatigue test. At 4 Hz there is more time for each cycle to be completed, so the lower bound for the stress could drop more than during a rate of 4 Hz. The current in this test once again ranged between 0.104 and 0.110 mA. As done previously, equation 1 was used to calculate the resistance of the sample during the fatigue test as seen in figures 7 and 8. The resistance values also have a maximum amplitude value of 90 ohm.

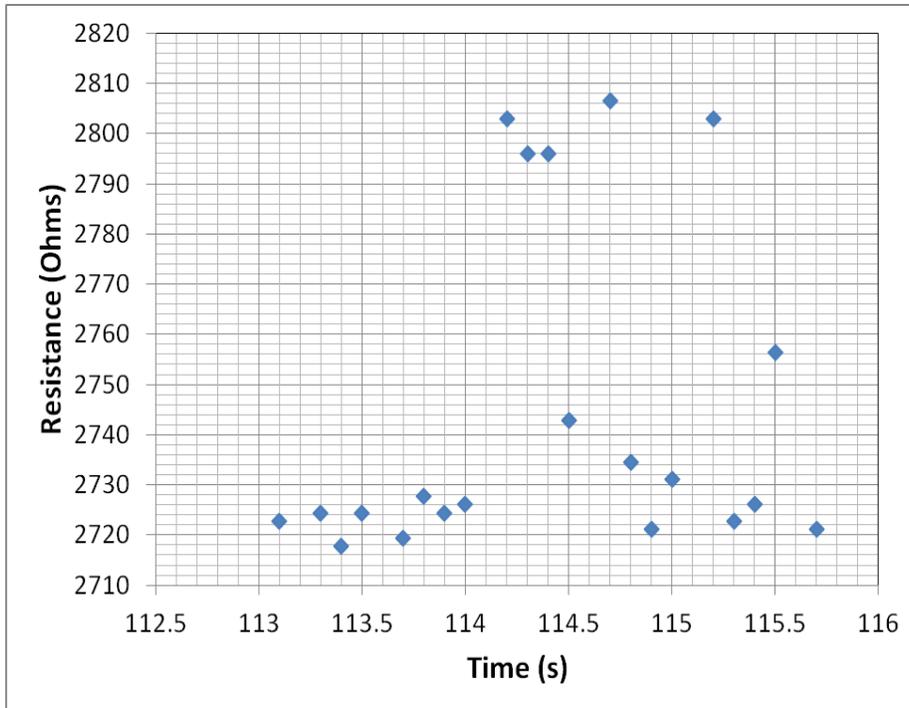
Figure 9. Resistance values for the 10,000-cycle fatigue test vs. time.

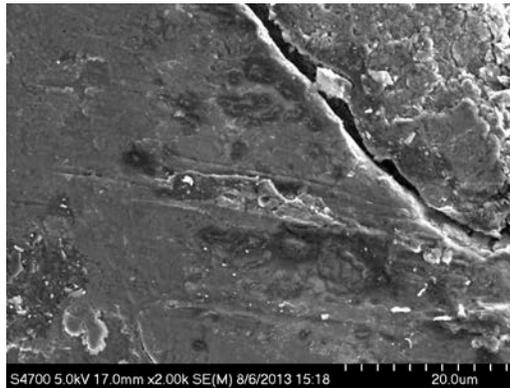
Figure 10. SEM image of cracks after fracture of super-aligned sample.

A fractographic analysis was performed to evaluate the damage sites that corresponded to a change in resistance readings. A scanning electron microscope (SEM) image of the cracks formed in the sample is shown in figure 10. The fractographic analysis reveals significant cracking of the resin that would contribute to a sharp change in the resistance values. After fracture, the current increases in value from 0.12 to 0.33 mA, while the resistance drops from 2750 to 950 ohm during the 10,000-cycle test. This is an example of how damage to the sample causes a change in the resistance.
