Evaluation of an Infrared Camera for Use in a Gun-Launched Unmanned Aerial Vehicle

ARL-TR-3302 **September 2004**

Marshal A. Childers and John A. Condon
Weapons and Materials Research Directorate, ARL

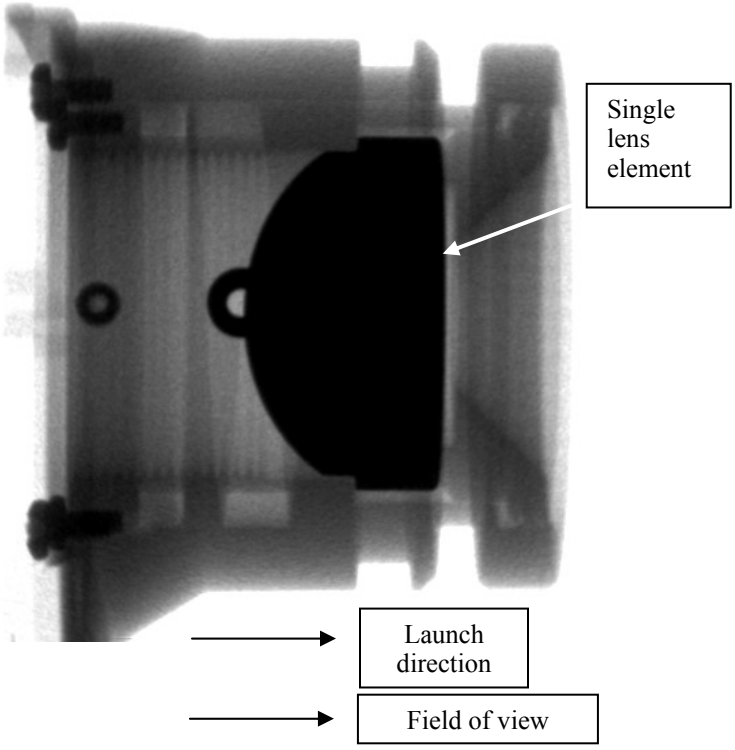
The lens assembly consists of a barrel that contains the lens, barrel housing, and a mounting plate that connects the assembly to the camera body. The lens is machined from zinc selenide and is glued to the inside of the barrel. The barrel is held in the housing by friction, and a set screw enables manual focusing of the lens by means of a guide groove (see figure 2). An x-ray of the lens assembly is shown in figure 3.

Figure 3. Pre-shock x-ray image of lens assembly.

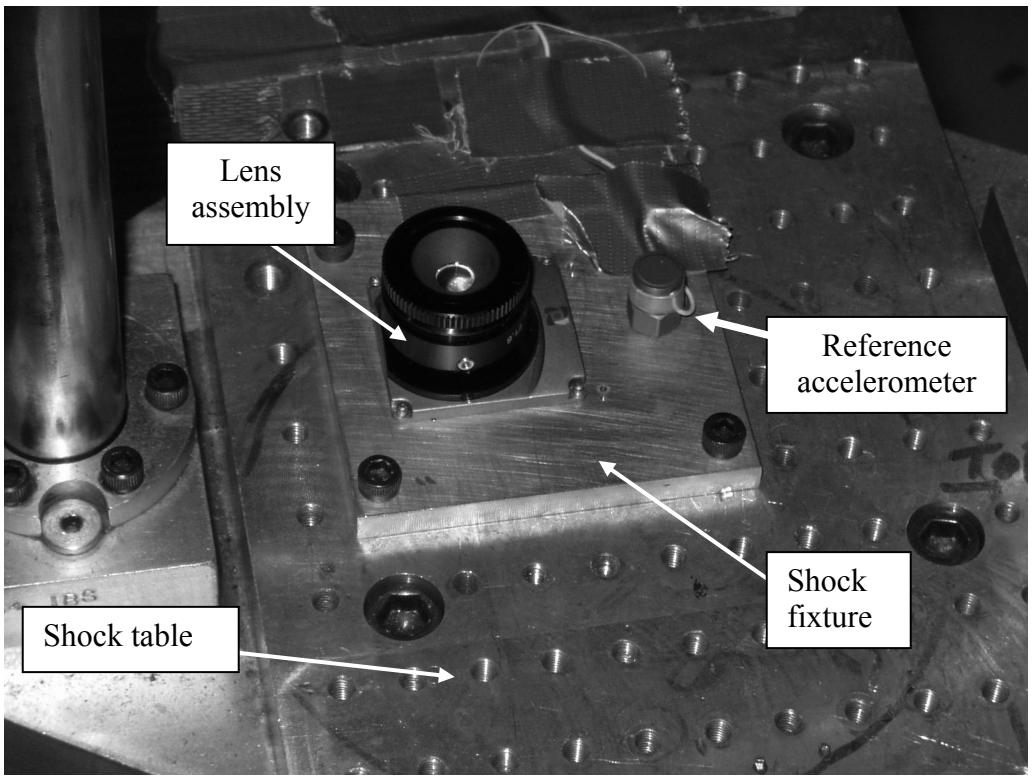
The proposed camera orientation is such that the camera faces the forward direction along the SOAR vehicle thrust axis. The lens assembly was tested separately from the camera. To secure the lens assembly during the shock event, a fixture was designed to attach the lens assembly to the shock table by the four mounting holes in the lens assembly (see figure 4). The fixture was fabricated from 7075-T6 aluminum.

Figure 4. Lens assembly attached to shock test fixture.

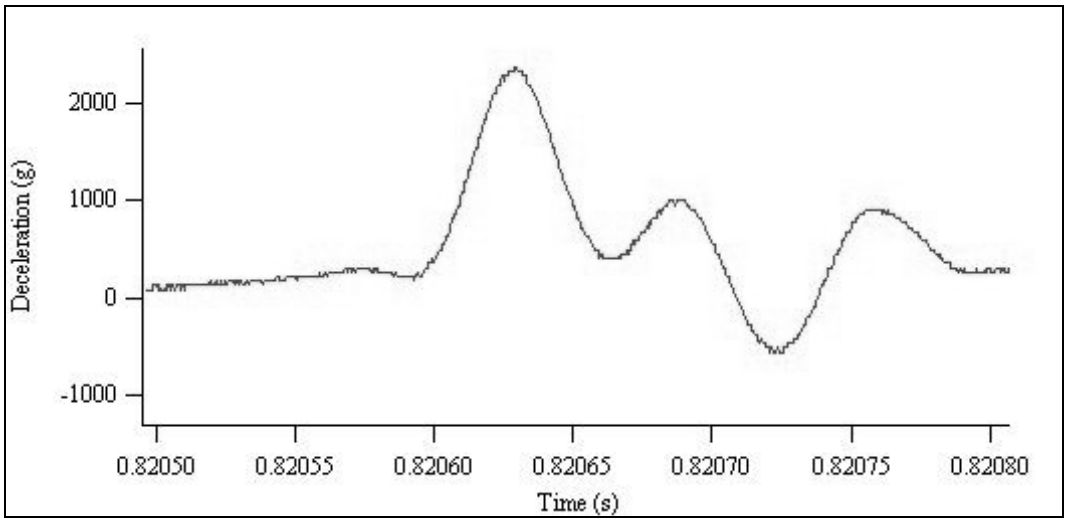
The shock pulse for the first shock is shown in figure 5. A 2300-g maximum deceleration of 60-microsecond (μs) duration was applied to the lens assembly. No damage to the lens assembly was sustained during this shock event, as verified by visual inspection and post-shock imaging upon camera reassembly.

Figure 5. Pulse from first shock test event.

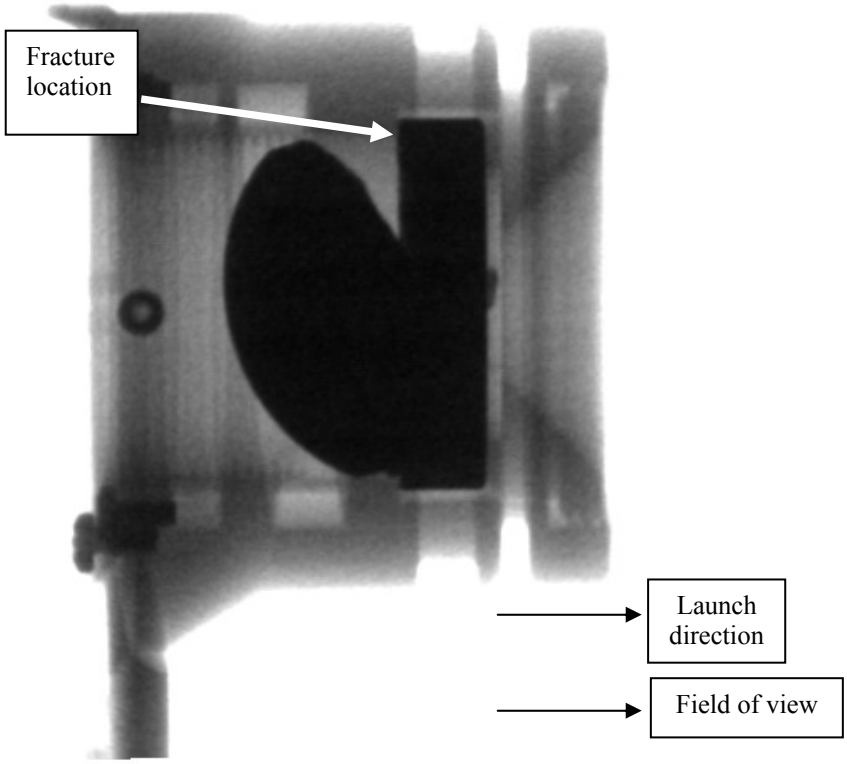
Figure 6. Post-shock x-ray image of lens assembly.

The third shock that was applied to the lens assembly achieved an 11,300-g maximum deceleration of 50-µs duration. Significant damage was sustained by the lens during this shock event. The lens fractured so that the unsupported back half of the lens dislodged from the portion that was glued to the barrel. The x-ray in figure 6 shows that the fracture initiated at the shoulder edge where the lens was supported by the barrel. The lens was nonfunctional as a result of the third shock event (see figures 7 and 8).

The cost of a replacement lens, as quoted by Indigo Systems Corporation, is $900.00. The lens manufacturer[7] claimed that by removing stress risers in the lens geometry and improving the method of supporting the lens, they could redesign the lens so that it could withstand a 15,000-g maximum acceleration shock event. The cost for a new lens design, as quoted by the lens manufacturer, was $2,200.00 for non-recurring engineering costs and $1,610.00 for five lenses ($6,393.00 for one lens).

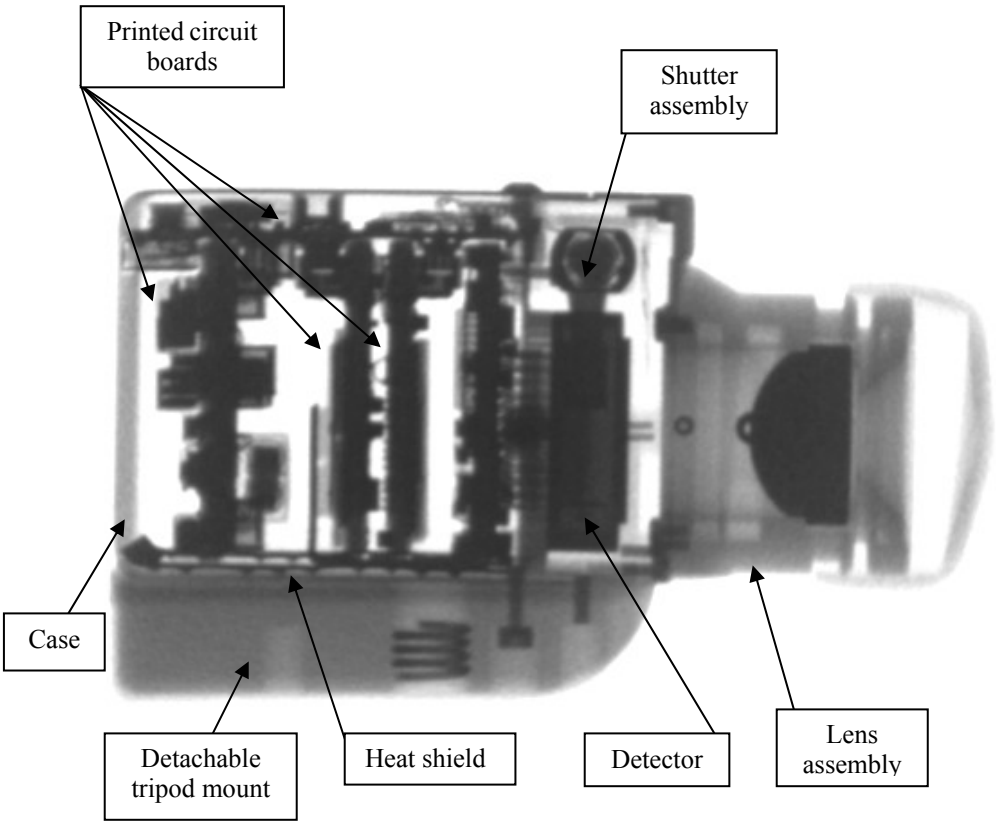
Figure 10. X-ray image of indigo omega camera.

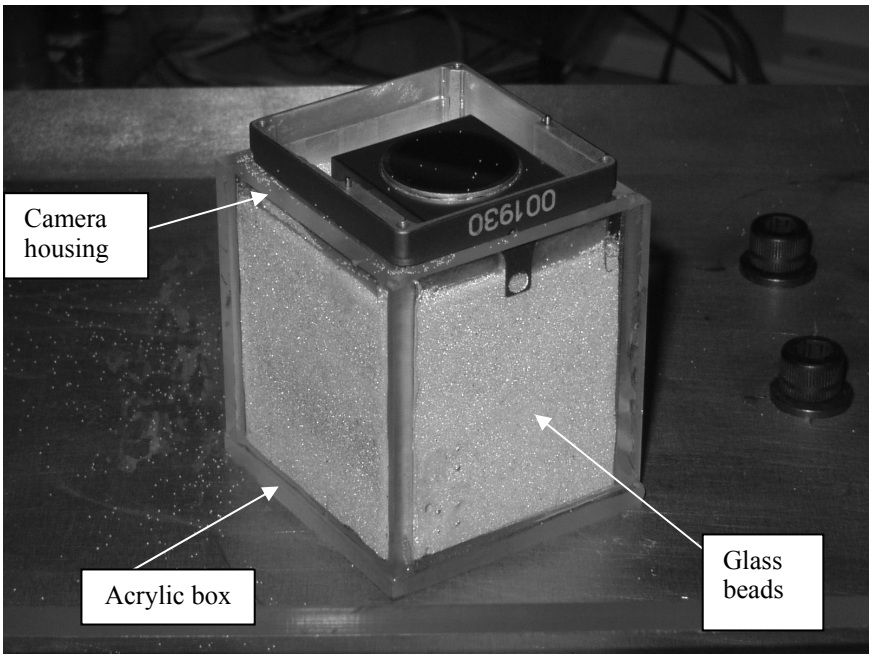
To verify that the glass spheres did not adversely affect the camera functionality, we performed video imaging before and after encapsulation. Figures 12 and 13 compare still photographs taken from the pre-encapsulation and post-encapsulation videos. The figure shows that there was no appreciable loss in the image quality as a result of glass sphere encapsulation.

Figure 11. Glass bead encapsulation of camera board assembly.
