Cold Spray Process Development for the Reclamation of the Apache Helicopter Mast Support

by P. F. Leyman and V. K. Champagne

ARL-TR-4922 **August 2009**

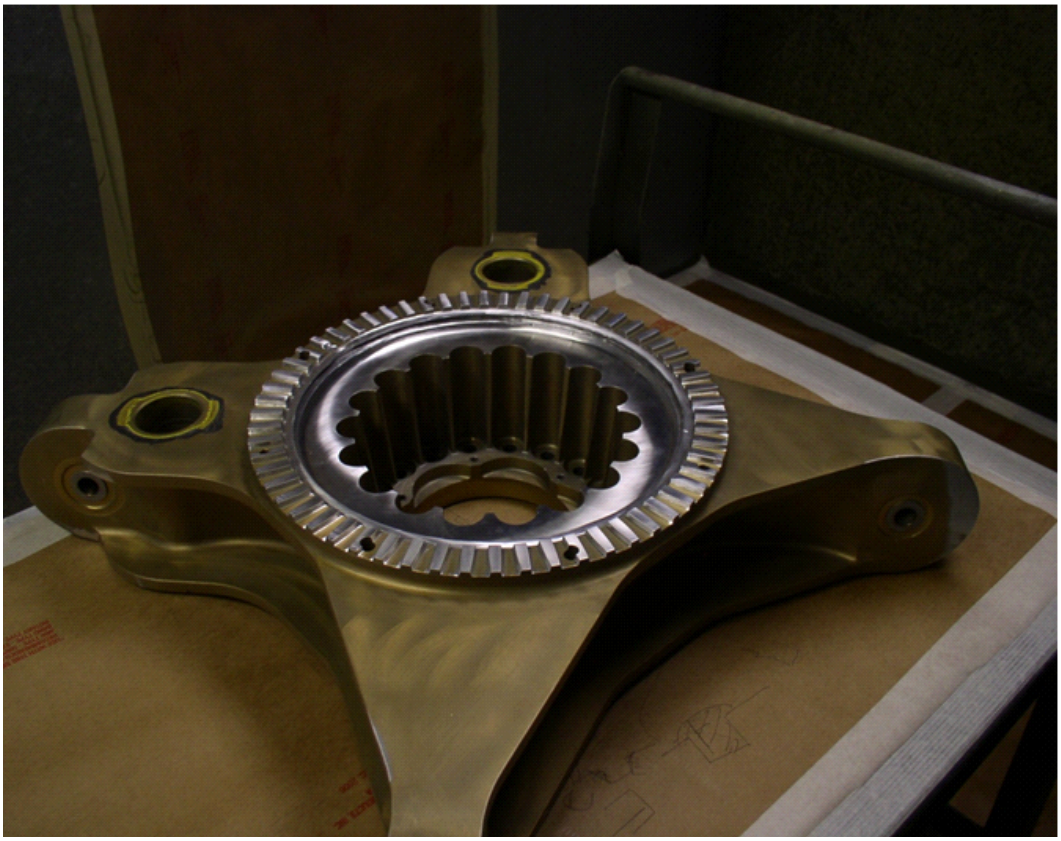
Currently, there are 50 helicopter mast supports that are unserviceable with no viable means to repair the component for service. ARL was requested to perform spray trials on a test section of an Army mast support and then provide technical support to the Aviation and Missile Research, Development and Engineering Center (AMRDEC) to perform the cold spray demonstration on an actual component at Dyn-Corp in Killeen, TX, to assess the feasibility of restoring an unserviceable component to service. This repair effort focused on three types of damage—corrosion pits along the lower lip of the snap ring groove, mechanical damage on the upper lip of the snap ring groove, and mechanical damage to the gear tooth. A helicopter mast support is shown in figure 1.

Figure 1. Aluminum helicopter mast support.

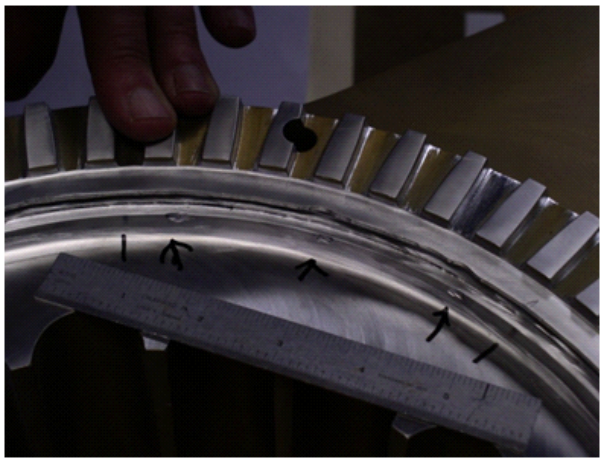
The first type of repair was performed on typical corrosion pitting damage shown near the lower lip of the snap ring groove on the Army helicopter mast support, as seen in figure 2. The pits, shown as a cross section in figure 3, were blended out as shown in figure 4, thereby reducing stress concentrators, and an aluminum coating was applied via cold spray to rebuild to original dimensions, as schematically shown in figure 5. A final machining and blending restored the original surface, as shown in figure 6.

Figure 2. Corrosion pits in the lower lip of the snap ring groove.

The strategy for repairing the corrosion pits was to blend out the pit using either a grinding tool or machining to provide a clean surface. The surface was then grit blasted with 60-grit aluminum oxide to promote adhesion of the cold spray filler to the substrate surface. The top

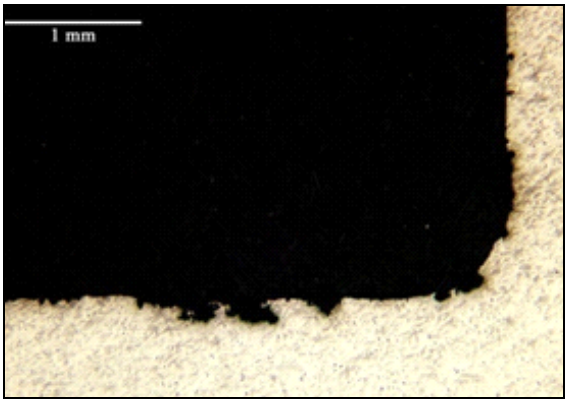
Figure 3. Cross section of the pitted surface.

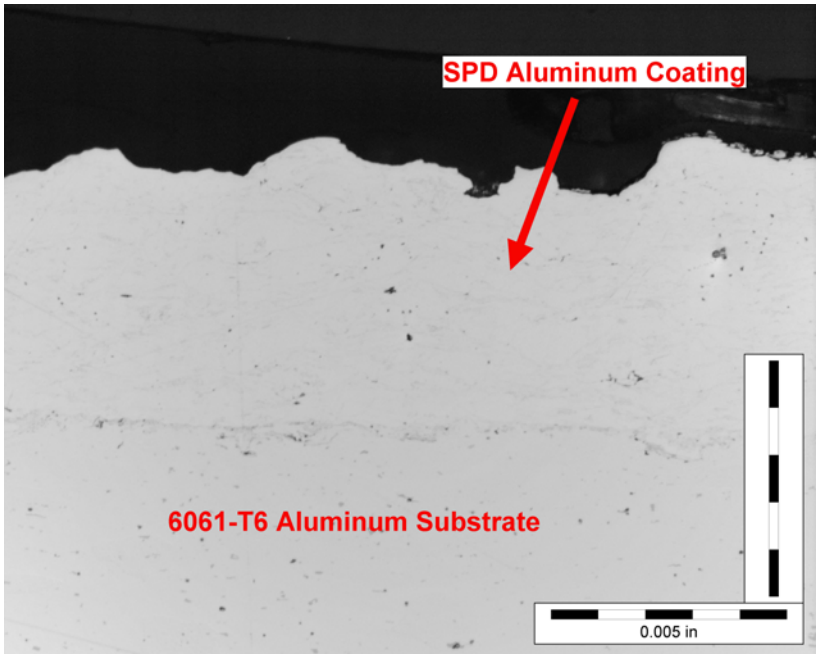
Coatings deposited using all three powders were cross-sectioned and metallographically prepared. A representative scanning electron micrograph for each coating is shown in figures 17, 18, and 19. The coatings exhibit a fully dense structure with no visible voids and good bonding

Figure 17. Microstructural analysis of CP-aluminum cold spray coating.

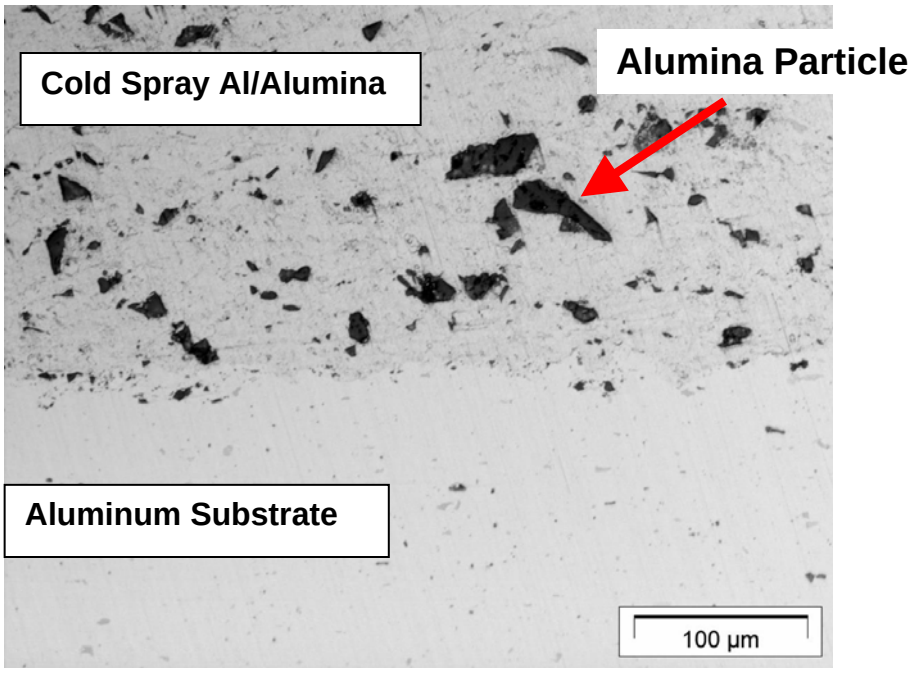
Figure 18. Microstructural analysis of aluminum/aluminum oxide cold spray coating.

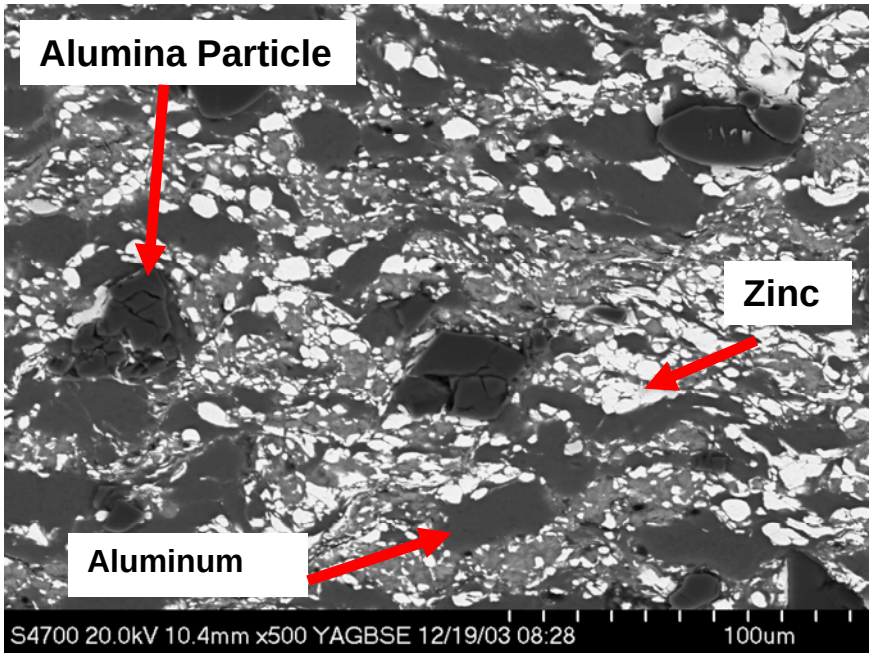
Figure 19. Microstructural analysis of the aluminum/zinc/aluminum oxide cold spray coating.

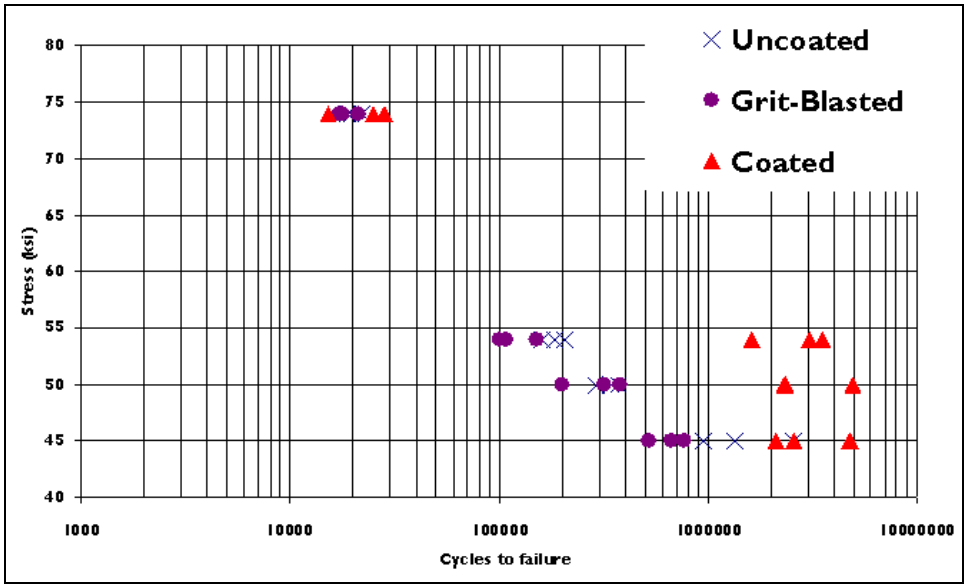
fatigue tests are performed at fully reversed (r = –1) loading at loading frequency of 100 Hz (6000 rpm), similar to the RR Moore fatigue testing. These were compared to specimens that were uncoated in addition to specimens that had been grit blasted using the same process as the coated specimens. The plot of the resultant data is shown in figure 20. The uncoated and grit blasted specimens had very similar cycles before failure, while the cold spray aluminum coated specimens had a consistently higher number of cycles before the specimens failed. The cold spray aluminum coating had an improved fatigue life and enhanced the fatigue performance of the 7075 aluminum alloy.

Figure 20. Plot of RCB fatigue test results for cold spray aluminum on 7075 aluminum RCB fatigue specimens. (*Australian Defence Science and Technology Organization)*

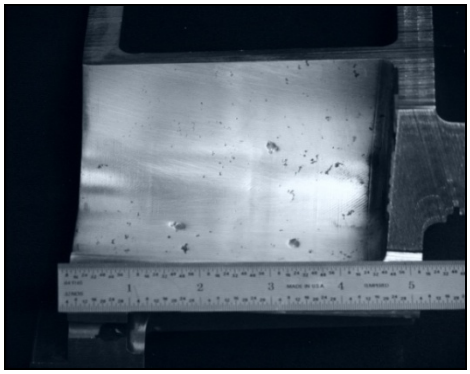
Figure 21. Mast support test section as received.

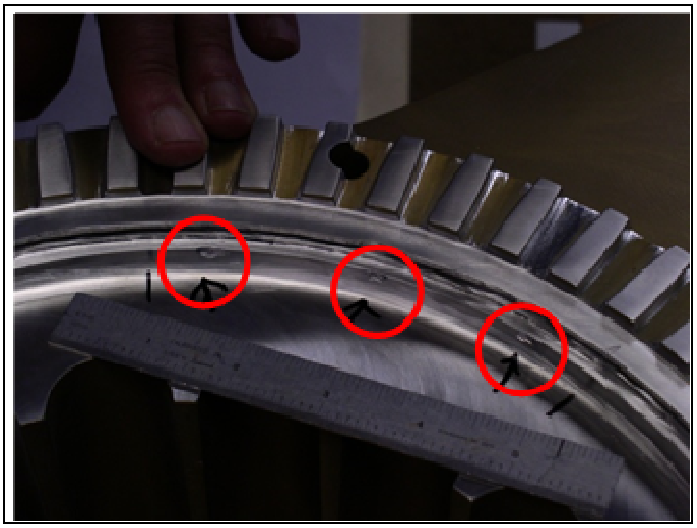
Figure 25. Corrosion pits in lower lip of snap ring groove before cold spray.

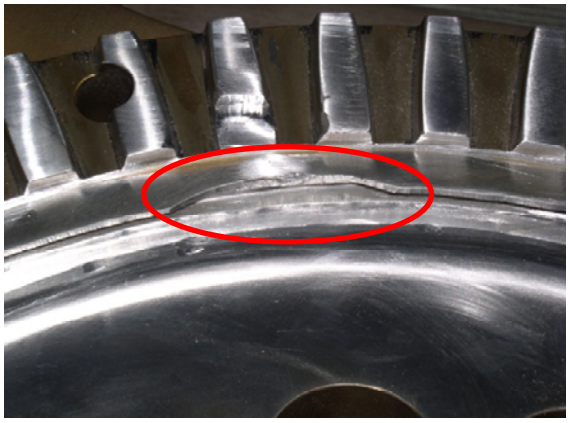
Figure 28. Mechanical damage on a snap ring groove.

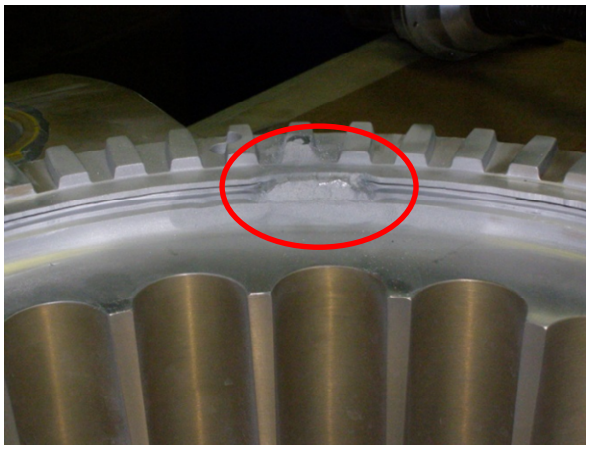
Figure 29. Areas on a snap ring groove and spline requiring repair.
