Cold Spray Process Development for the Reclamation of the Apache Helicopter Mast Support

by P. F. Leyman and V. K. Champagne

ARL-TR-4922 **August 2009**

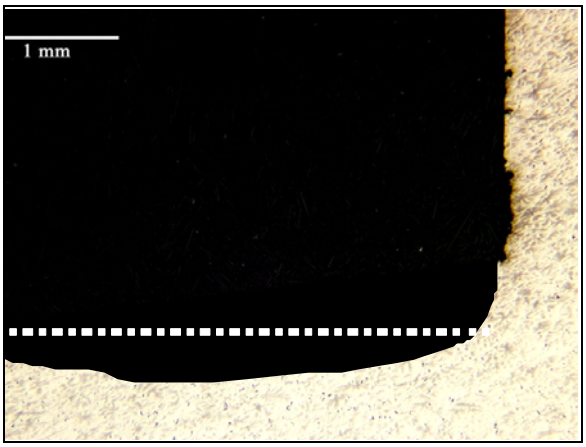
Figure 4. Blending out of the corrosion pits with a grinding tool.

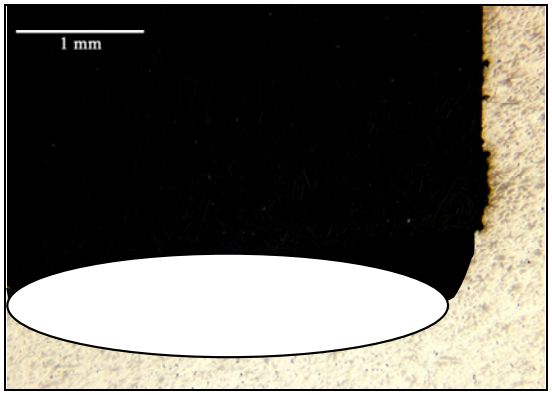
Figure 5. Area filled with cold spray material.

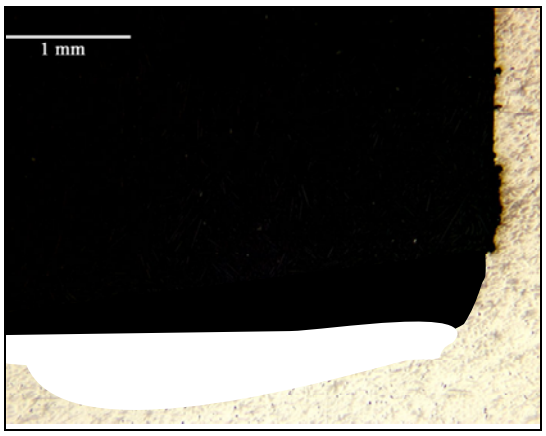
Figure 6. Surface ground or machined back to original surface.

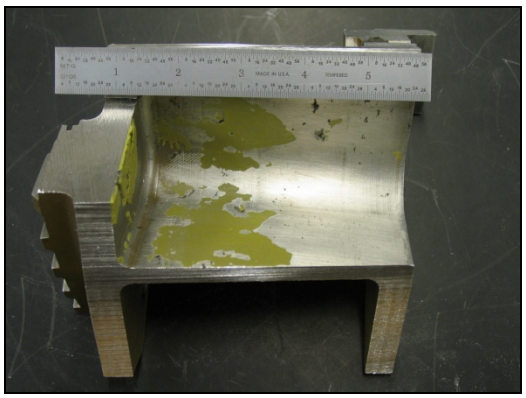
Figure 22. Test section after cleaning and grinding out the pits.

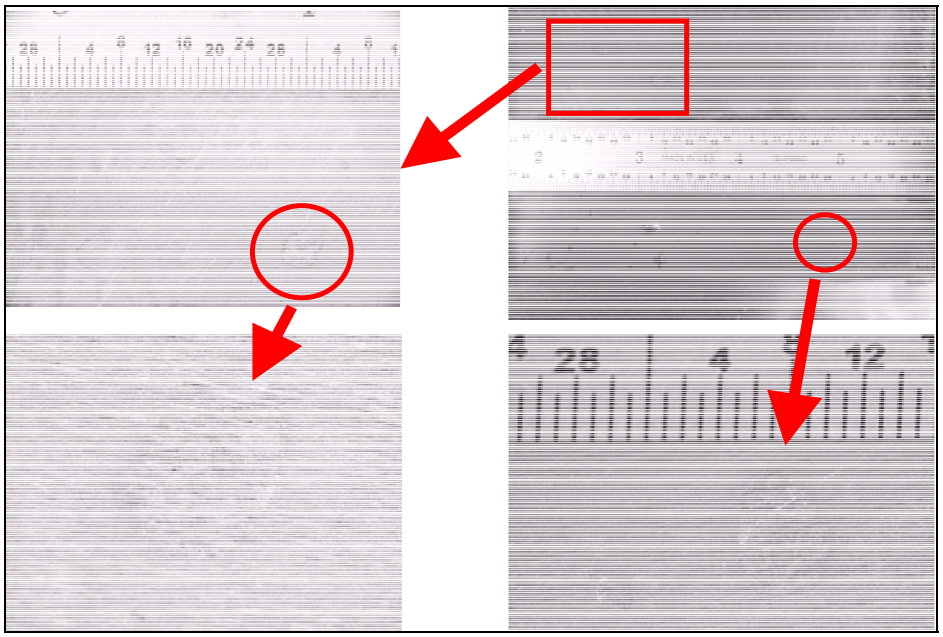
Figure 23. High magnification of cold spray repair to corrosion damage conducted at ARL.

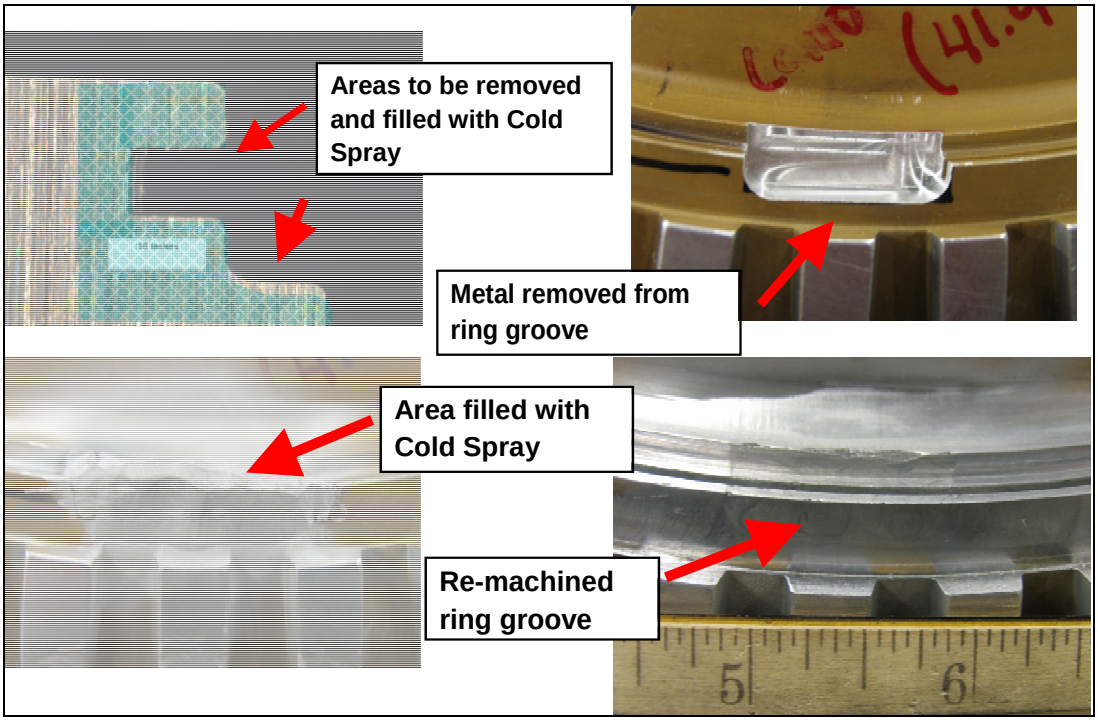
Figure 24. Cold spray repair on mechanical damage to a snap ring groove conducted at ARL.

Cold spray trials were also performed on the snap ring groove by removing a section of the snap ring groove to about 0.50 in deep and 1.0 in long into the snap ring groove (figure 19) and then filling it with cold spray aluminum above the surface of the snap ring grove. The excess material was machined back to the original surface contour of the component, as seen in figure 24.

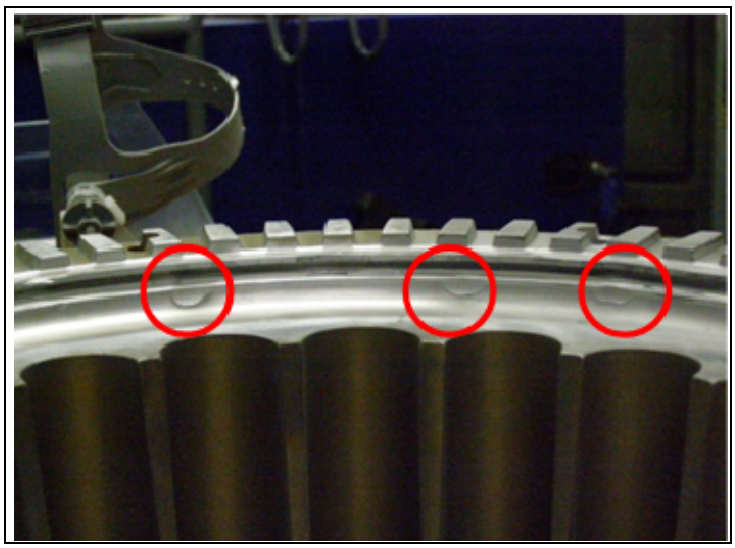
Figure 26. Corrosion pits after cold spray fill and restoring back to original dimensions.

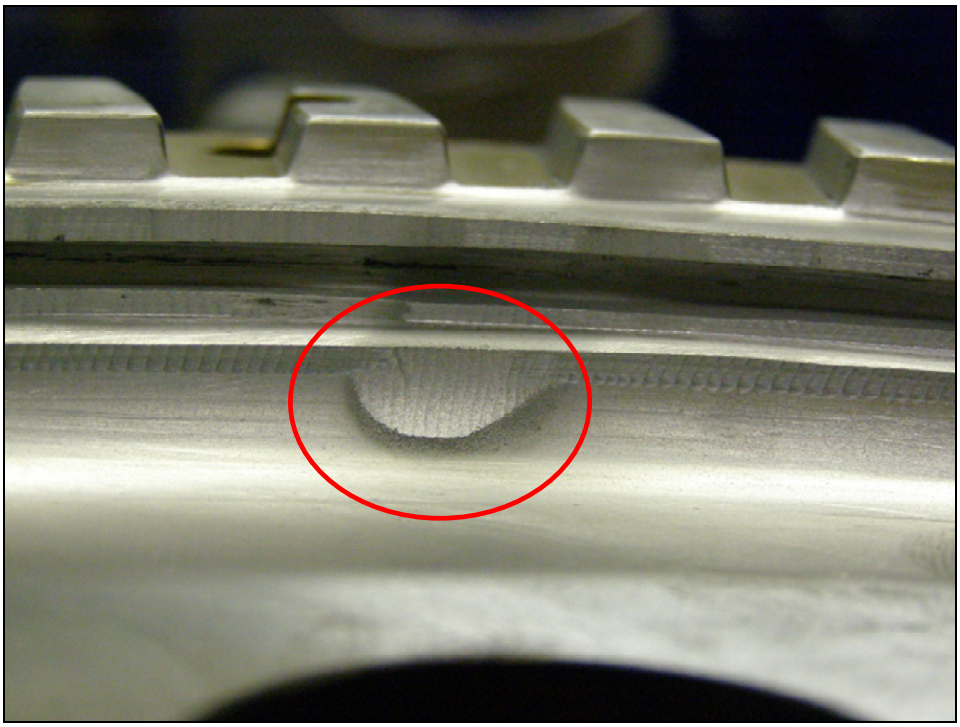
Figure 27. Close up of a corrosion pit filled with cold spray aluminum, machined back to the original dimensions.

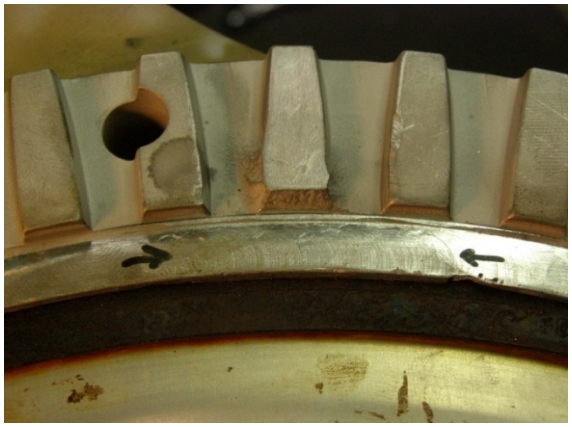
Figure 30. Cold spray aluminum fill machined back to the original dimensions.

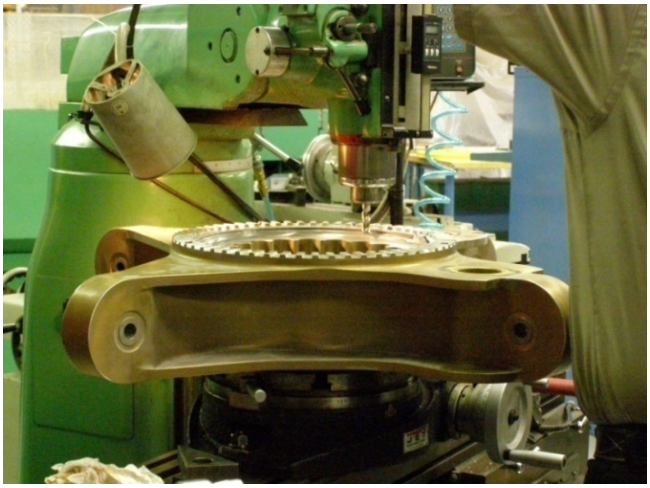
Figure 31. Machinist performing re-contouring of the cold spray aluminum repair to the original dimensions.
