**Failure Analysis of an AH-64 Main Rotor Damper
Blade Rod End, P/N 7-211411186-5**

by Scott M. Grendahl and Marc S. Pepi

ARL-TR-3100

December 2003

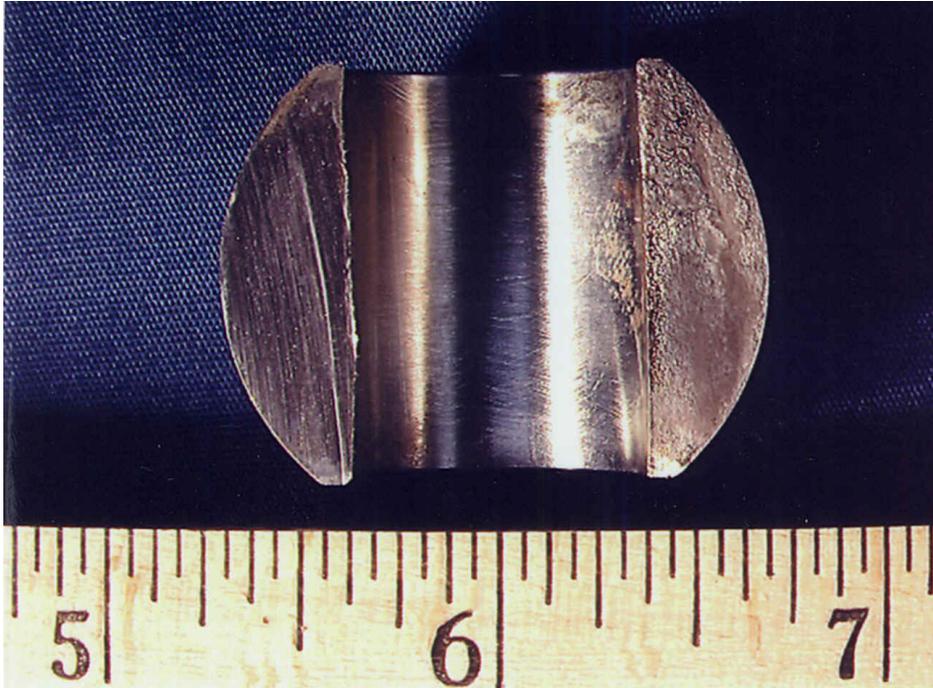
Figure 5 shows half “B,” which remained in the as-received condition for further analysis (see SEM/EDS section 9).

Figure 5. Fracture half "B," left in the as-received condition (scale in inches).

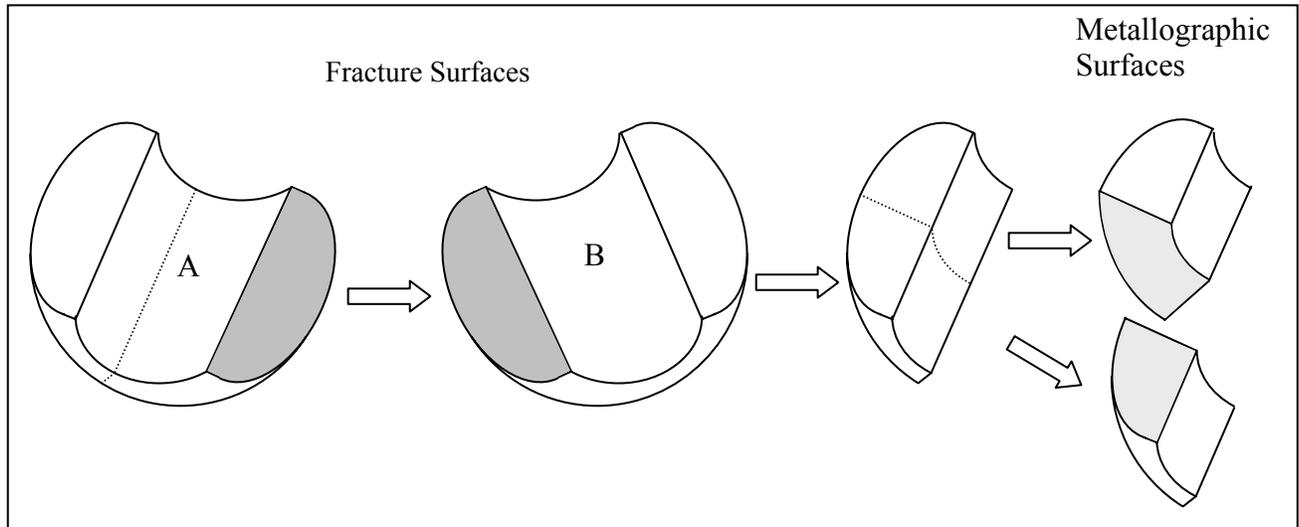
Longitudinal and transverse sections of the failed component were metallographically prepared with silicon carbide papers, ranging in grit from 120 to 600, followed by 12 and then 9 micron diamond, and finished with 0.05-micron alumina. The specimens were sectioned as shown in figure 15.

Figure 15. Sectioning schematic of the failed type 440C ball.

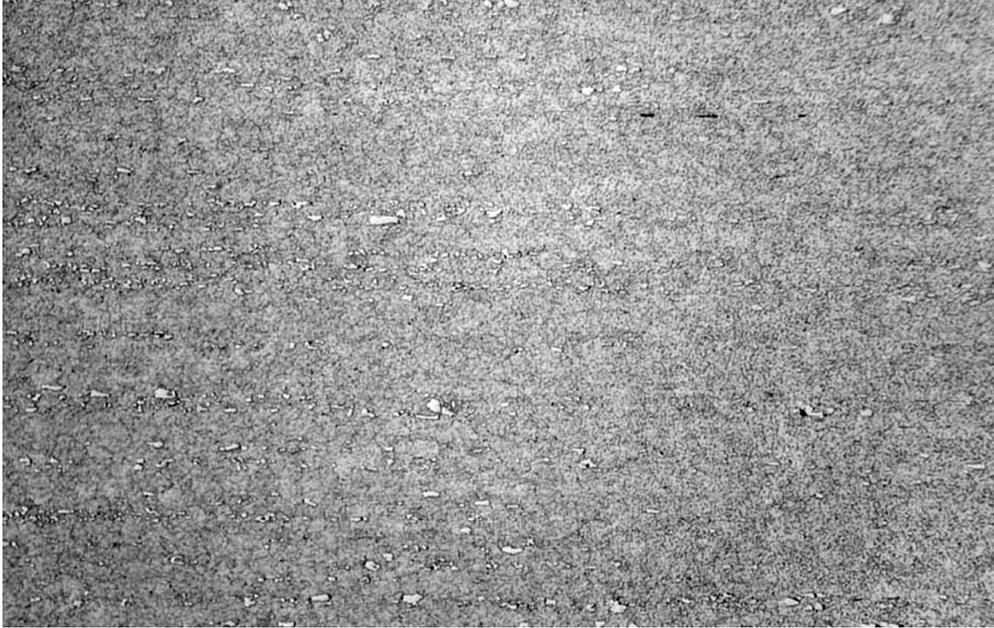
The samples were subsequently etched with Vilella's reagent to reveal the microstructural features. At low magnification, some banding was noted, indicative of the prior flow direction (see figure 23) in the material.

Figure 23. Etched microstructure of the ball material showing the presence of banding (mag 100x).

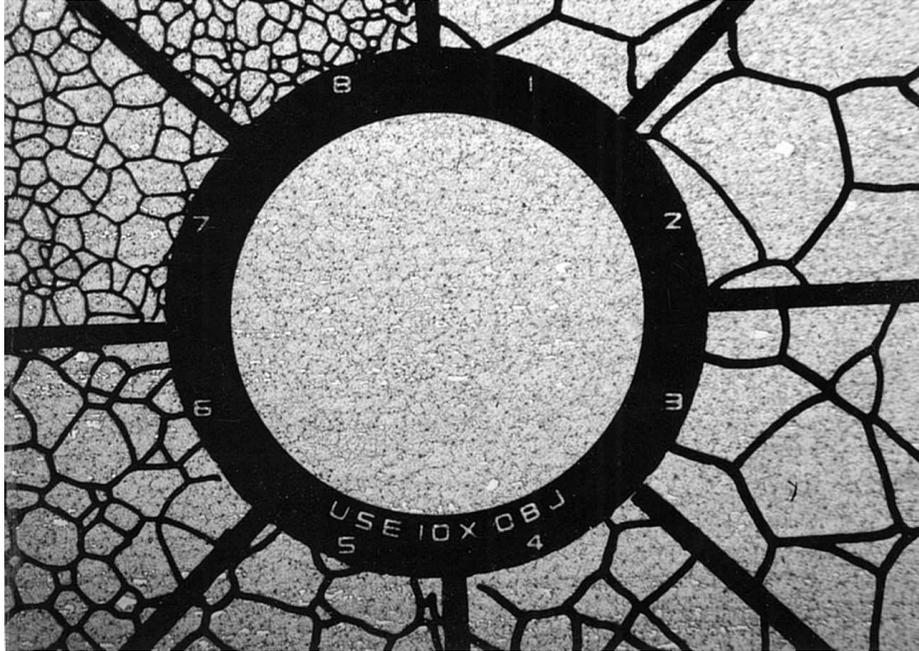
The grain size of the material was determined to be 8 or finer with the reticle overlay shown in figure 24. The regions of inter-granular attack were observed after the etchant was applied. Figures 25 through 30 correspond to the respective regions depicted in figures 17 through 22. The inter-granular nature of the attack became enhanced upon etching.

Figure 24. Etched microstructure demonstrating the grain size to be 8 or finer (mag 100x).

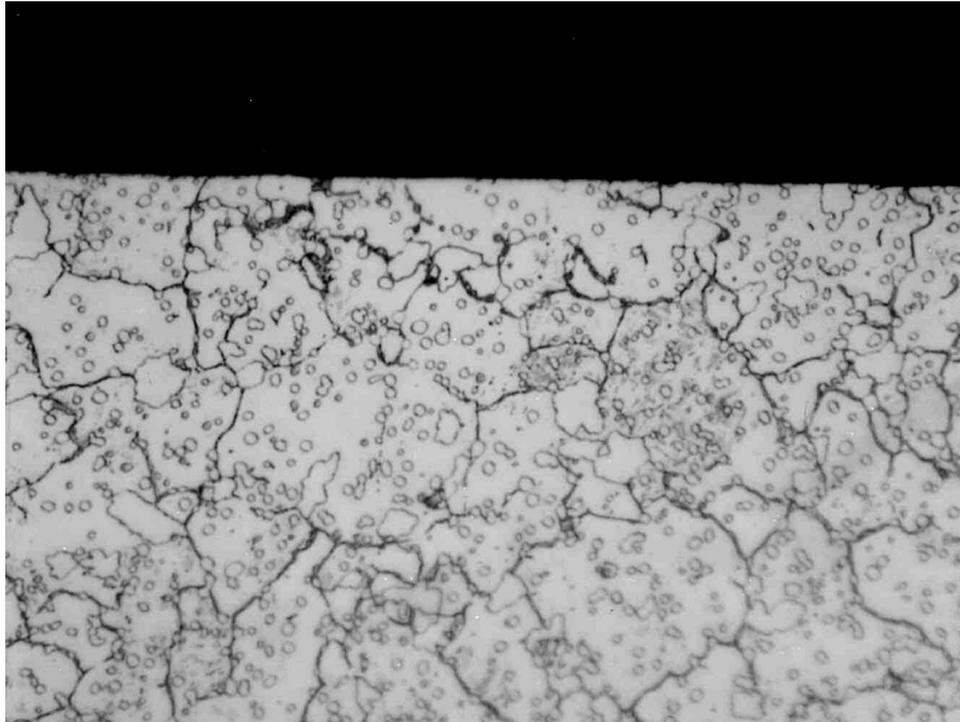
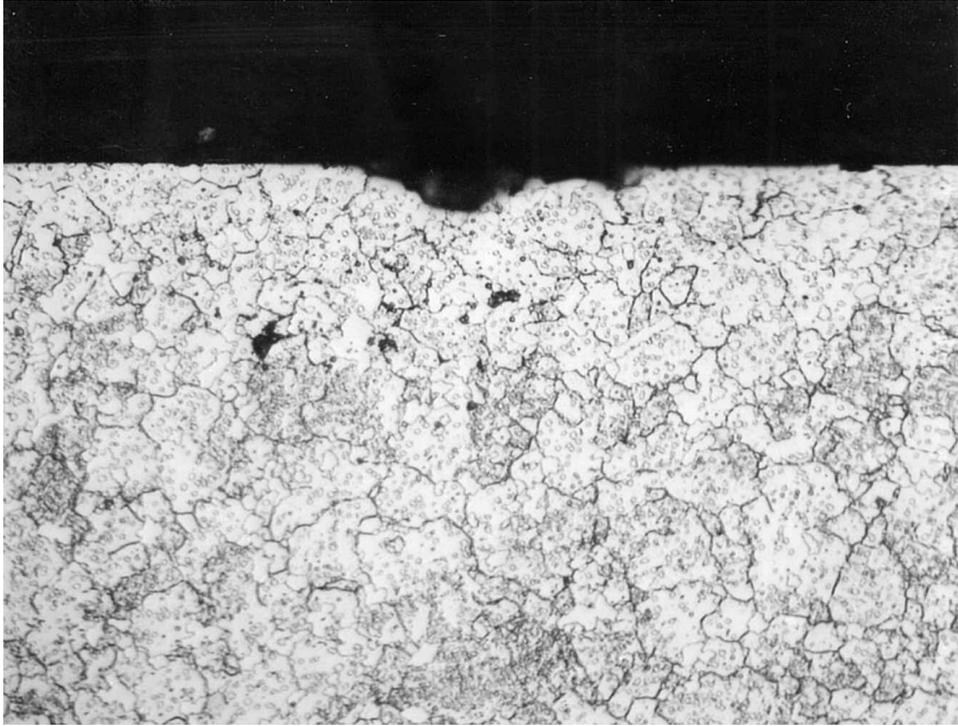
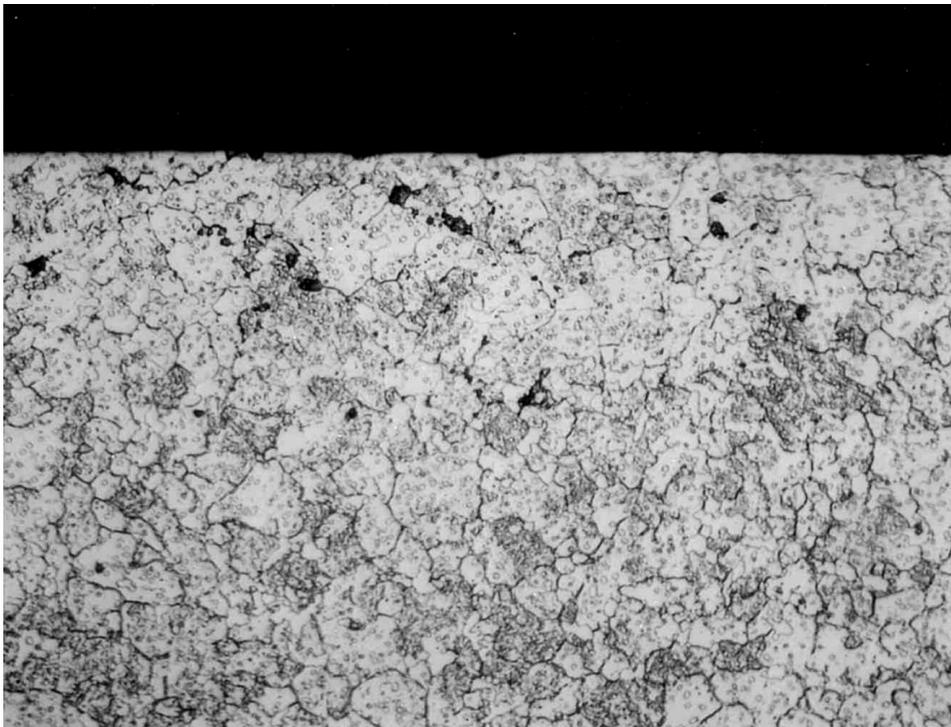
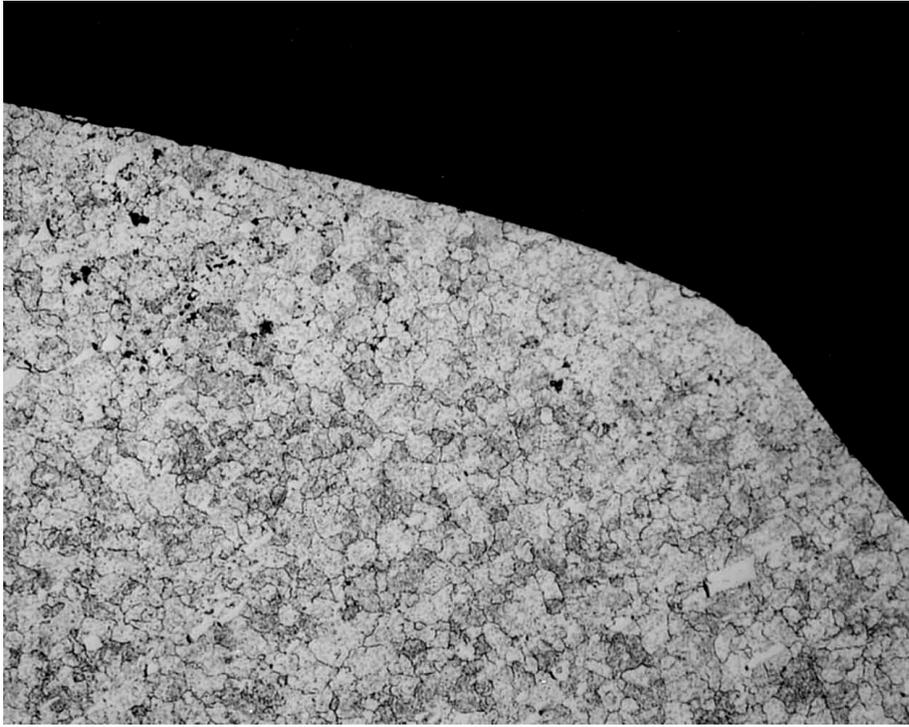
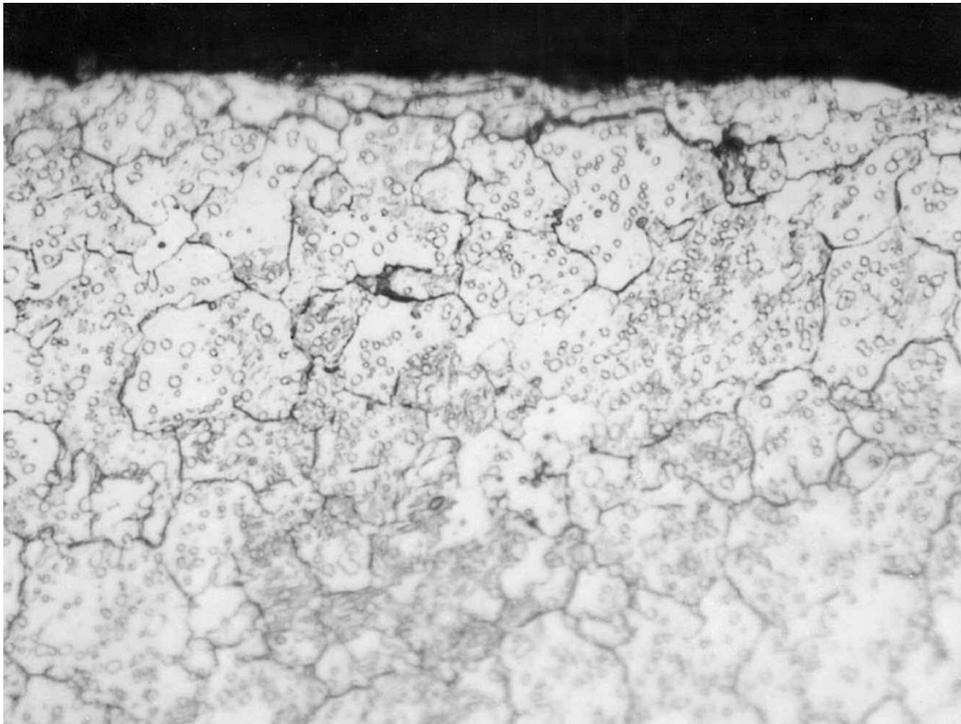
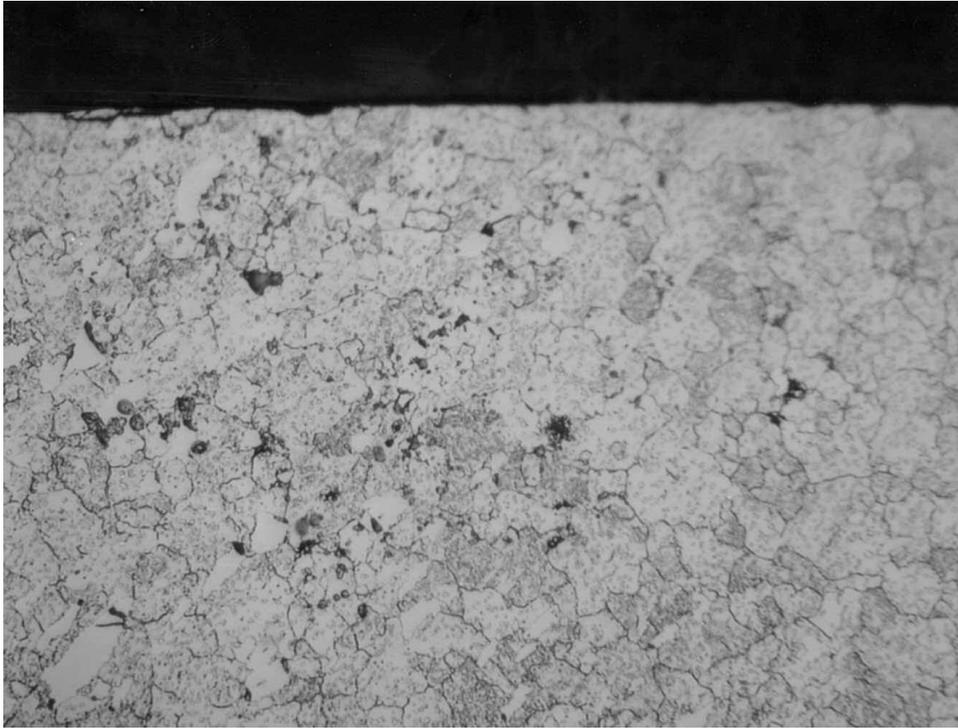
Figure 25. Etched transverse metallographic section area "A," (mag. 1kx).

Figure 26. Etched transverse metallographic section area "B," (mag 500x).

Figure 27. Etched transverse metallographic section area "C," (mag 500x).

Figure 28. Etched longitudinal metallographic section area "A," (mag 200x).

Figure 29. Etched longitudinal metallographic section area "B," (mag 1kx).

Figure 30. Etched longitudinal metallographic section area "C," (mag 400x).

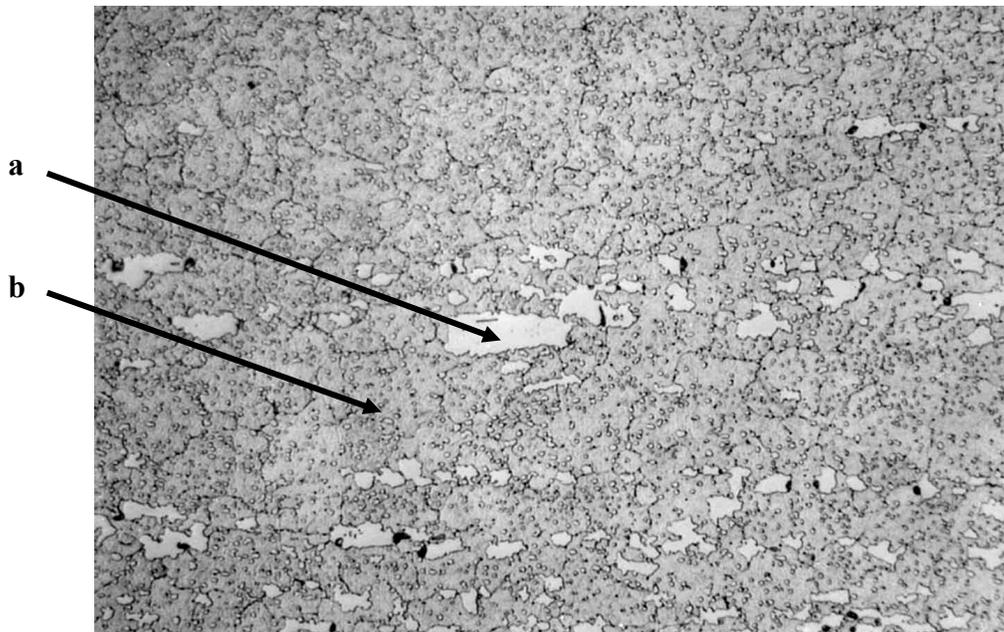
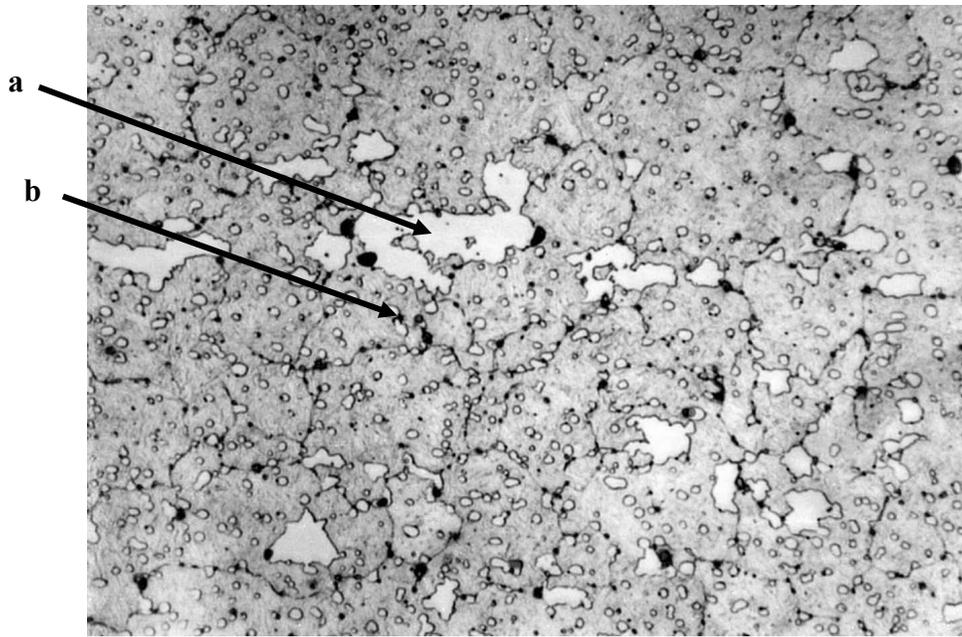
The microstructure was subsequently observed at 500x and 1000x magnification (see figures 31 and 32, respectively). The structure consisted of primary M_7C_3 carbides (figures 31a and 32a) and secondary carbides (small spheroidal particles shown in figures 31b and 32b) in a matrix of tempered martensite. Note, however, that Vilella's reagent does not reveal the tempered martensitic structure in this material as it appears in other common steels. The lathe-like structure is noticeably obscured. The primary carbides ranged in size, measuring as long as 0.0012 inch (30 μm). This size was well within the nominal size (as long as 60 μm) to be expected for this alloy. The structure was typical of type 440C stainless steel that has been austenitized, quenched, and tempered.

Figure 31. Etched longitudinal microstructure of 440C ball (mag 500x).

Figure 32. Etched longitudinal microstructure of 440C ball (mag 1kx).

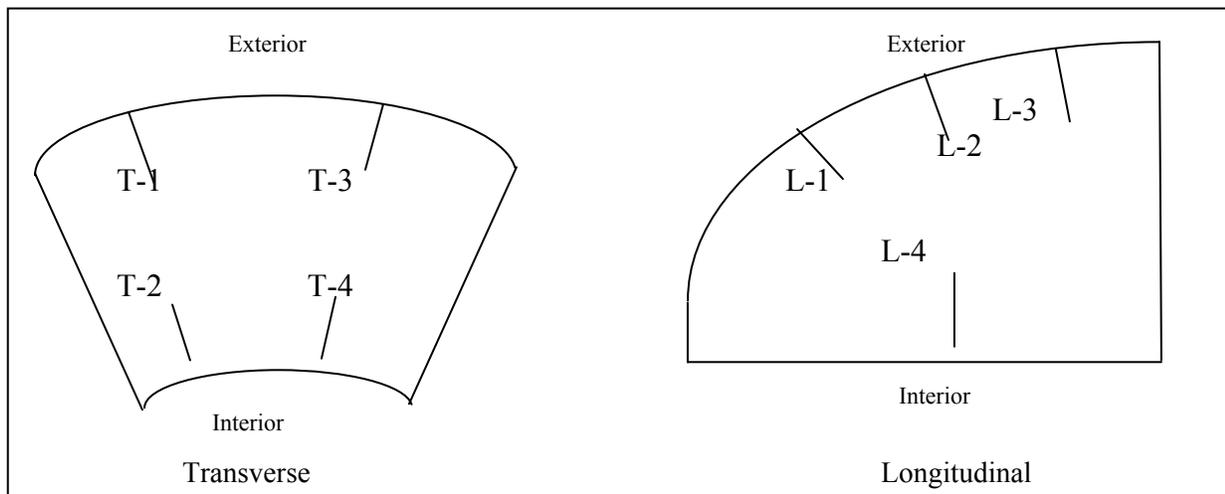
Micro-hardness profiles were taken on the metallographically polished transverse and longitudinal cross sections of the failed ball. This was performed in order to determine the presence and thickness of any possible surface chemistry gradients. Paragraph 3.3.2.4 of HP1-1 states that the depth of carburization, decarburization, or nitriding shall be determined by a micro-hardness traverse. Carburization and/or nitriding are disallowed per HP1-1. The boundary of the carburization, decarburization, or nitriding shall be at the depth at which the hardness rises/falls to the equivalent of 20 points Knoop above/below the core hardness. The Knoop hardness scale was used for this testing, and the readings were obtained in a staggered traverse to maximize the amount of readings that could be taken close to the surface, while maintaining the rule-of-thumb distance between indents. Four sets of readings were taken on each specimen. Figure 33 illustrates the location of the hardness profiles on the metallographic cross sections.

Figure 33. Schematic of hardness profile traverses.

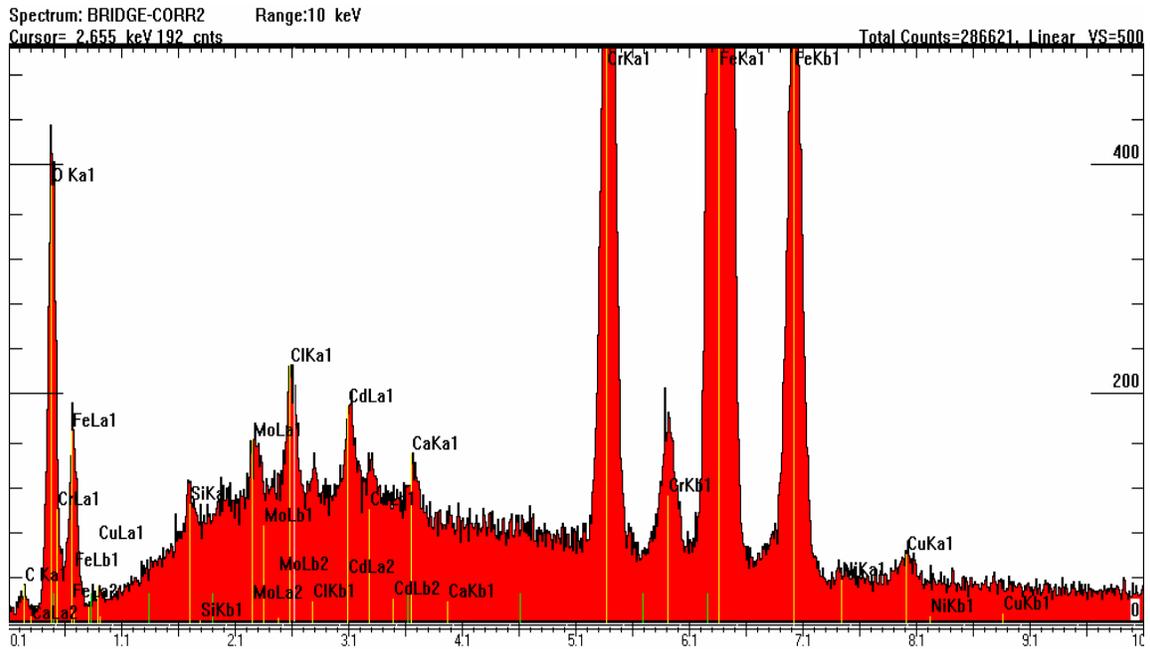
The attacked area was filled with corrosion product. This product was analyzed with EDS. The EDS spectrum produced from this product can be observed in figure 37. It was similar in chemistry and composition to the other attacked areas on the ball. However, it was slightly different from the corrosion product on the fracture surface that is presented later.

Figure 37. EDS spectrum collected from the product within the inter-granular attack.

Naturally occurring chloride salts can explain the presence of calcium and chlorine. The copper, nickel, and molybdenum are alloying elements within the material, so it is understandable that they are revealed within the corrosion product. The cadmium, however, must have originated from a foreign source to this ball. This is discussed in more depth later.

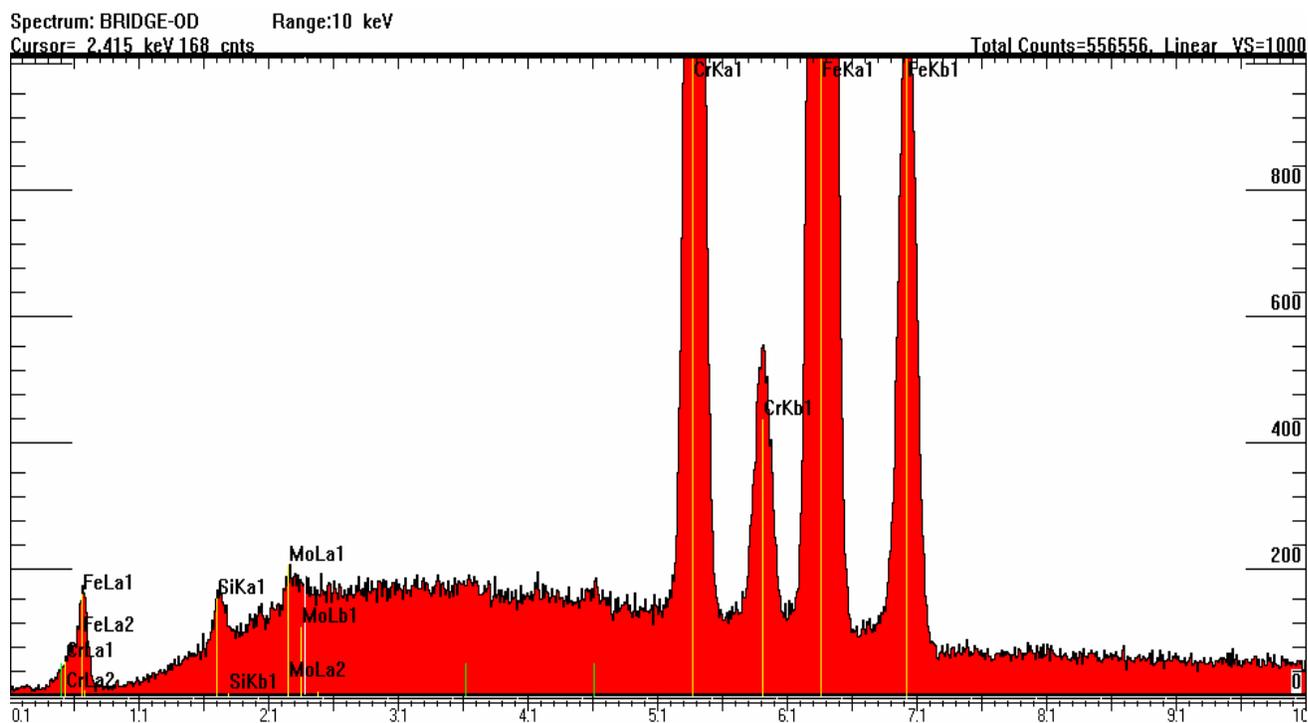
The corresponding quantitative analysis of this product is presented in table 14. This spectrum, along with the other EDS data presented, can be contrasted with the base material spectrum that is presented in figure 38 along with its corresponding qualitative and quantitative analysis in table 15.

Figure 38. EDS spectrum collected from the base material of the failed component.

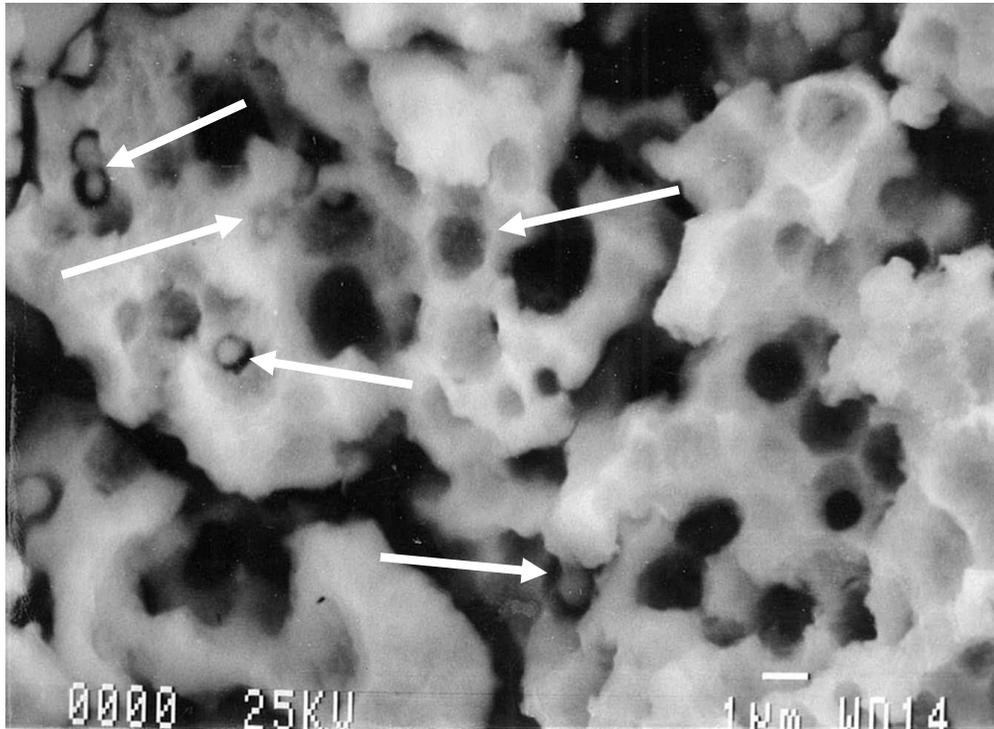
attacked. Conversely, they are dislodged by the attack. Figure 40 depicts this region. The depletion of chromium in the regions surrounding the precipitates makes this occurrence intuitive. The white arrows indicate the precipitates in advancing stages of dislodgment. Figure 41 presents the precipitates shown in figure 40 at higher magnification. Other inter-granular attacked areas demonstrated evidence leading to this conclusion.

Figure 41. High magnification showing detail of figure 40 (mag. 5kx).

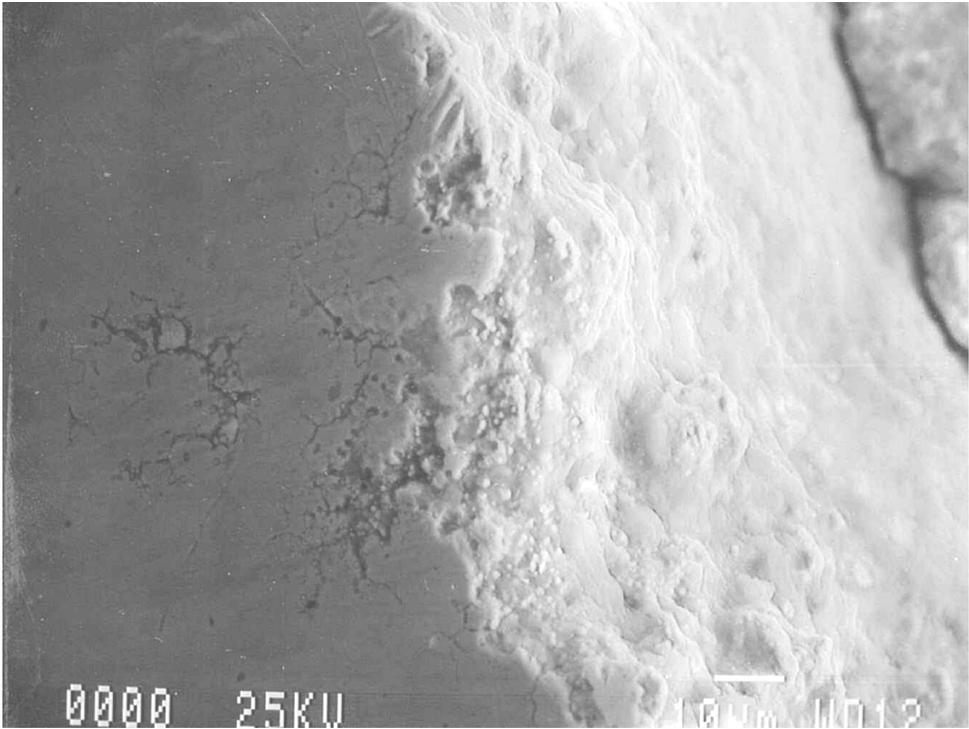
Figure 42 was situated approximately 1 mm from the origin along the fracture surface. Intergranular attack around precipitates near the surface is indicated by the arrows. Another region adjacent to the fracture surface, figure 43, depicts attack around precipitates as well as dislodged precipitates embedded within the corrosion product on the fracture surface. High magnification of another attacked area away from the fracture surface shows four distinct precipitates clearly dislodged from the matrix material. These precipitates are shown in figure 44. The EDS spectrum of the precipitates displayed increased levels of chromium and carbon compared with the matrix base material as might be expected with the formation of iron-chromium carbides of this material (see Metallography section). Figure 45 displays this spectrum and the corresponding increases in chromium and carbon compared with the base material. Note that no carbon was detectable by EDS within the base material. Table 16 shows the qualitative and quantitative results generated from the spectrum.

Figure 43. Attack around precipitates and dislodged precipitates (mag. 750x).

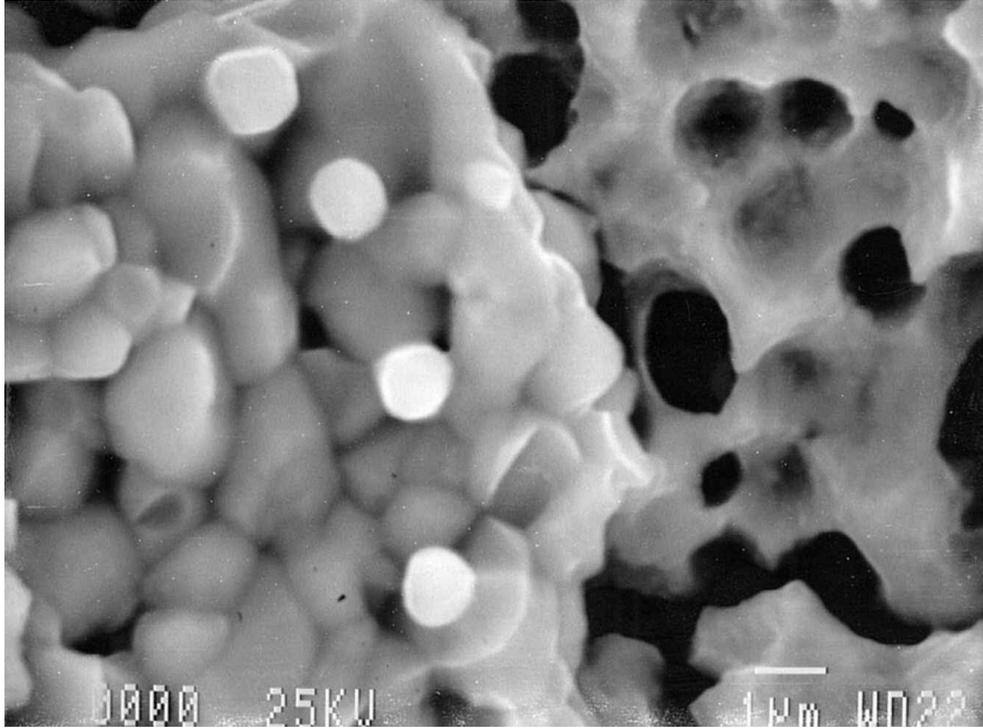
Figure 44. Four distinct dislodged precipitates (mag. 7500x).

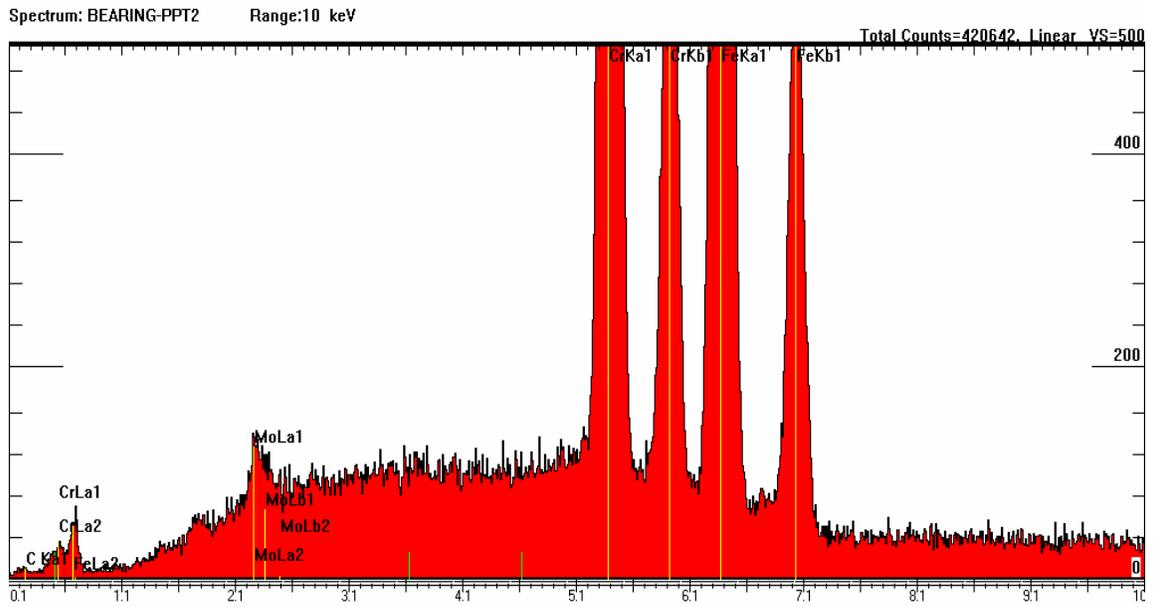
Figure 45. EDS spectrum of the precipitates within the matrix.

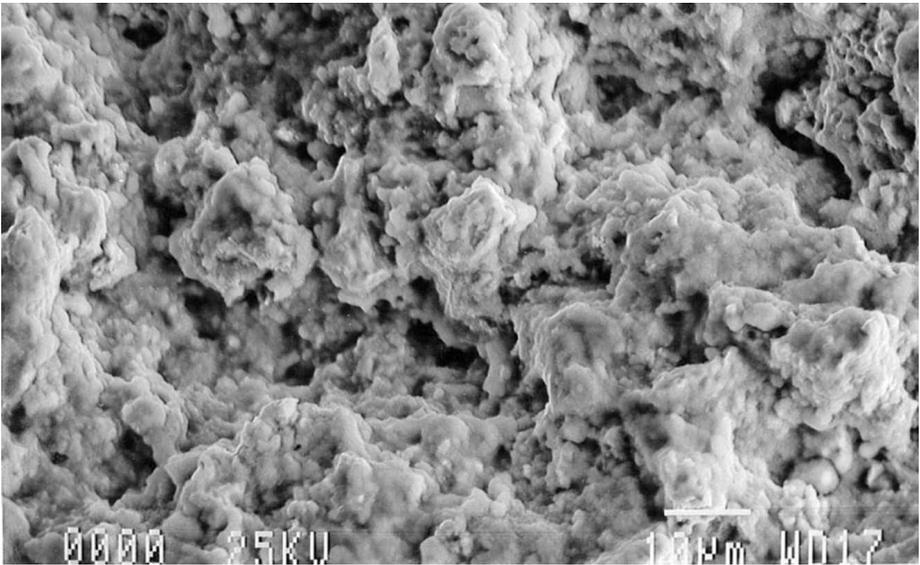
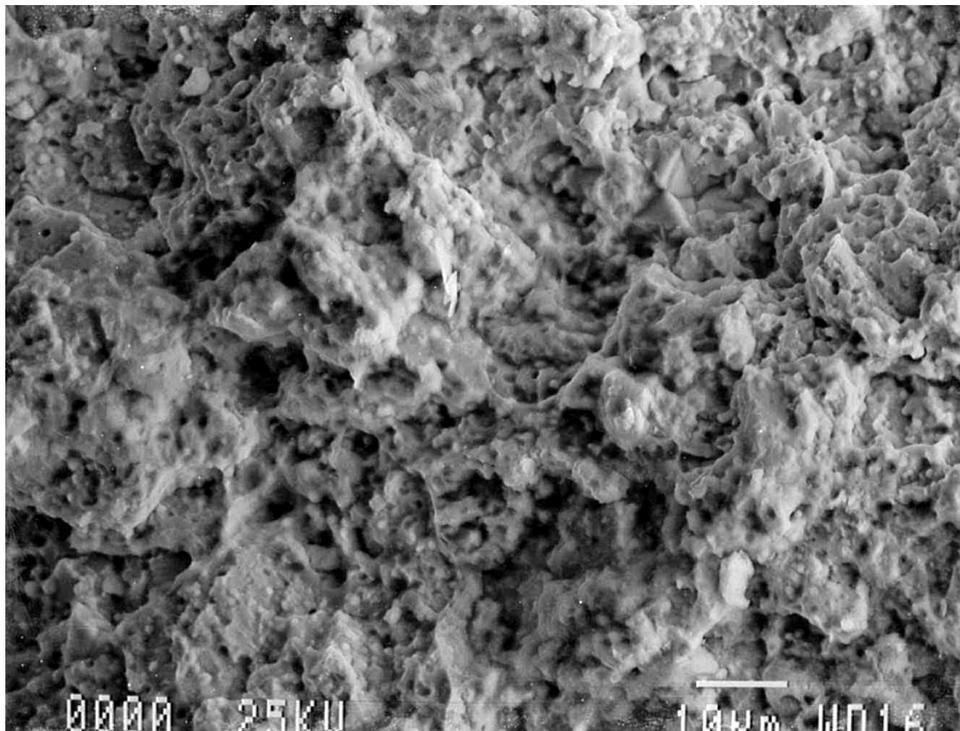
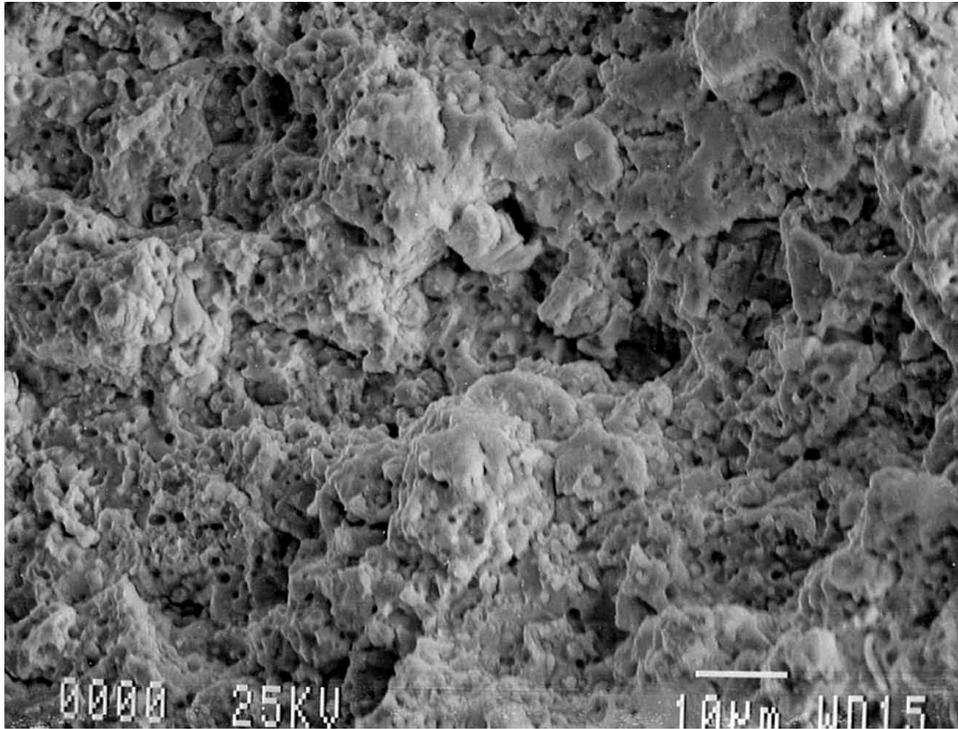
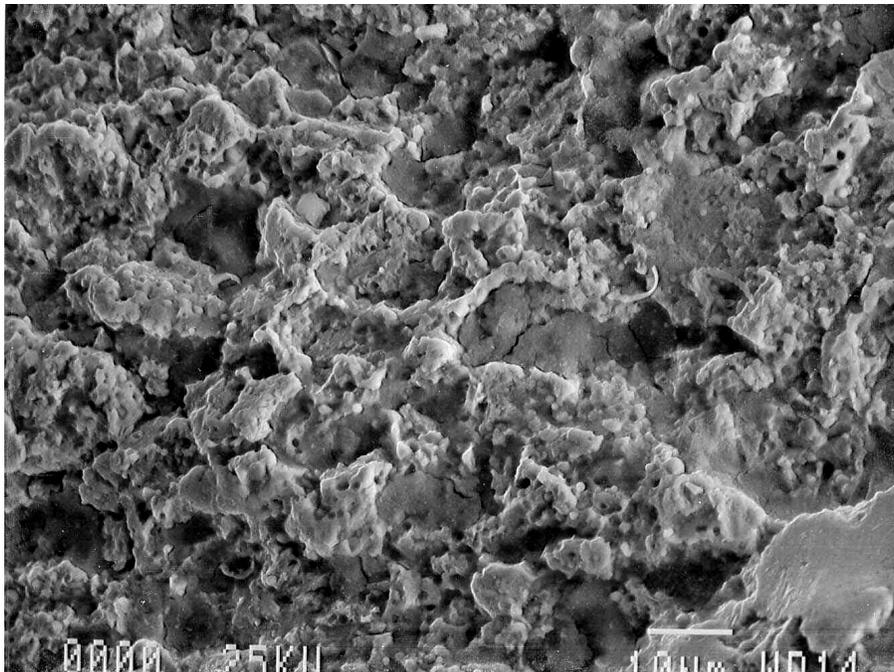
The fracture surface did not add considerable significant information to that which was concluded from the surface of the ball. Five fractographs were taken evenly spaced across the fracture surface to identify differences as the fracture progressed. The fracture mode, however, was mixed transgranular favored by fatigue and inter-granular favored by corrosion. These fractographs are presented in figures 48 through 52, from the origin. Within these fractographs, it is discernible that the fracture progressed in a mixed mode (trans-granular/inter-granular), aided by alternating stresses and corrosive action. The preferential cracking around the precipitates is readily discernible since several precipitates and cavities are easily recognized. The severity of the corrosion increased with age, toward the origin, as would be expected. The fracture was notably

Figure 48. Fractograph 1 of 5, nearest the origin (mag. 1kx).

Figure 50. Fractograph 3 of 5, at the midpoint of fracture (mag. 1kx).

Figure 51. Fractograph 4 of 5, showing only light corrosion (mag. 1kx).

Figure 52. Fractograph 5 of 5, farthest from the origin (mag. 1kx).

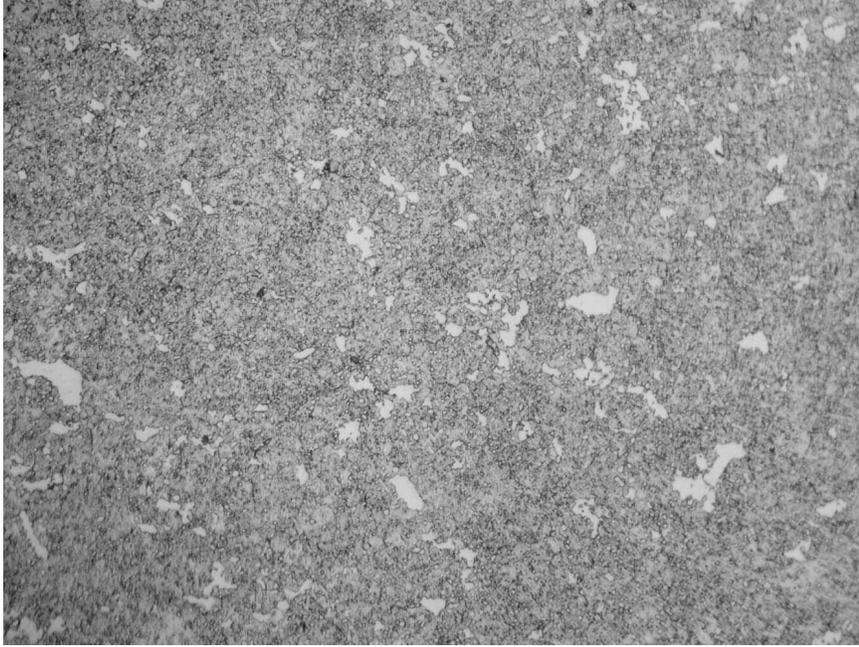
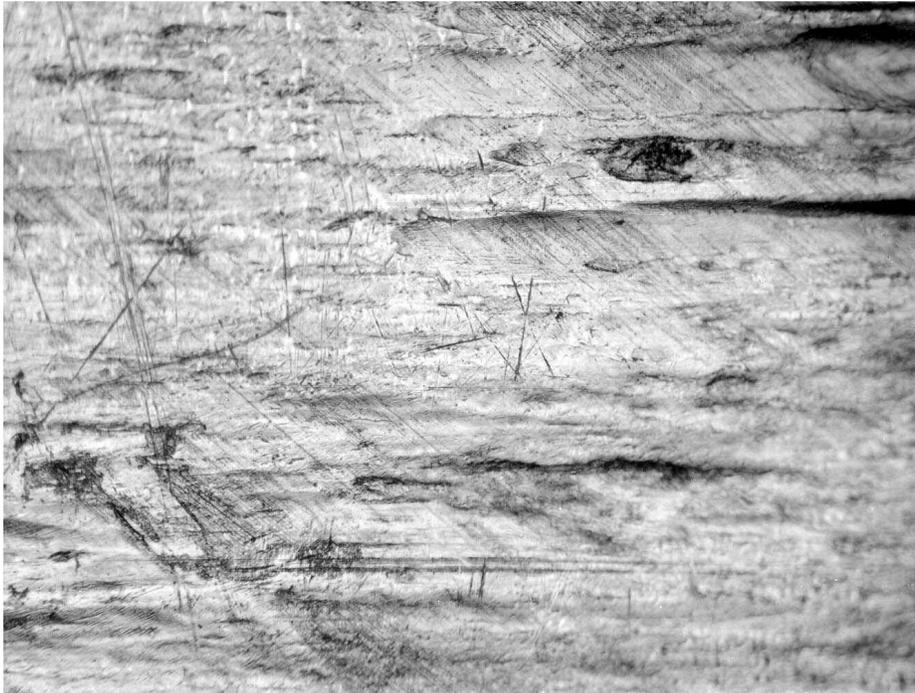
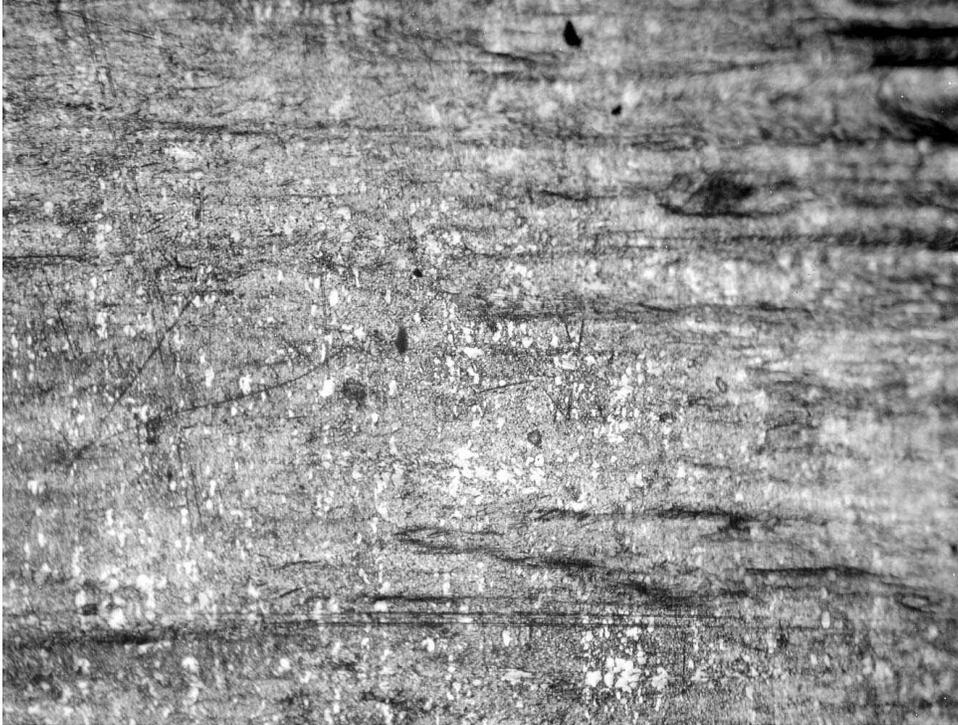
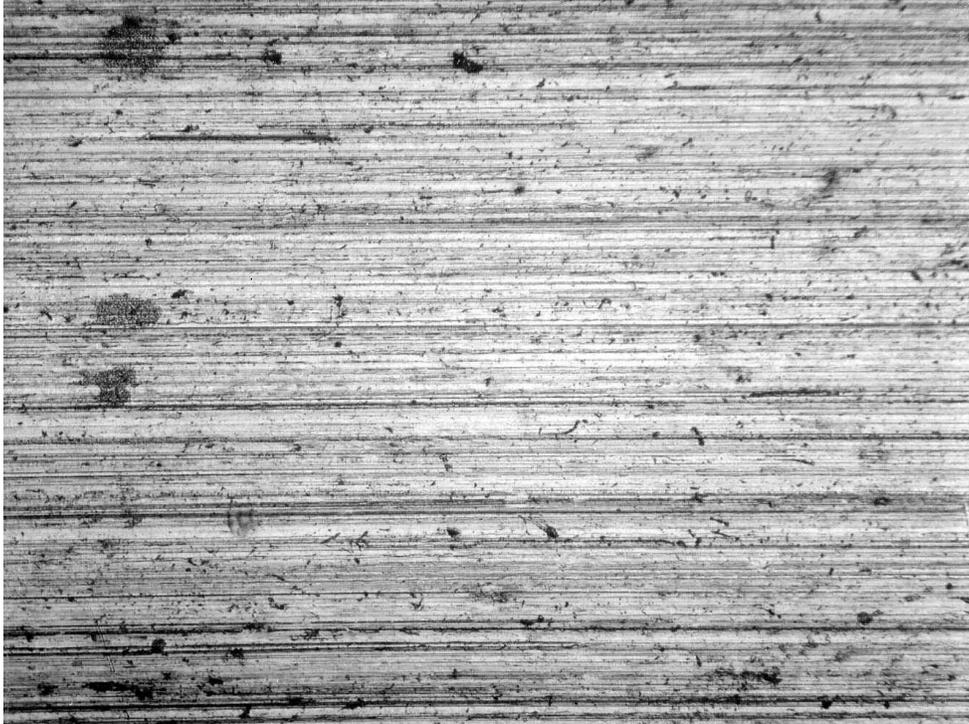
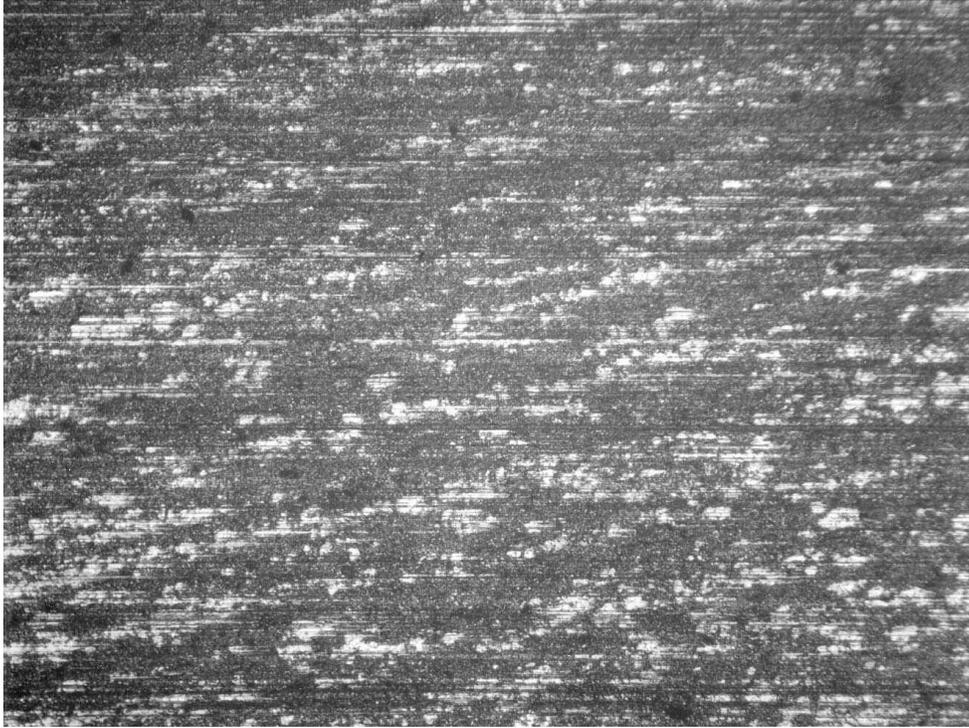
It was speculated that this component was perhaps sensitized during production because of the presence of inter-granular attack at the surface. Specification HP 1-1 summarizes a laboratory test that was used by ARL to determine whether the component had been sensitized. Paragraph 3.3.2.5 states that type B steels (type 440C) shall be metallographically prepared and etched for 1 to 2 minutes in a freshly prepared solution consisting of 1 gram of picric acid, 5 ml of hydrochloric acid, and 100 ml ethanol. Paragraph 2.1.1.4 indicates that components with ultimate tensile strength greater than 220 ksi shall not exhibit inter-granular attack greater than 0.0005 inch in depth. The sample showed negligible evidence of inter-granular attack as a result of this test (see figure 54), which did not exceed the depth requirement. In addition to the metallographic sample, ARL subjected a piece of the actual component in the as-received condition to the etchant. Photographs were taken before and after the application of the etchant (figures 55 through 58, respectively) on both the as-received surface and a machine cut surface. There was no evidence of inter-granular attack on any of these surfaces.

Figure 54. Structure of type 440C steel after sensitization testing (negligible inter-granular attack was noted as a result of this testing) (mag. 400x).

Figure 55. Macrograph of as-received surface of rod end fitting ball (mag. 100x).

Figure 56. Macrograph of as-received surface of rod end fitting ball subjected to sensitization testing (no inter-granular attack was noted) (mag. 100x).

Figure 57. Macrograph of machined surface of rod end fitting ball (mag. 100x).

Figure 58. Macrograph of the machined surface of rod end fitting ball subjected to sensitization testing (no inter-granular attack was noted (mag. 100x).
