**Examination of Spray-Applied Oxsilan 9810/2 Steel  
Pretreatment on a Mine Resistant Ambush Protected  
(MRAP) Vehicle**

**ARL-TN-578**

**October 2013**

**Jack Kelley and Tom Braswell  
Weapons and Materials Research Directorate, ARL**

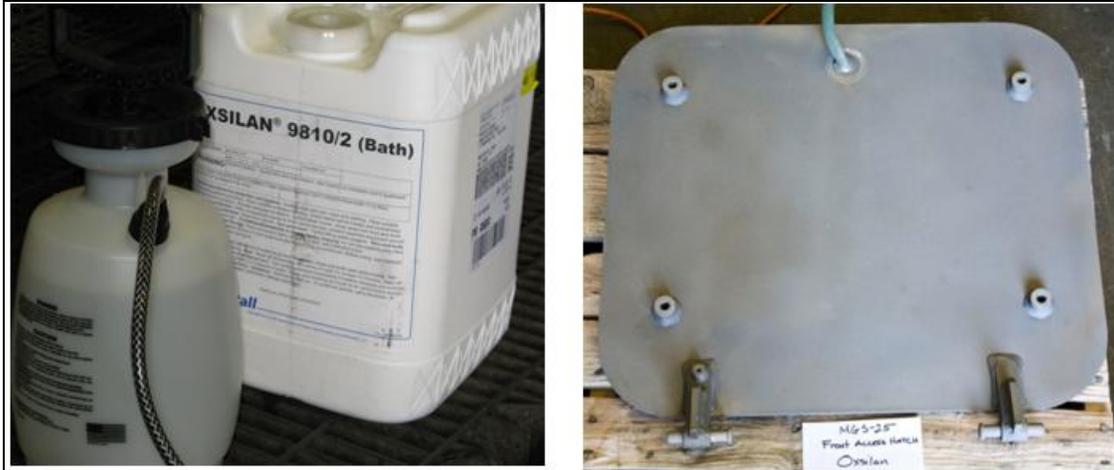
Furthermore, upon completion of all laboratory tests, ARL initiated a demonstration of the pretreatments on Stryker combat vehicles. The demonstration took place at Anniston Army Depot (ANAD) during an ongoing reset of Stryker DRCF-3 vehicles. The Stryker Brigade Combat Team (SBCT) agreed to allow ARL to demonstrate the pretreatments on the hatches of three Stryker vehicles (power entry panel [PEP] hatch, front access hatch, and side egress hatch). Consistent with test panels obtained from the vendor earlier in the project, the hatches treated with Oxsilan 9819/2 showed no signs of discoloration. All hatches treated with the Oxsilan 9810/2 (a front-access hatch depicted in figure 2) were light-gray in color, similar to freshly cleaned steel.

Figure 2. Container of Oxsilan 9810/2 and sprayer used to apply the pretreatments at ANAD (left), Stryker hatch treated with Oxsilan 9810/2 after 19 hours (h) (right).

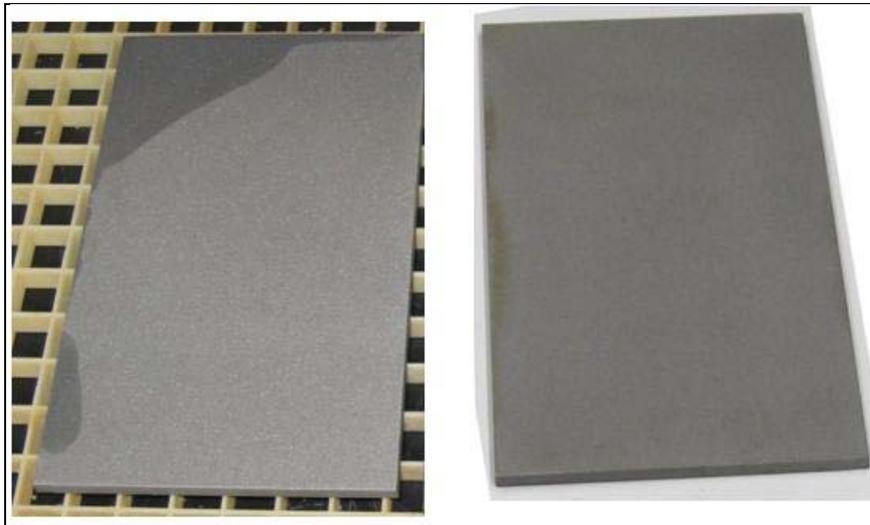
Following the ANAD demonstration, HHA test panels were treated using the same batch of the Oxsilan 9810/2 used on the Strykers during the ANAD demonstration. These test panels were treated with the remaining Oxsilan 9810/2 in order to conduct additional accelerated corrosion tests and humidity testing. Below in figure 3 are pictures of a sample treated with the ANAD batch of Oxsilan 9810/2. Once again, no discoloration was observed on the panels.

Figure 3. A panel treated with the same batch of Oxsilan 9810/2 from the ANAD demonstration of Stryker (left), shown during drying (right), fully dried 24 h.

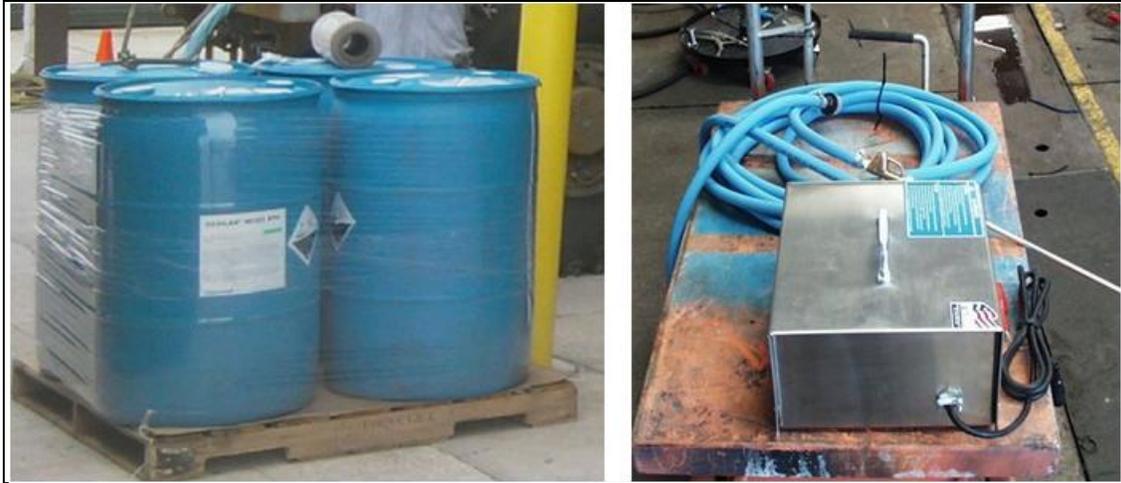
Two pumps (depicted in the demonstration plan and in figure 4) were used to apply the Oxsilan 9810/2 and the DI rinse water. The flow rate of each of the pumps was measured at 1.1 gallons per minute (min). The process called for wetting the MRAP with Oxsilan 9810/2, allowing it to dwell for 60–90 s and rinsing it with clean DI water. The process was carried out as close as practical with two applicators and one person blow-drying with compressed air. However, during the application of the pretreatment, the color of MRAP No.1 began to change to a reddish hue within 1 min. As the application progressed into the rinse and dry phase, a darker reddish-brown color appeared, which looked similar to flash-rusting, on the steel surface. We estimated that about 90% of the vehicle was covered with this reddish-brown color. After some of the areas on the vehicle were fully dry, pull-off tape tests were conducted to determine the stability of the reddish-brown surface finish. Tape adhesion was very tight, comparable to taping a blasted-steel surface, with little or no reddish-brown product pulled off with the tape. In fact, in some cases the backing adhesive was pulled off of the test tape.

Figure 4. Camp Lejeune demonstration. Drums of Oxasilan 9810/2 RTU (left), and pump sprayer used for applying the pretreatment (right).

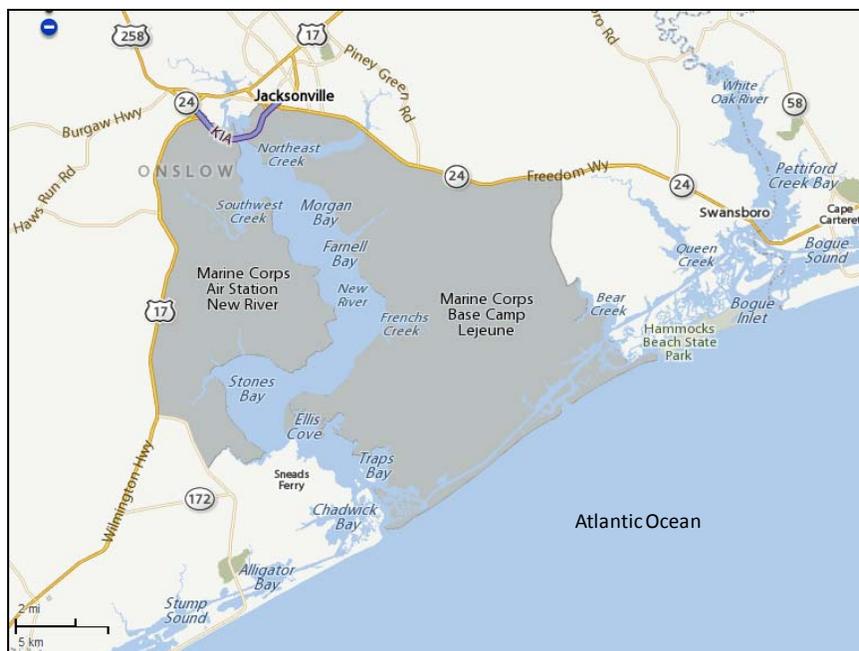
The results of the ARL HHA test panel experiments indicate that the unusual MRAP result was caused by multiple factors. The brownish-red color of the MRAP was most likely the product of both surface contamination, and insufficient flow and rinsing of the Oxsilan 9810/2. The surface may have been first contaminated by the blast media, which may have contained soluble salts, and/or by the bare freshly blasted steel being exposed to the uncontrolled environment near the Atlantic Ocean at Camp Lejeune, NC (figure 10) for 72 h. Ionogenic contamination from abrasives is transferred uniformly onto steel surfaces. This can turn the steel surface a homogeneous light-gray-to-black color, depending on the concentration (11). The trucks were light-gray with no noticeable corrosion before treatment. But once the pretreatment was applied (using insufficient flow rate in this case), the reaction produced a corrosion-like color on the vehicle. Laboratory tests also indicate that it is possible for optimum flow of the Oxsilan 9810/2 to perhaps compensate for the contamination by essentially washing away the contaminants quickly enough to allow the Oxsilan 9810/2 organo-silane polymers to react with the cleaned metal, leaving a clean-gray finish behind. In addition to the panel testing, evidence of the advantage of the greater flow rate can be seen in the MRAP picture in figure 11. The light-gray streaks occurred at locations where there was a higher flow rate of Oxsilan 9810/2 (i.e., continuously running down the side).

Figure 10. Marine Corps Base, Camp Lejeune, NC. Site of demonstration is within close proximity to the Atlantic Ocean (12).
