**Evaluation of an Army Aviator's Ability to Conduct Ingress  
and Egress of the RAH-66 Comanche Crew Station  
While Wearing the Air Warrior Ensemble**

**ARL-TR-3404**

**December 2004**

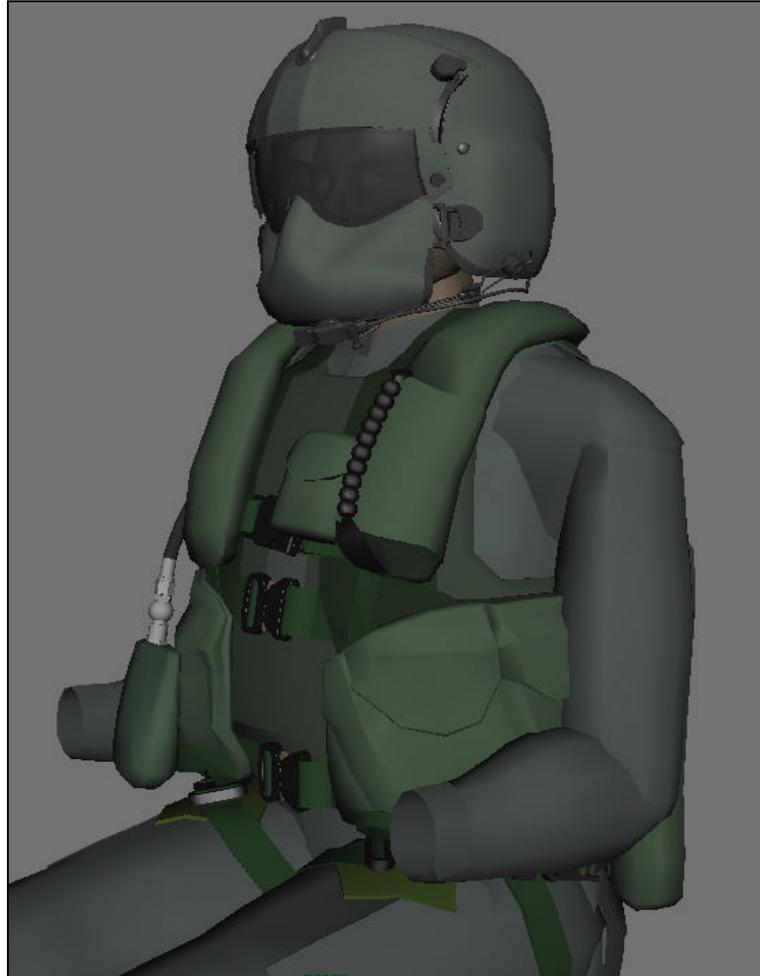
Figure 6. Example of digitized AW ensemble on 3-D human figure model.

Other researchers from ARL modeled AW during its development to gain an understanding of how the ensemble would affect human performance, both cognitive and physical. Kozycki (1998) argued that, over time, growing burdens from a pilot's ALSE have begun to severely degrade helicopter operator performance. Kozycki described an approach to assess the operational impact of AW using three-dimensional (3-D) graphical anthropometric human figure models fitted with digitized ALSE in a software program called Jack<sup>4</sup>. This method of 3-D human figure modeling minimizes the need for an actual aircraft or physical mock-up early in the design process. This is particularly important in the case of the RAH-66 since only two prototypes are available, and access to these is very limited. See figure 6 for a recent example of the AW ensemble applied to human figure model in Jack.

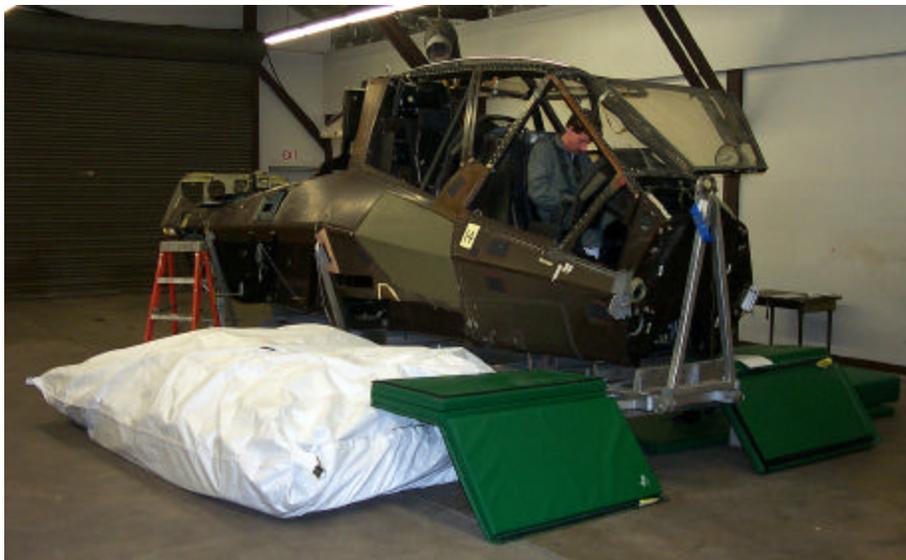
Figure 8. Comanche structural test article (STA) mock-up. (Note the foam mats and Tyvek bag for safety.)

Several safety measures were in place during the conduct of the evaluation. First and foremost, at least two (sometimes three) spotters were next to the aircraft during all trials to assist, even support, the participants if necessary for safety reasons. However, the spotters did not support the weight of a participant unless injury was imminent. Mats were placed around the mock-up to minimize injuries to participants if they fell during the trials. A 12- by 10-foot mass of foam blocks, enclosed in a Tyvek<sup>6</sup> protective cover, was positioned underneath the appropriate side for emergency egress trials. See figure 8 for an image of some of the safety matting used.

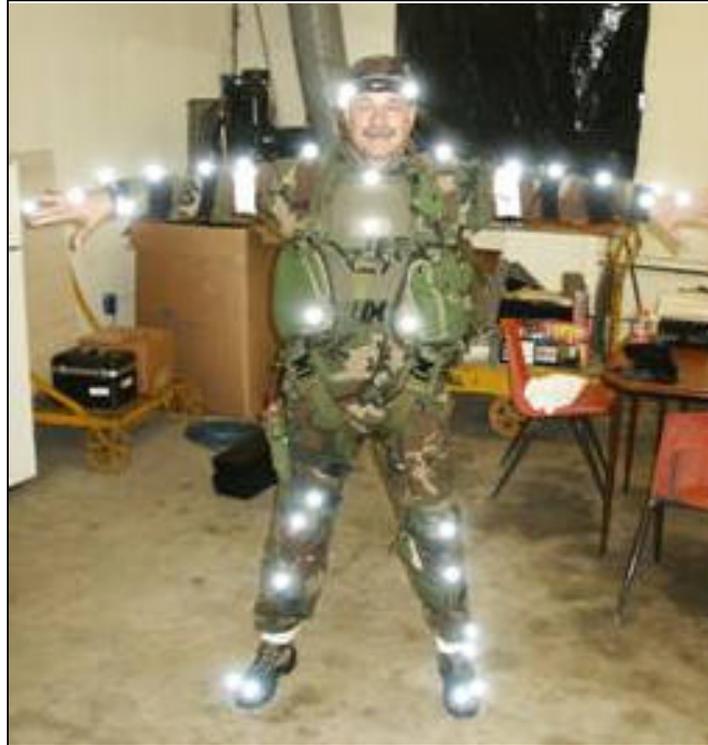
Figure 9. Large male wearing the motion capture body markers.

markers were attached to the participants with tape and elastic bands to keep them as close to the body as possible. The foot markers had to be taped onto the boots near the foot landmarks. For the head, the markers had to be attached to the HIDSS instead. Another problem encountered with markers was that some of them frequently became dislodged from their attachment points as the participants came into contact with crew station components or canopy frame structure during trials (especially emergency egress trials).

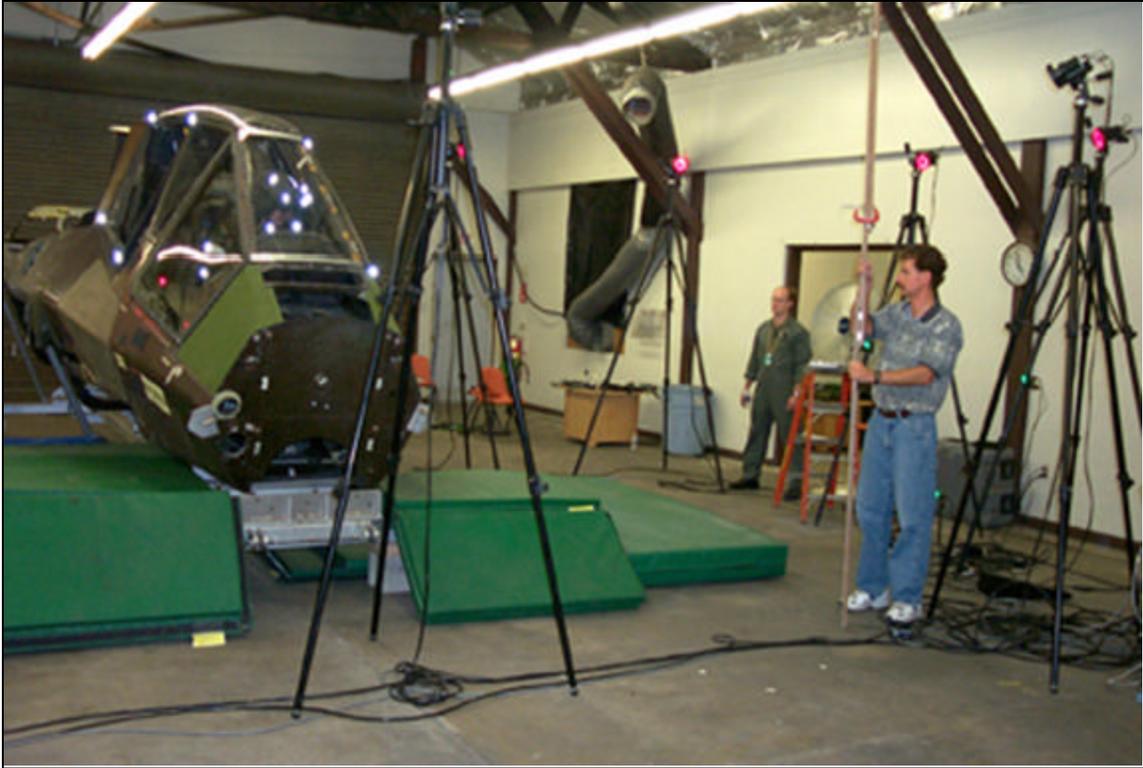
Figure 10. Placement of the infrared motion capture cameras around the STA.

The most challenging problem with collecting motion capture data for this evaluation was the obscuration of the markers to the cameras. Most motion capture applications usually take place in an open, unobstructed environment. For this evaluation, the Comanche crew station components, canopy frame structure, safety spotters, and even the safety mats often obscured the markers from the cameras, especially those markers on the lower extremities. The standard infrared cameras were set up on tripod mounts elevated approximately 10 feet off the ground in order to gain optimal exposure to the markers (see figure 10).

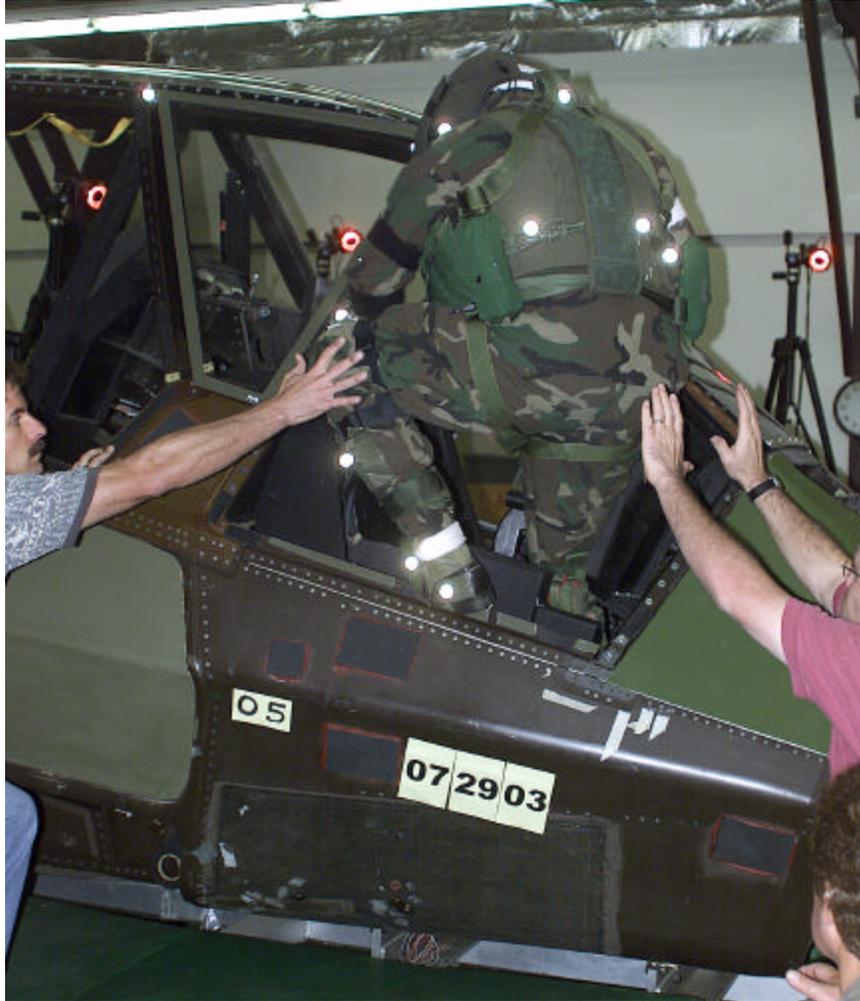
Figure 11. Large percentile male participant conducts an emergency egress from the front crew station through the right window by standing on the edge of the window. (If the participants had stood to full height, the rotor system on a real aircraft would have likely contacted his head. This situation would have been exacerbated by an egress from the rear crew station.)

The STA mock-up lacks nearly every normal subsystem that would typically be installed on a helicopter. In particular, there is no rotor blade system, and the lack of one became especially highlighted during the pilot study conducted in early June 2003. During the pilot study and formal trials, several people conducted emergency egress trials out the right window by actually standing up on the edge of the right window (instead of simply swinging their legs over and sitting) before jumping out and to the safety mats below. As they stood up to almost full height, each became aware that his or her head would have almost certainly come into contact (probably fatally) with the still-spinning rotor system, even if it had little kinetic angular velocity and energy remaining as it wound down (see figure 11). For this evaluation, subjects were briefed about the lack of a rotor system and to be cognizant of where the tip-path plane of the rotor blades would likely be during an emergency egress.

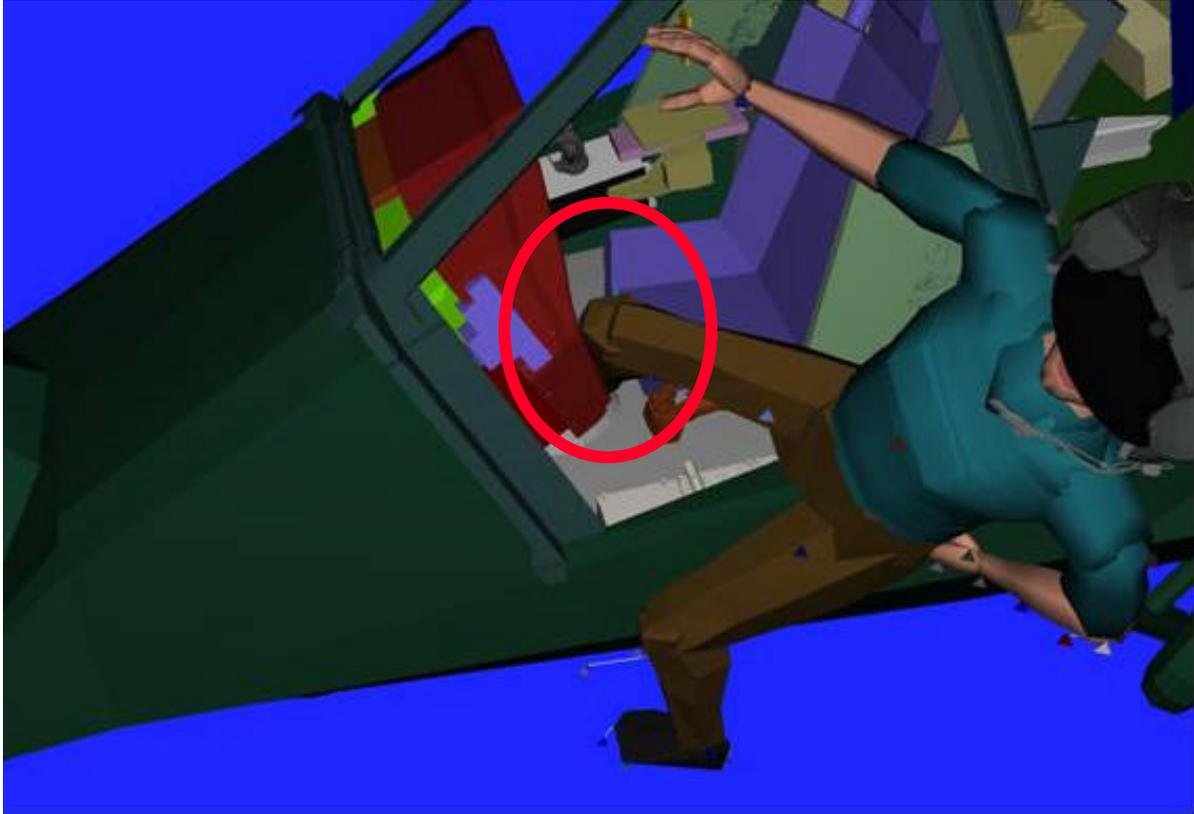
Figure 14. Jack and motion capture data show problem with the LMPD and glare shield by the large male pilot.

Even with the difficulties encountered in collecting motion capture data, a replay of the motion capture from various viewing angles with the Jack software helped us to detect some of the problems encountered by the large male pilot during the early trial exercises. In particular, during egress of the forward crew station, the motion capture clearly shows how the large male pilot had some difficulty clearing the knee and foot past the outboard edge of the glare shield on the left-hand side of the instrument panel (see figure 14). This analysis graphically confirms observations from the participants and authors during multiple trials.
